Dilapidation Building Report

Property: john street SAMPLE

Report Number: 857809A

Sydney Building Consultants was commissioned by to carry out a building dilapidation report on the above property. The purpose of this inspection is to provide a report on the current condition of the property prior to construction commencing on number **SAMPLE**

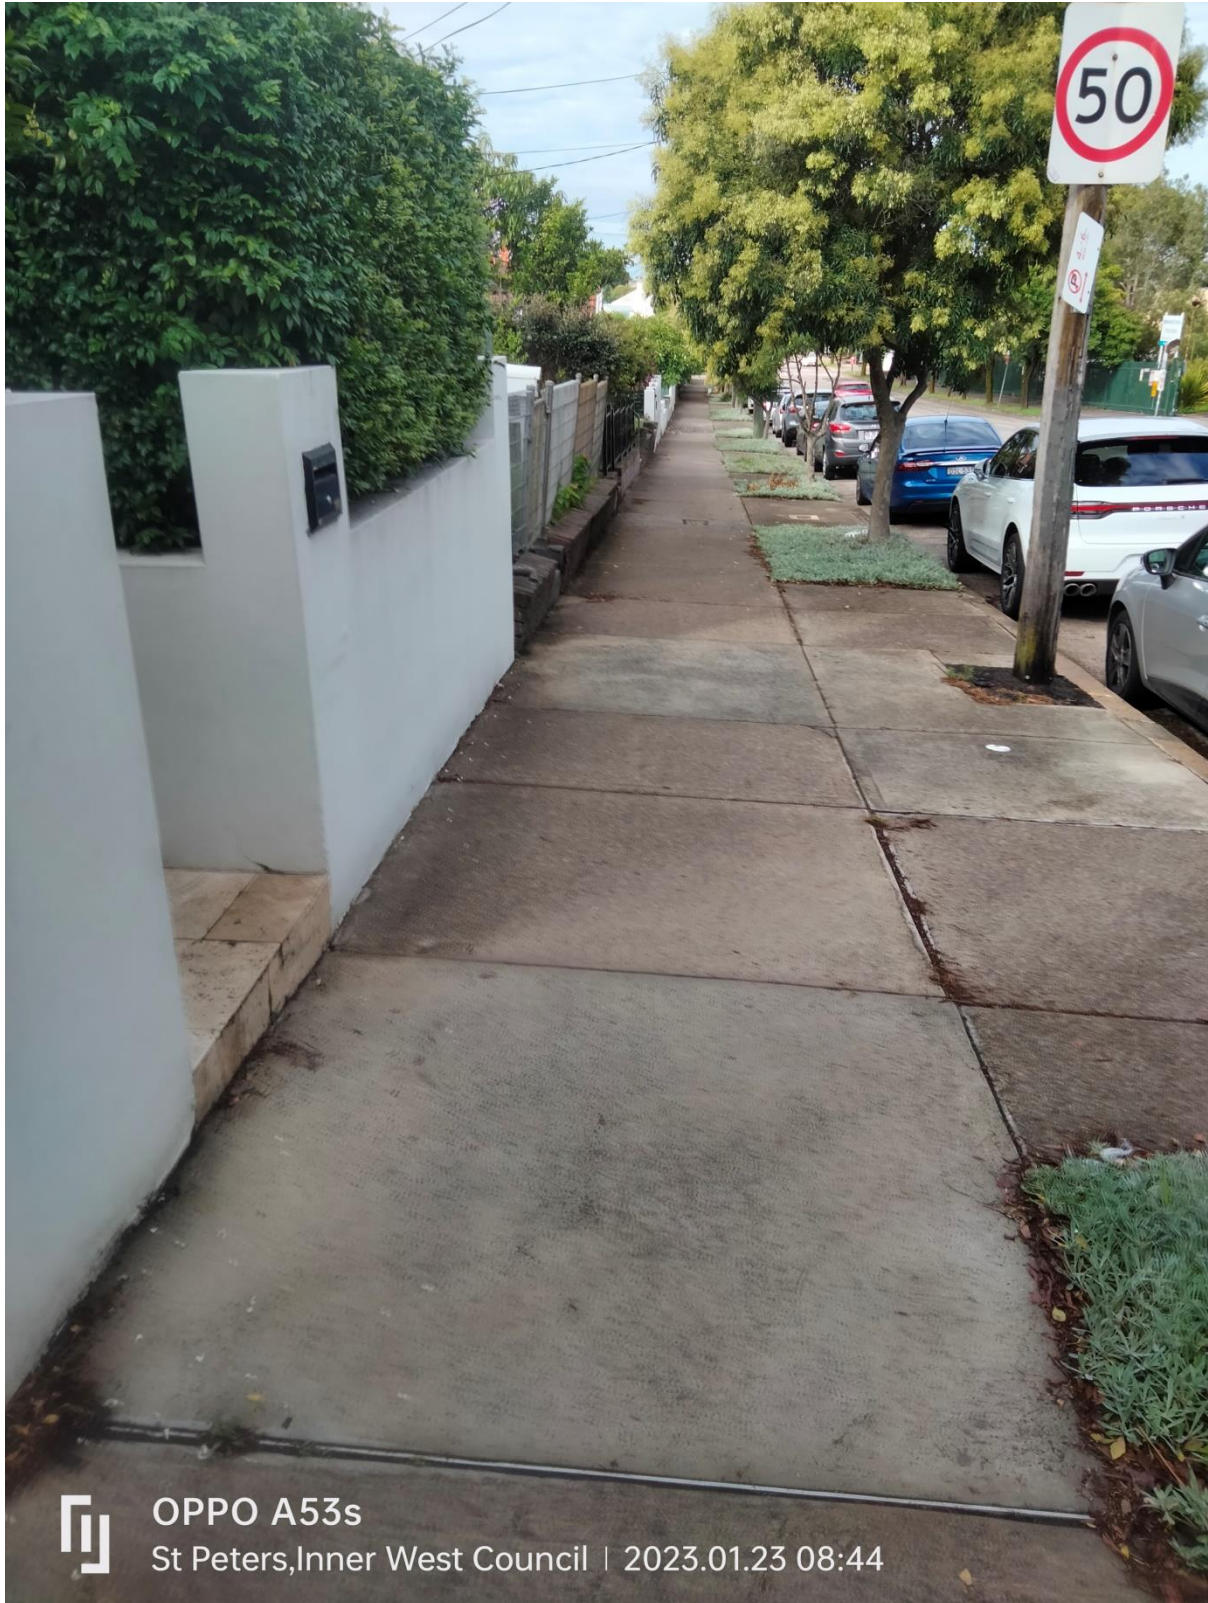
Figure 1 frontage foot path view.

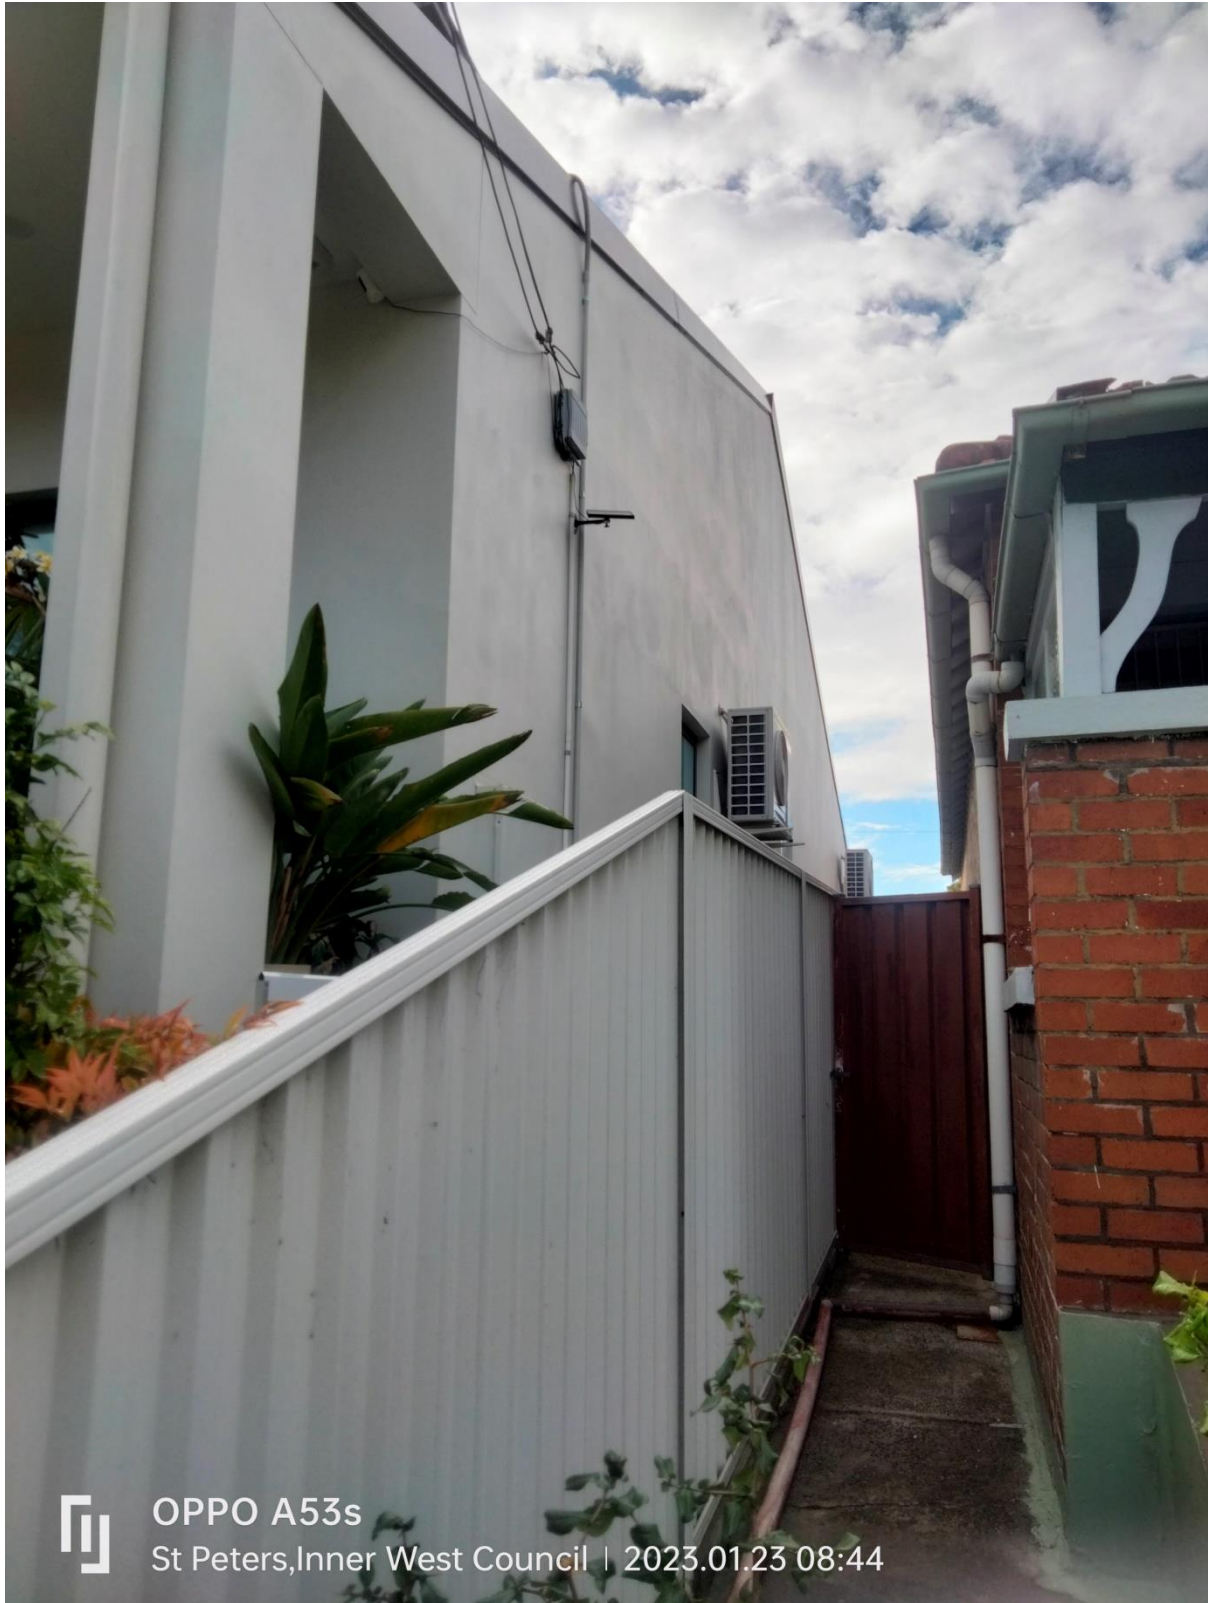
Figure 2 right hand side view of 118.

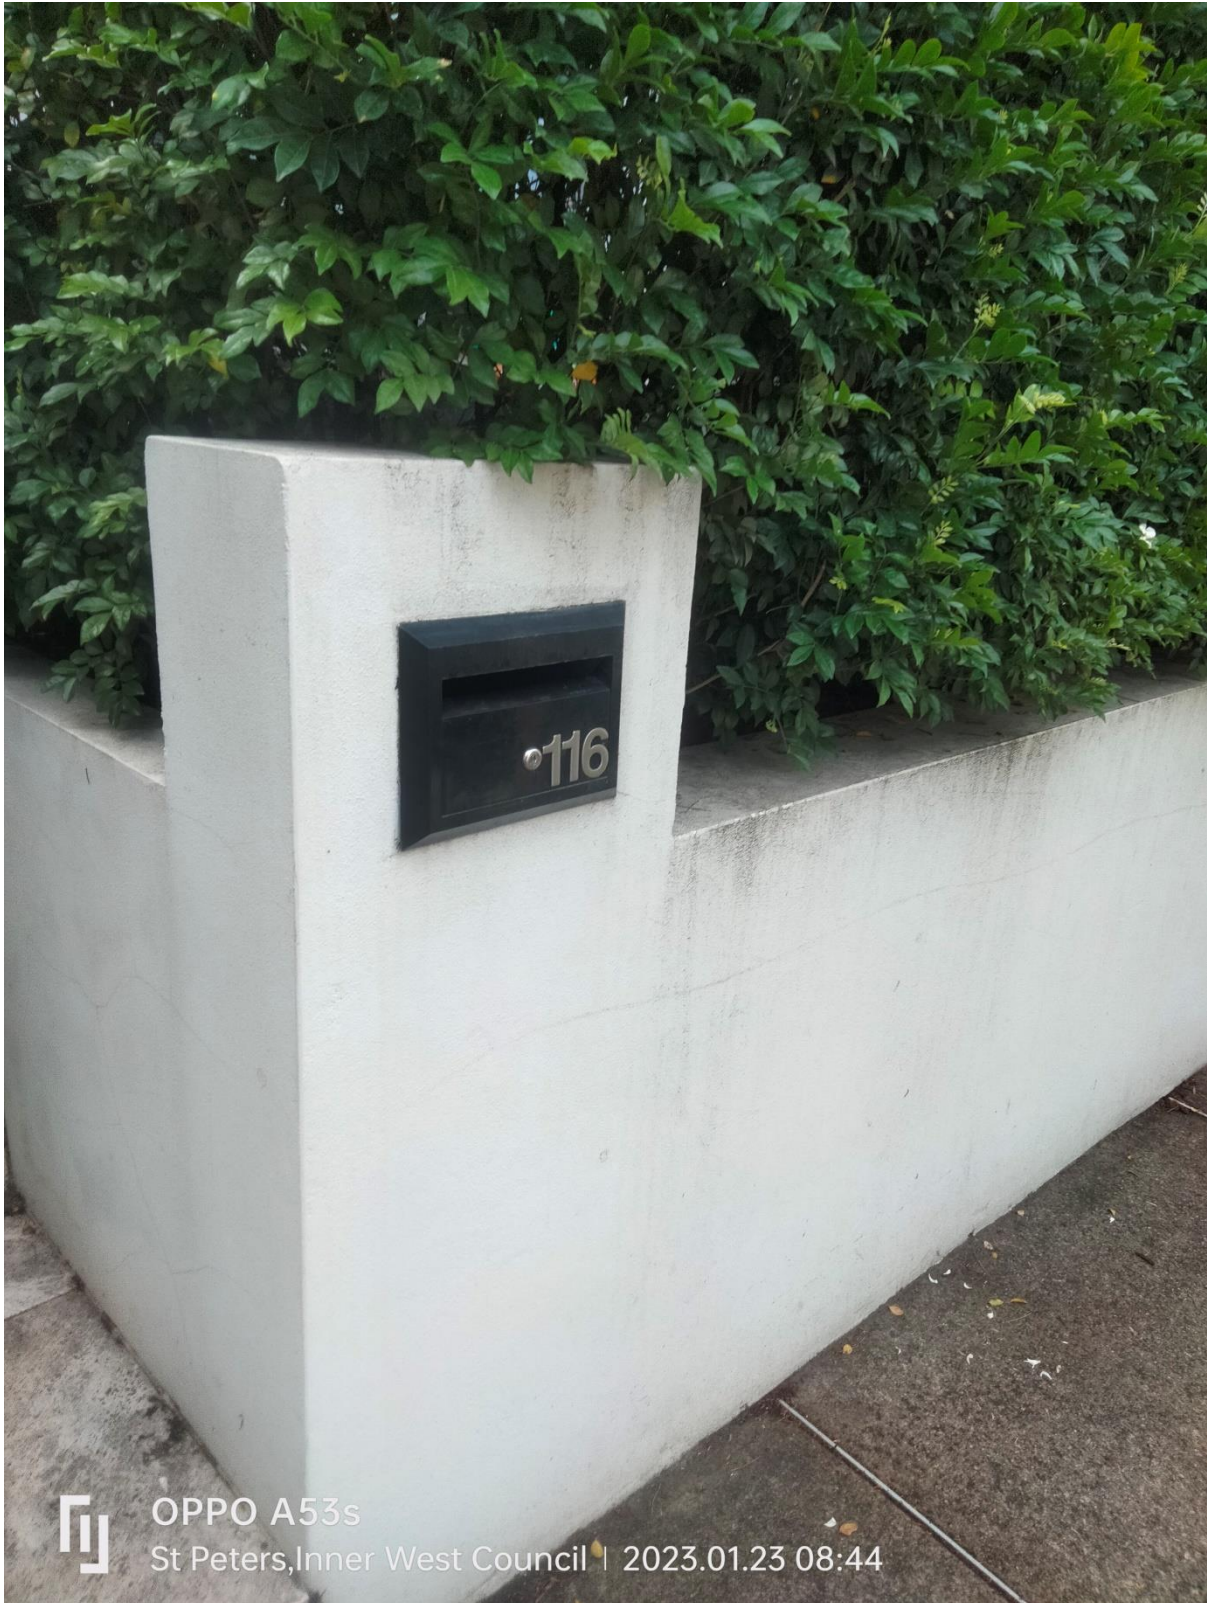
Figure 3 116 was inspected only at the frontage location no access was granted internally by the home owner.

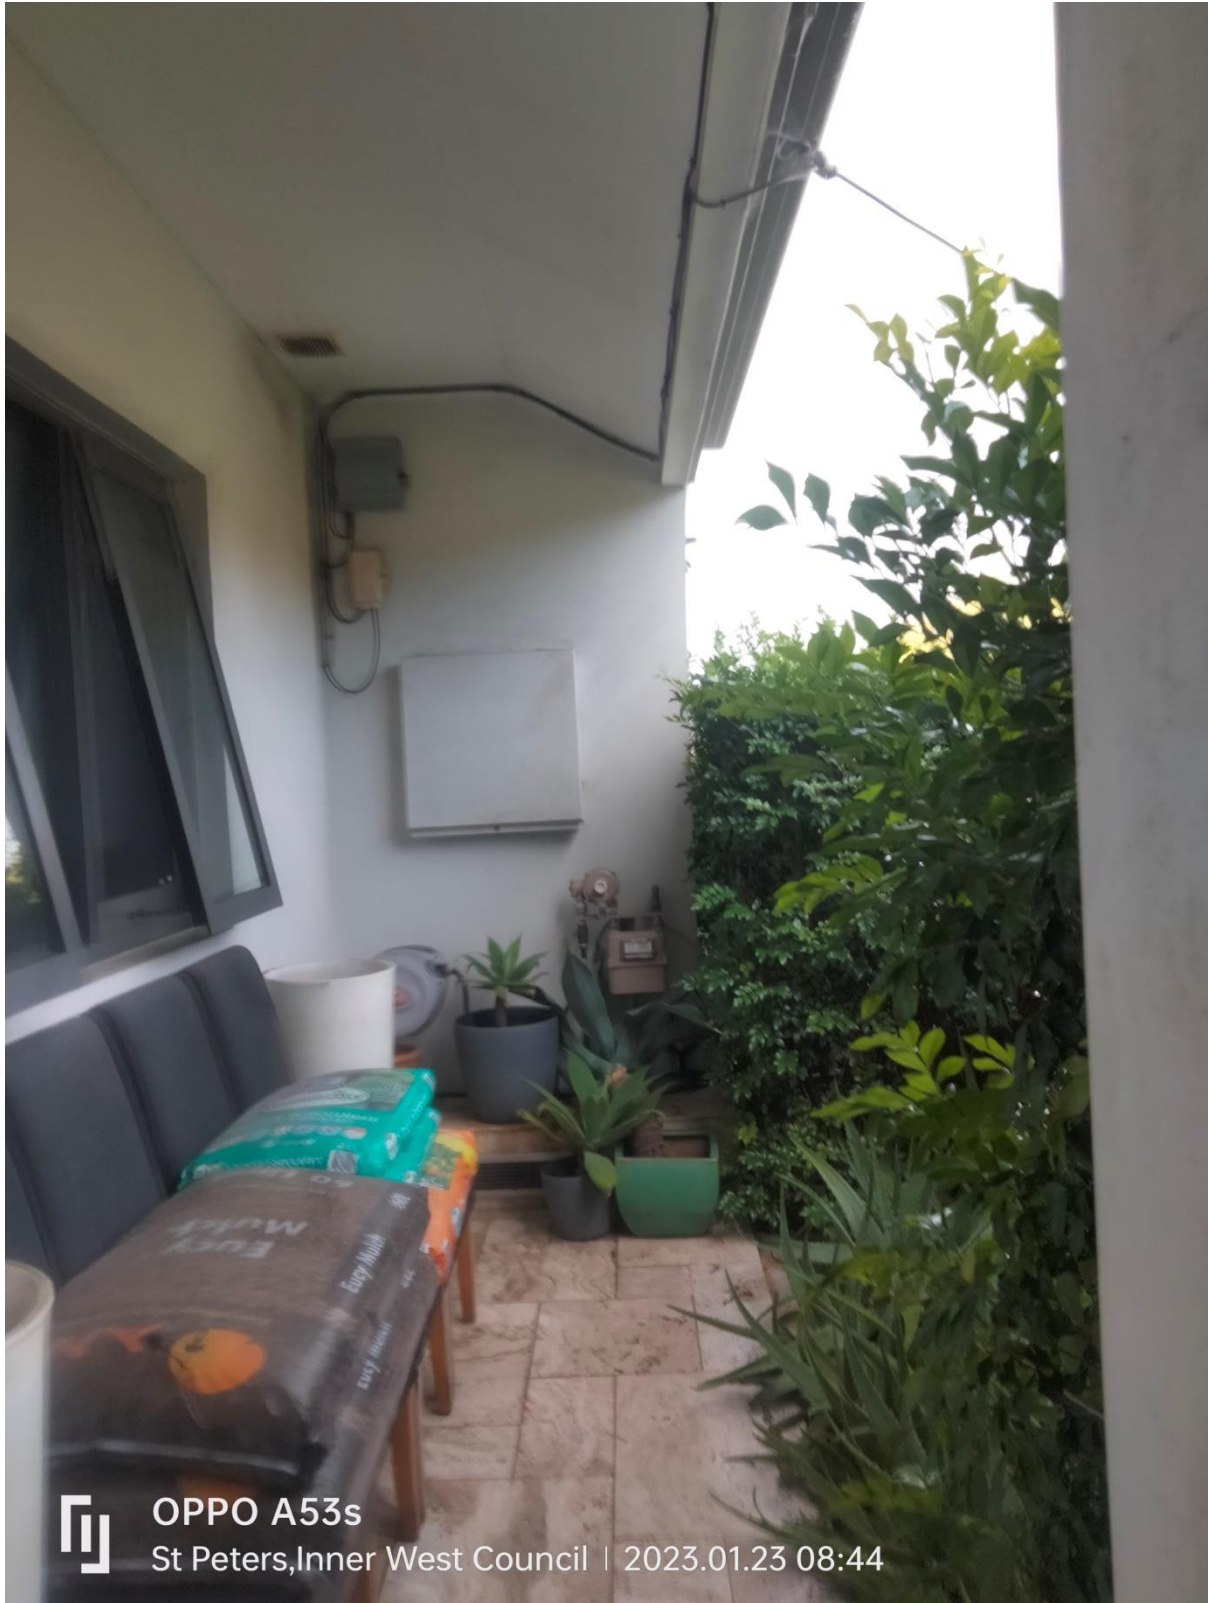
Figure 4 dividing wall between number 116 and 118.

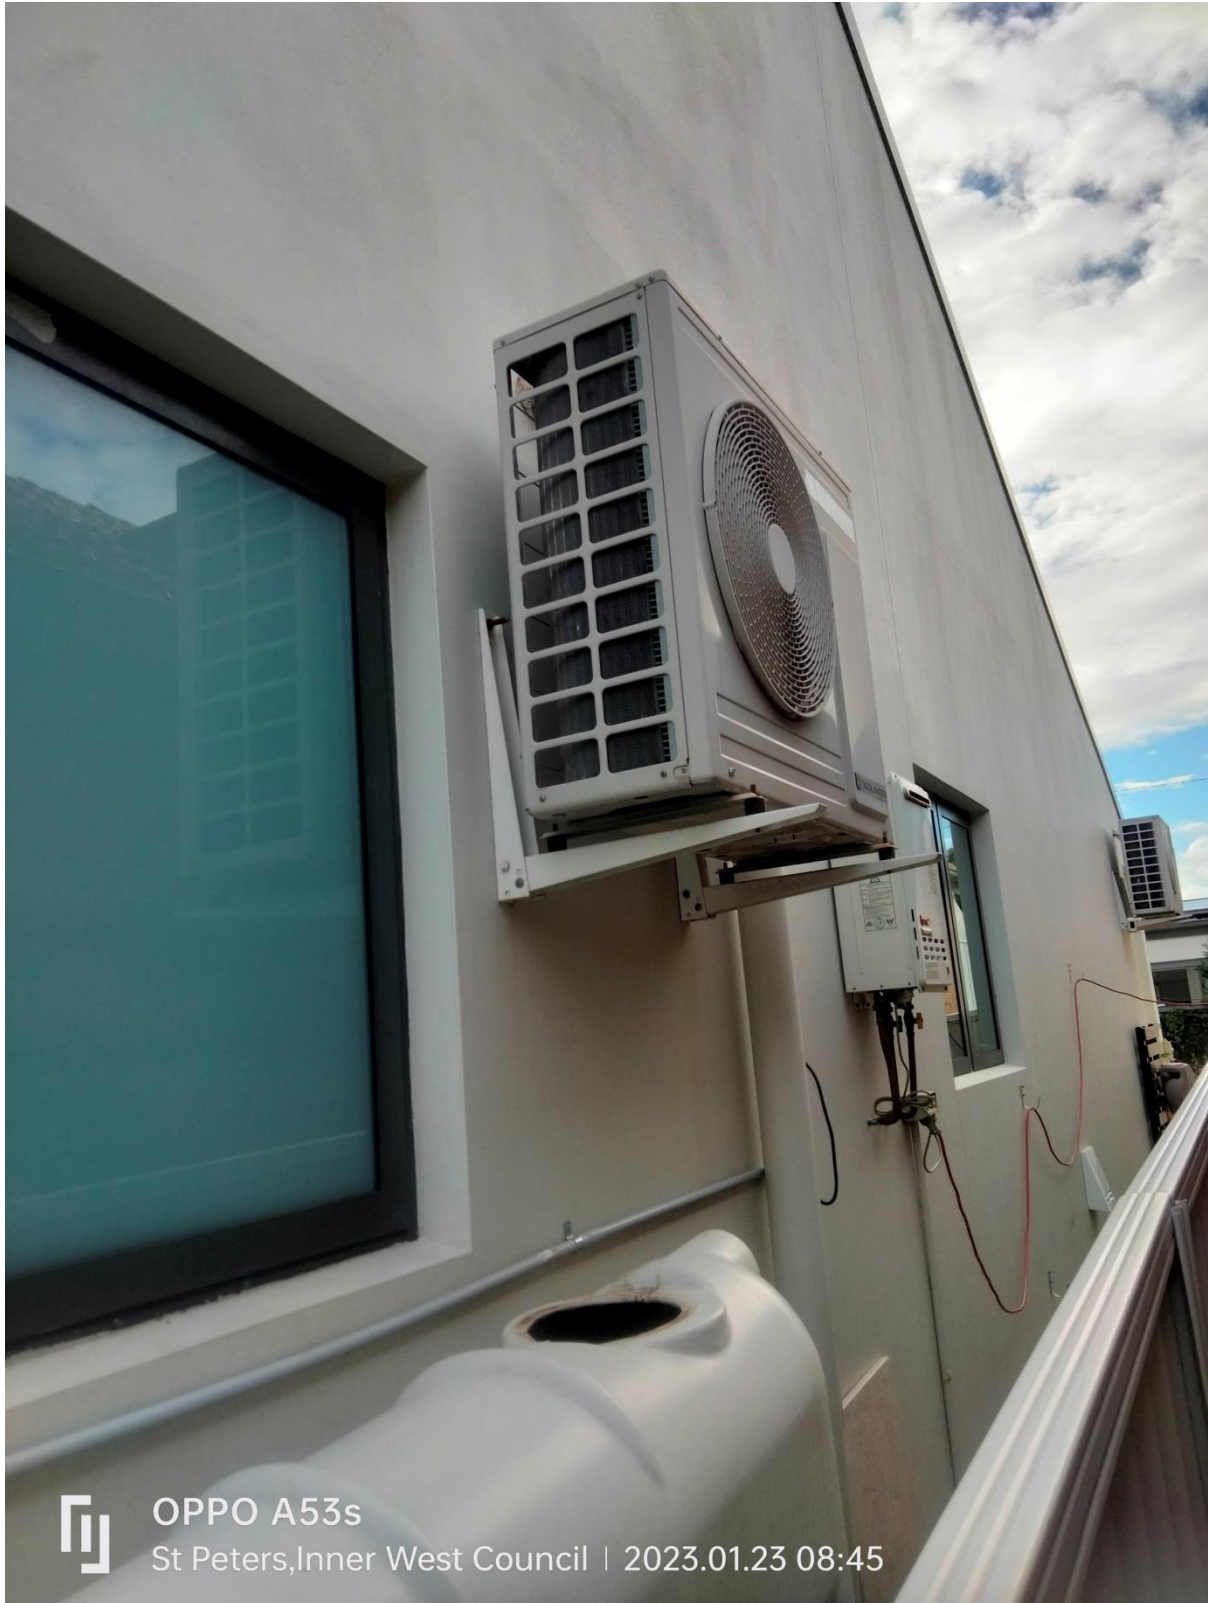
Figure 5 view from number 120.

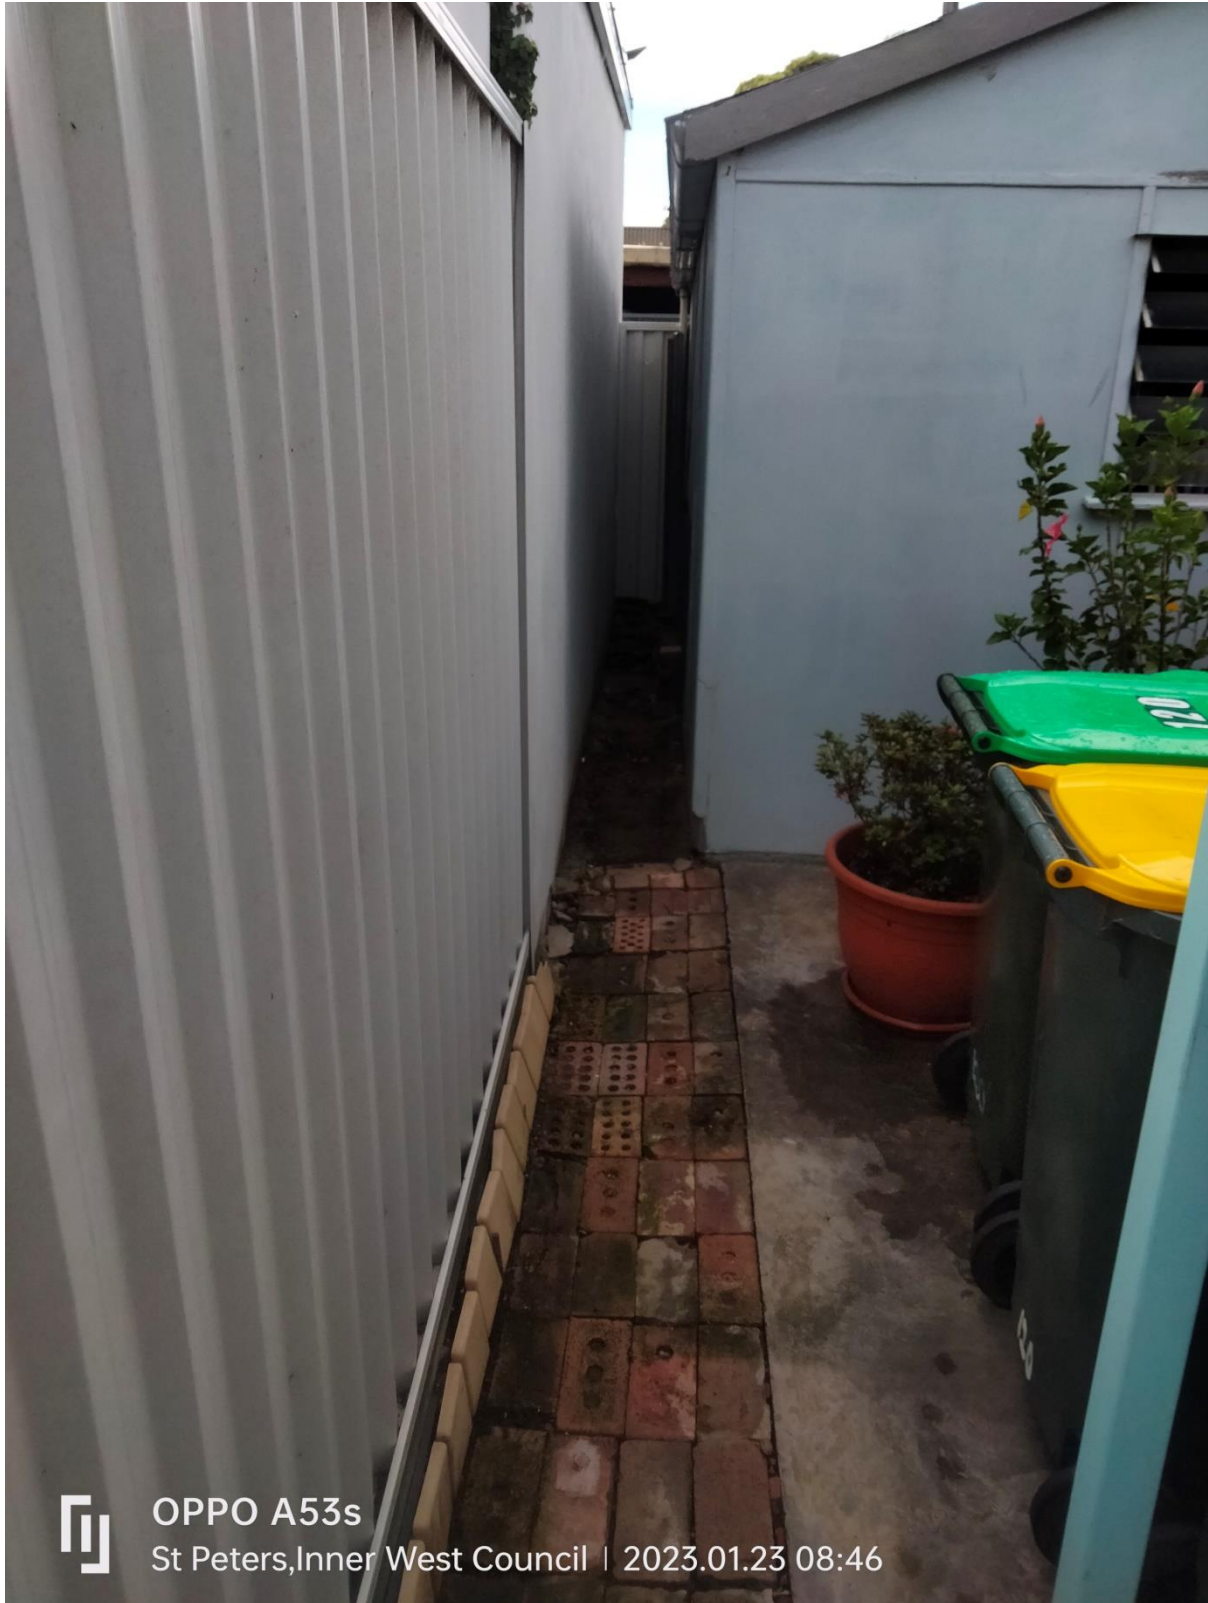
Figure 6 rear of the neighbouring number 120.

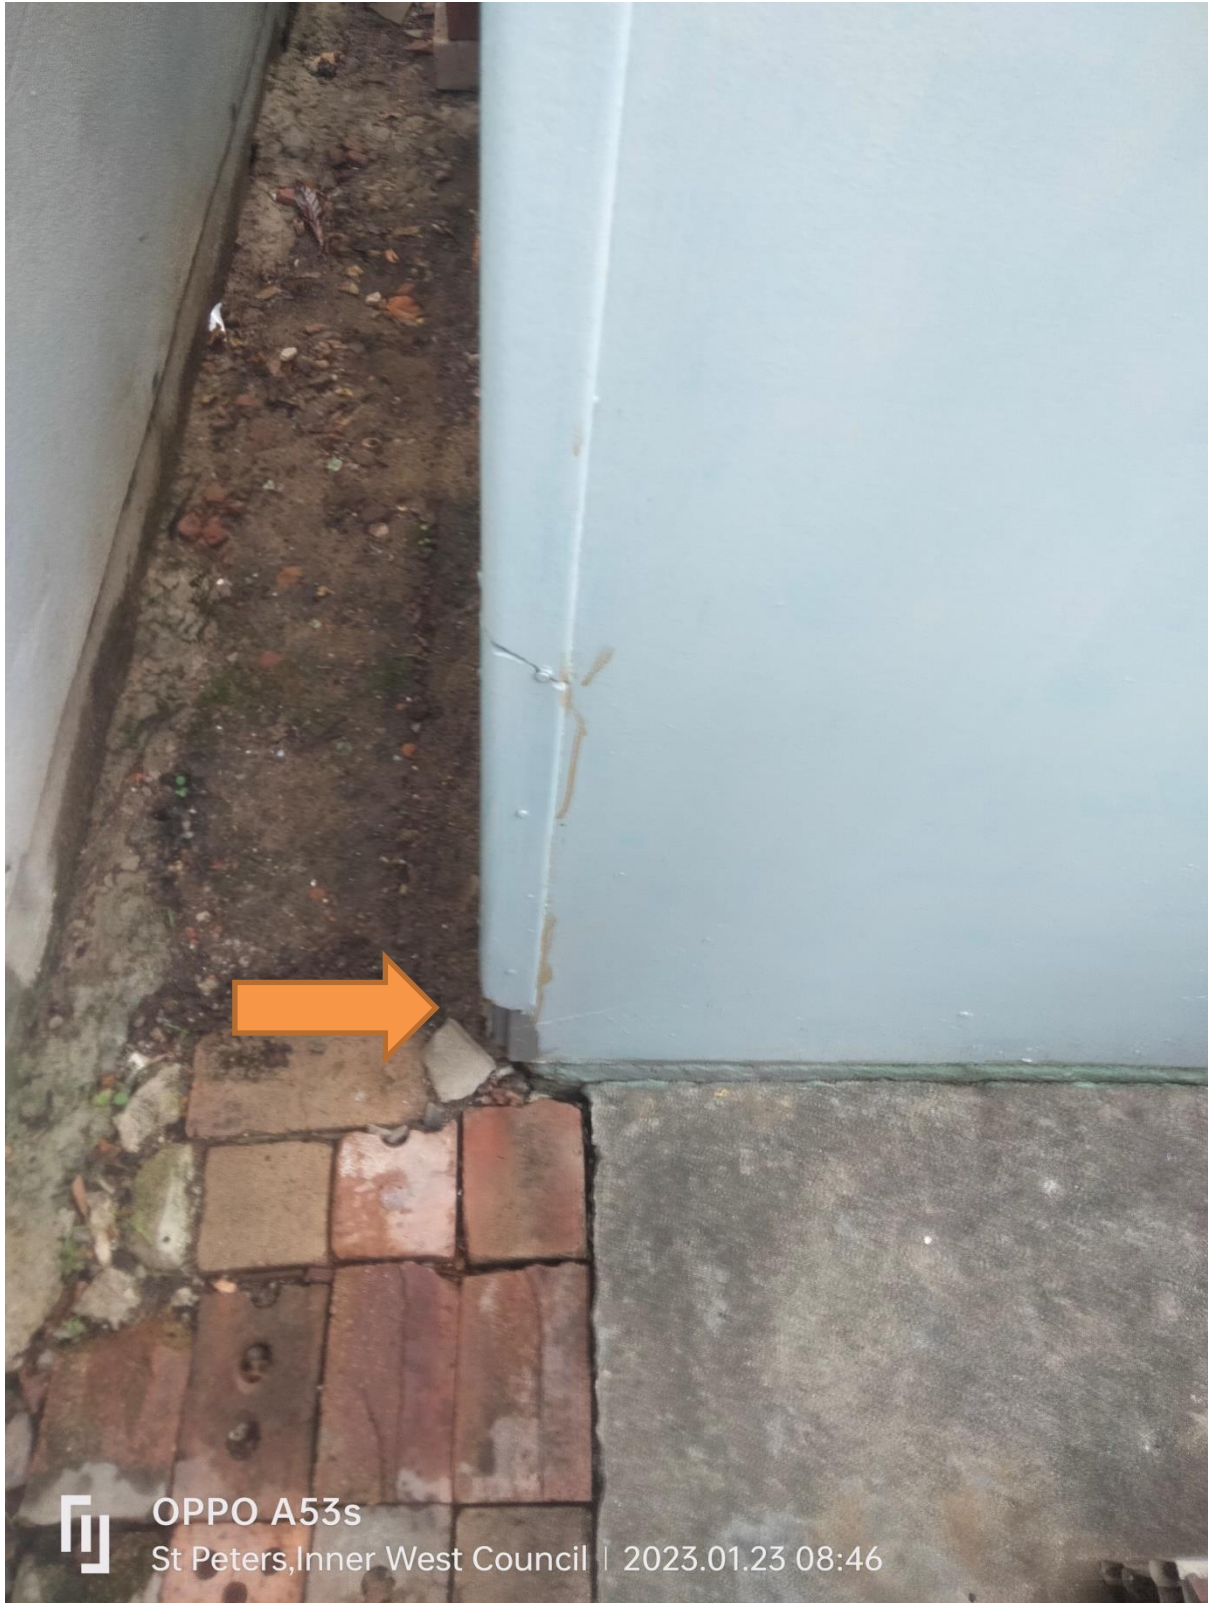
Figure 7 impact damage observed to the garage of number 120.

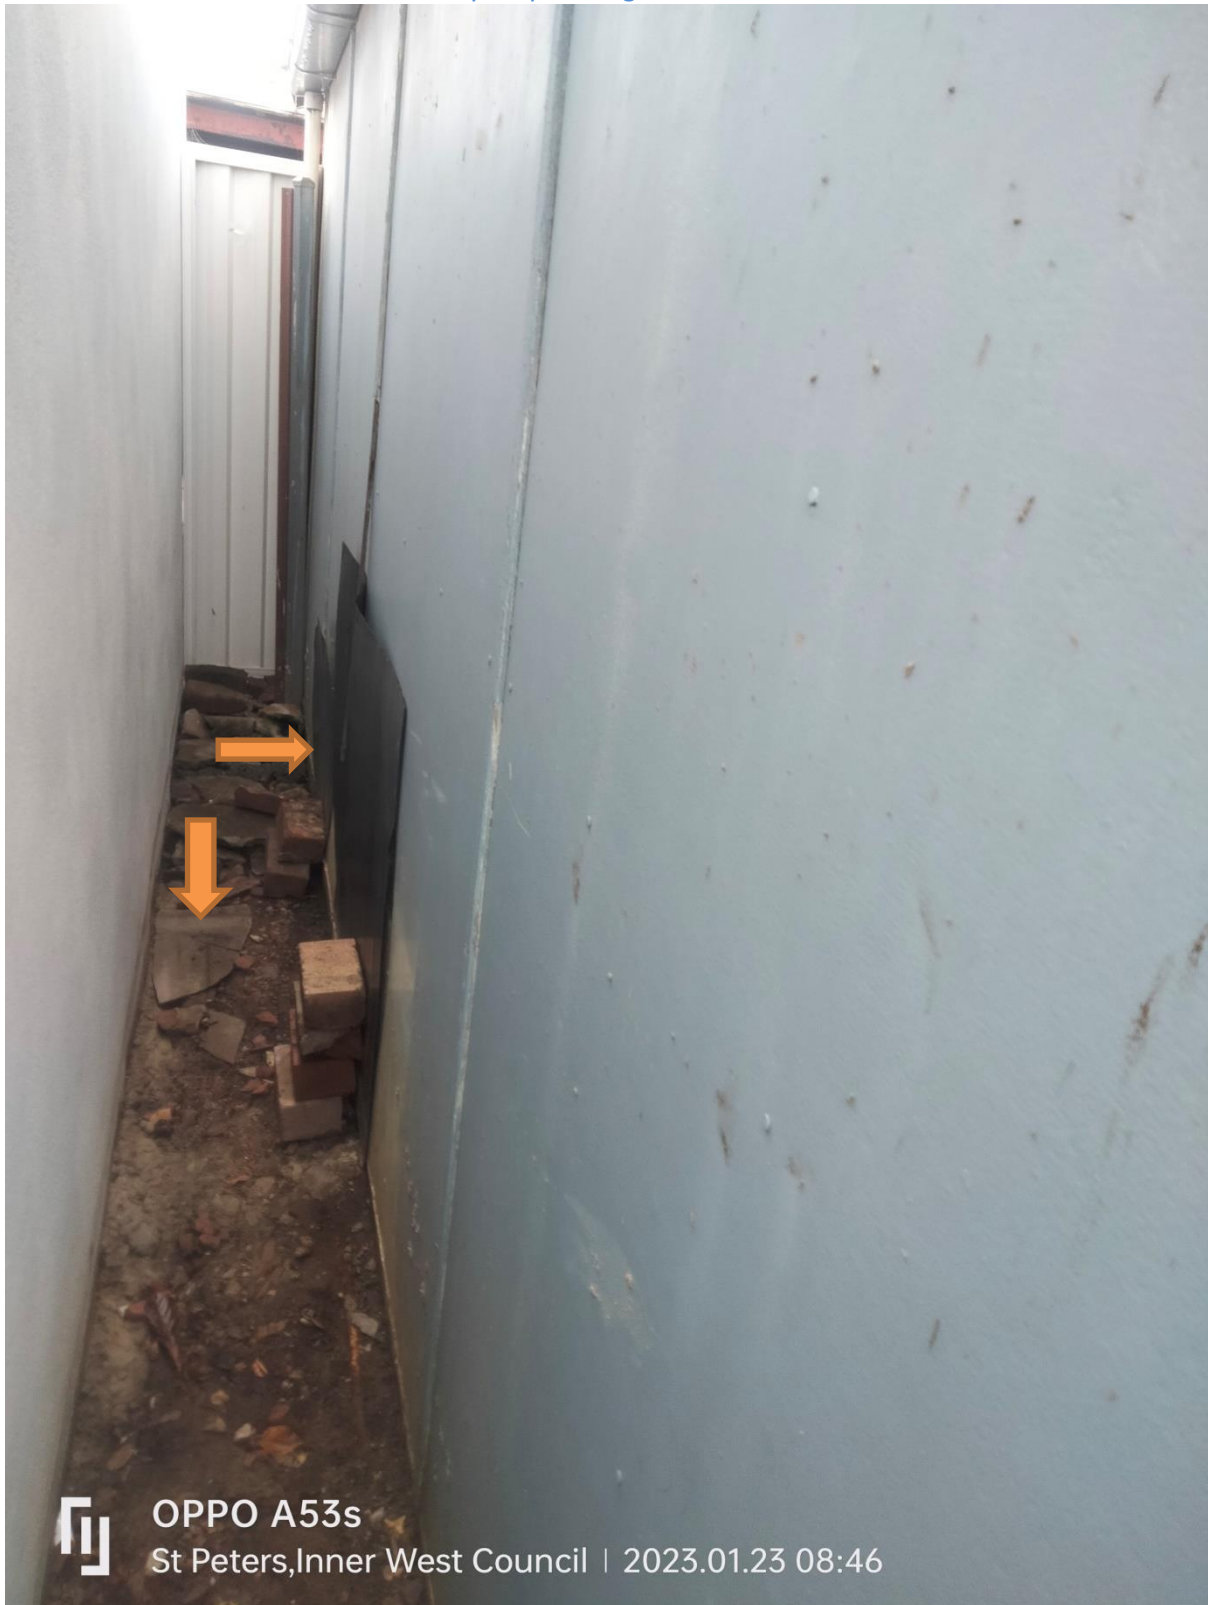
Figure 8 existing impact damage to number 120 garage location, I note asbestos was evident on the floor dividing the two garages.

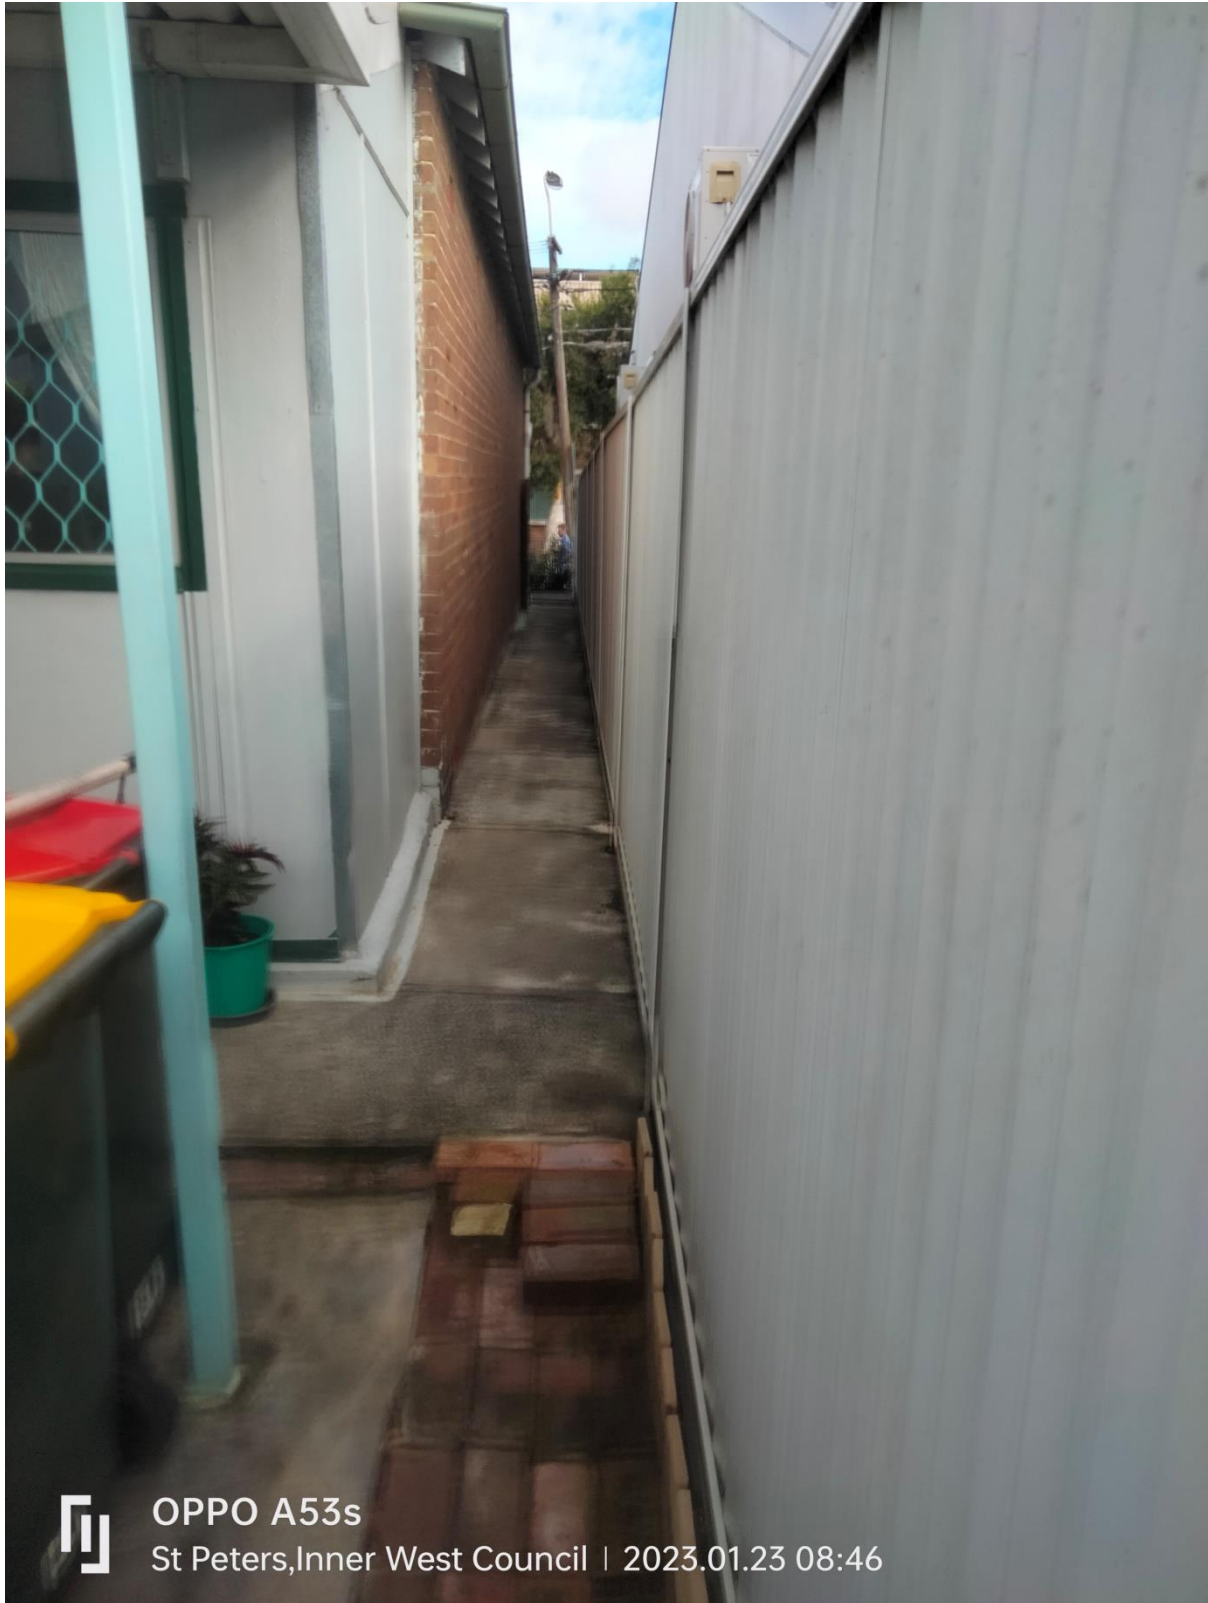
Figure 9 view from the rear of number 120 to the front street showing a brick pathway and concrete Paththway area.

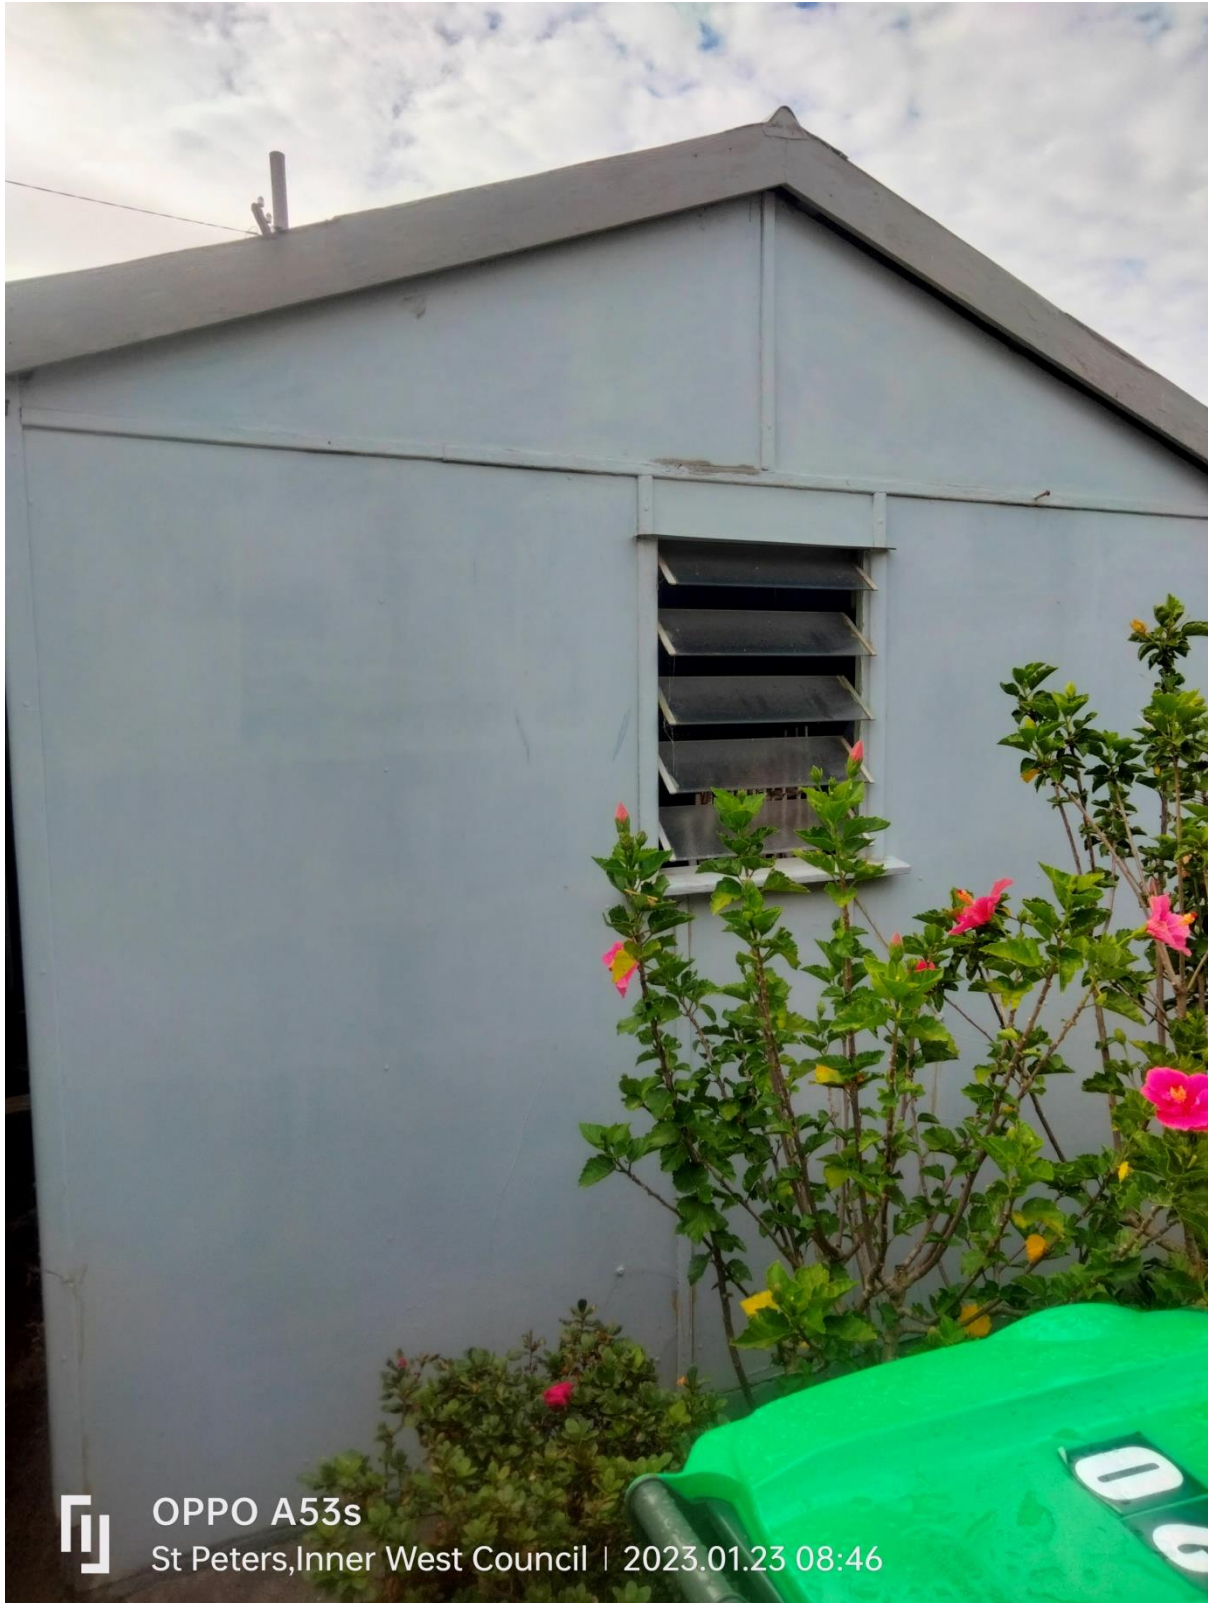
Figure 10 exterior front of the garage at number 120.

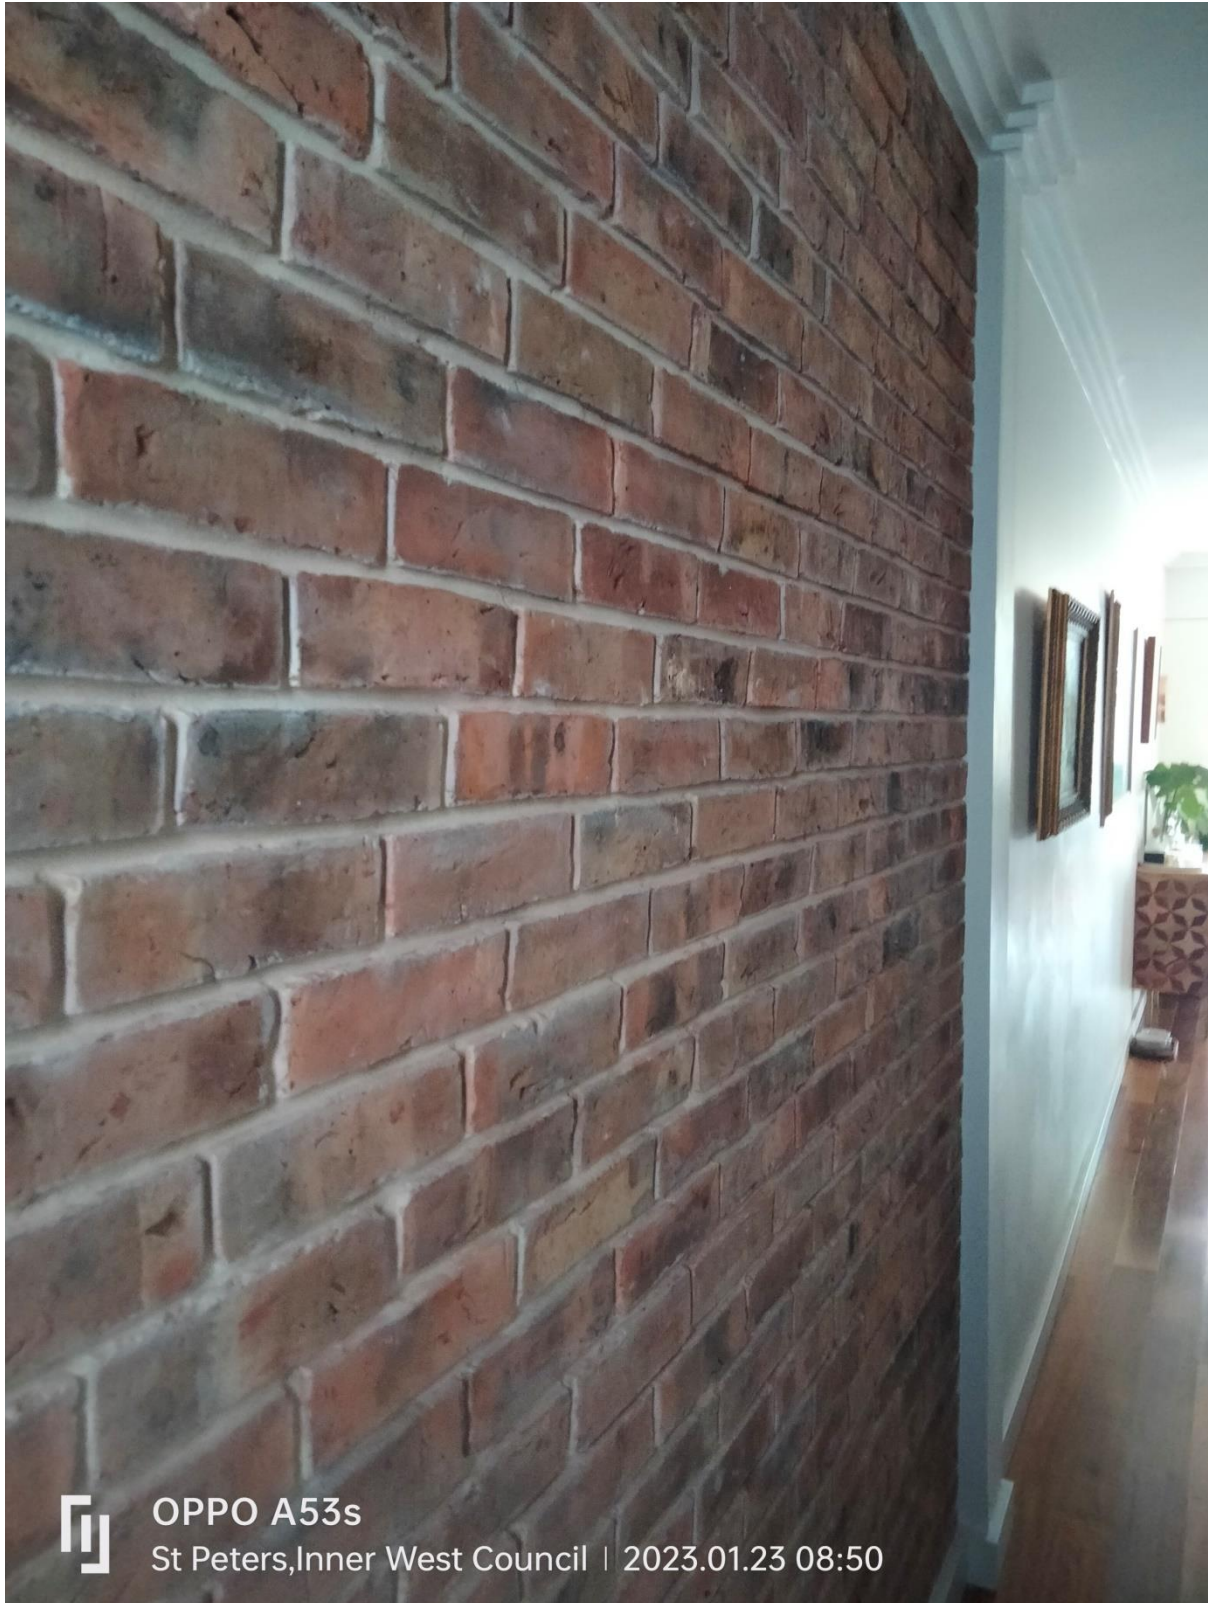
Figure 11 the interior dividing wall located between 116 and 118 was visually accessed by the home owner.
