Dilapidation Building Report

Property: john street SAMPLE

Report Number: 857809A

Sydney Building Consultants was commissioned by to carry out a building dilapidation report on the above property. The purpose of this inspection is to provide a report on the current condition of the property prior to construction commencing on number **SAMPLE**

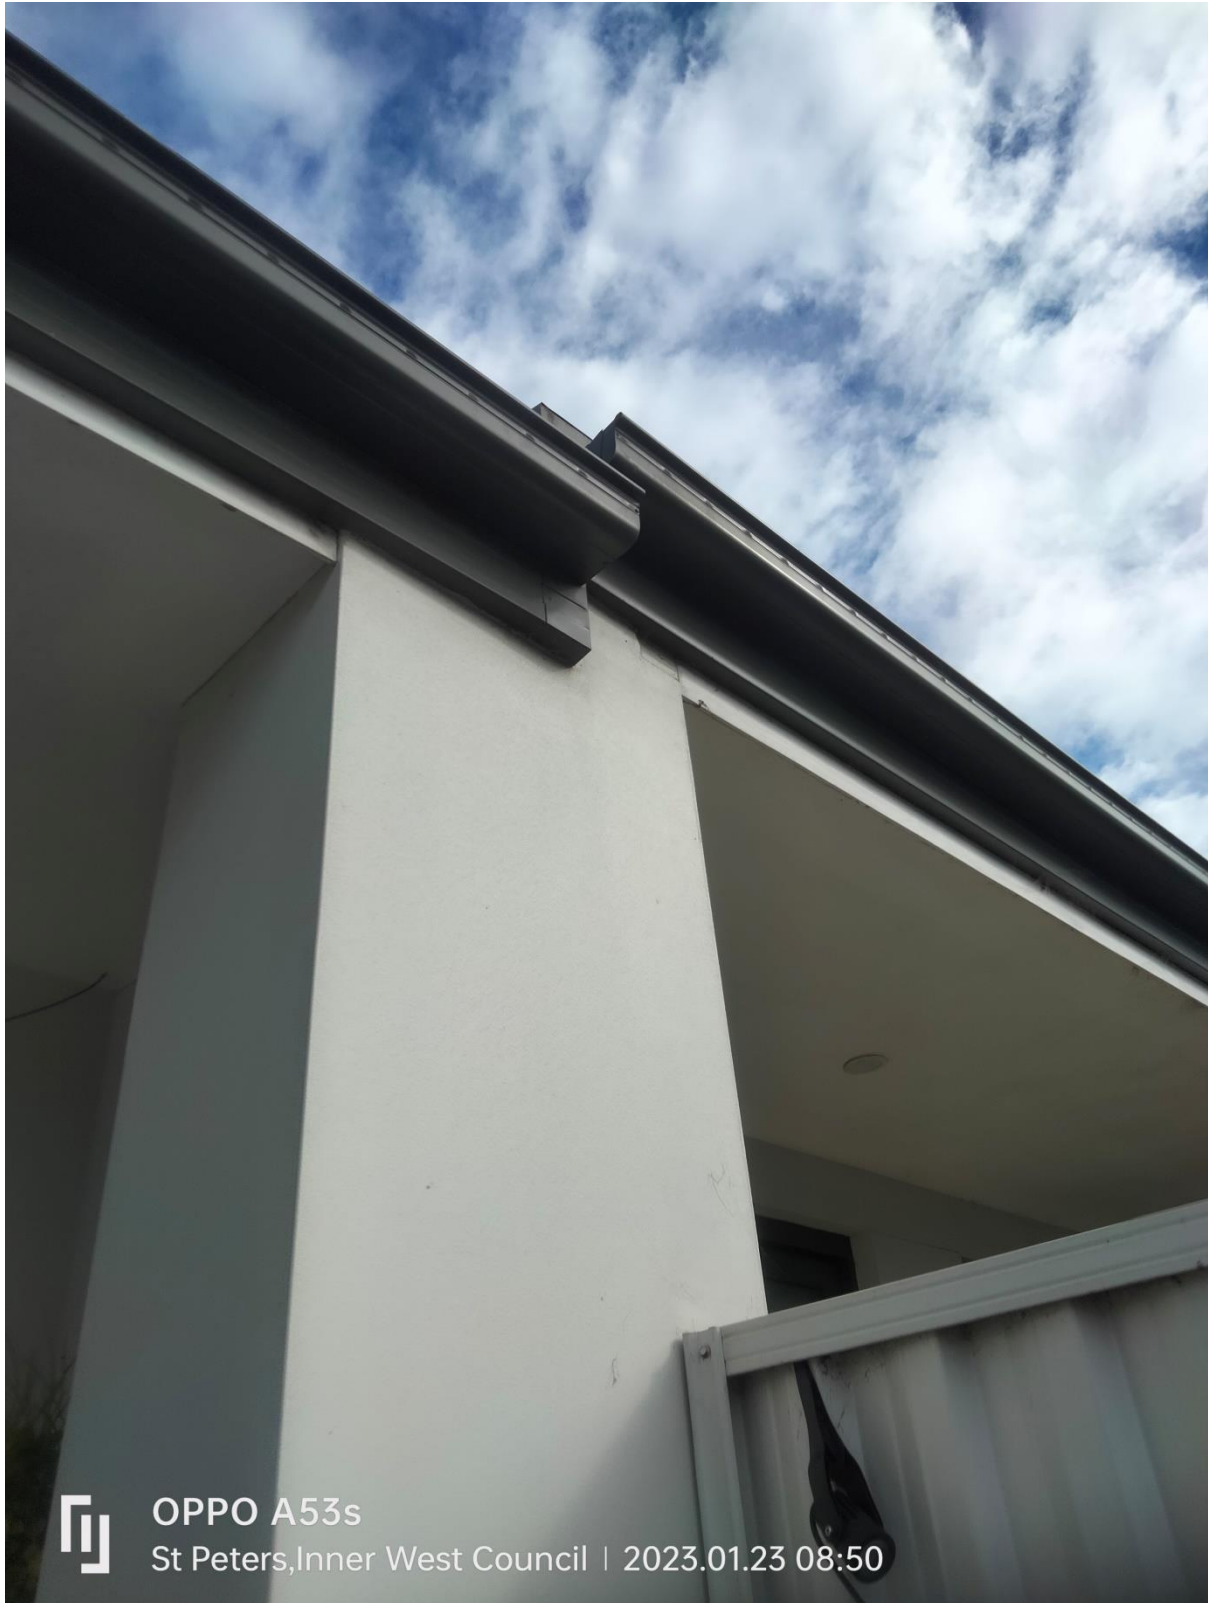
Figure 12 the rear of 116 and number 118 adjoining pier was photographed.

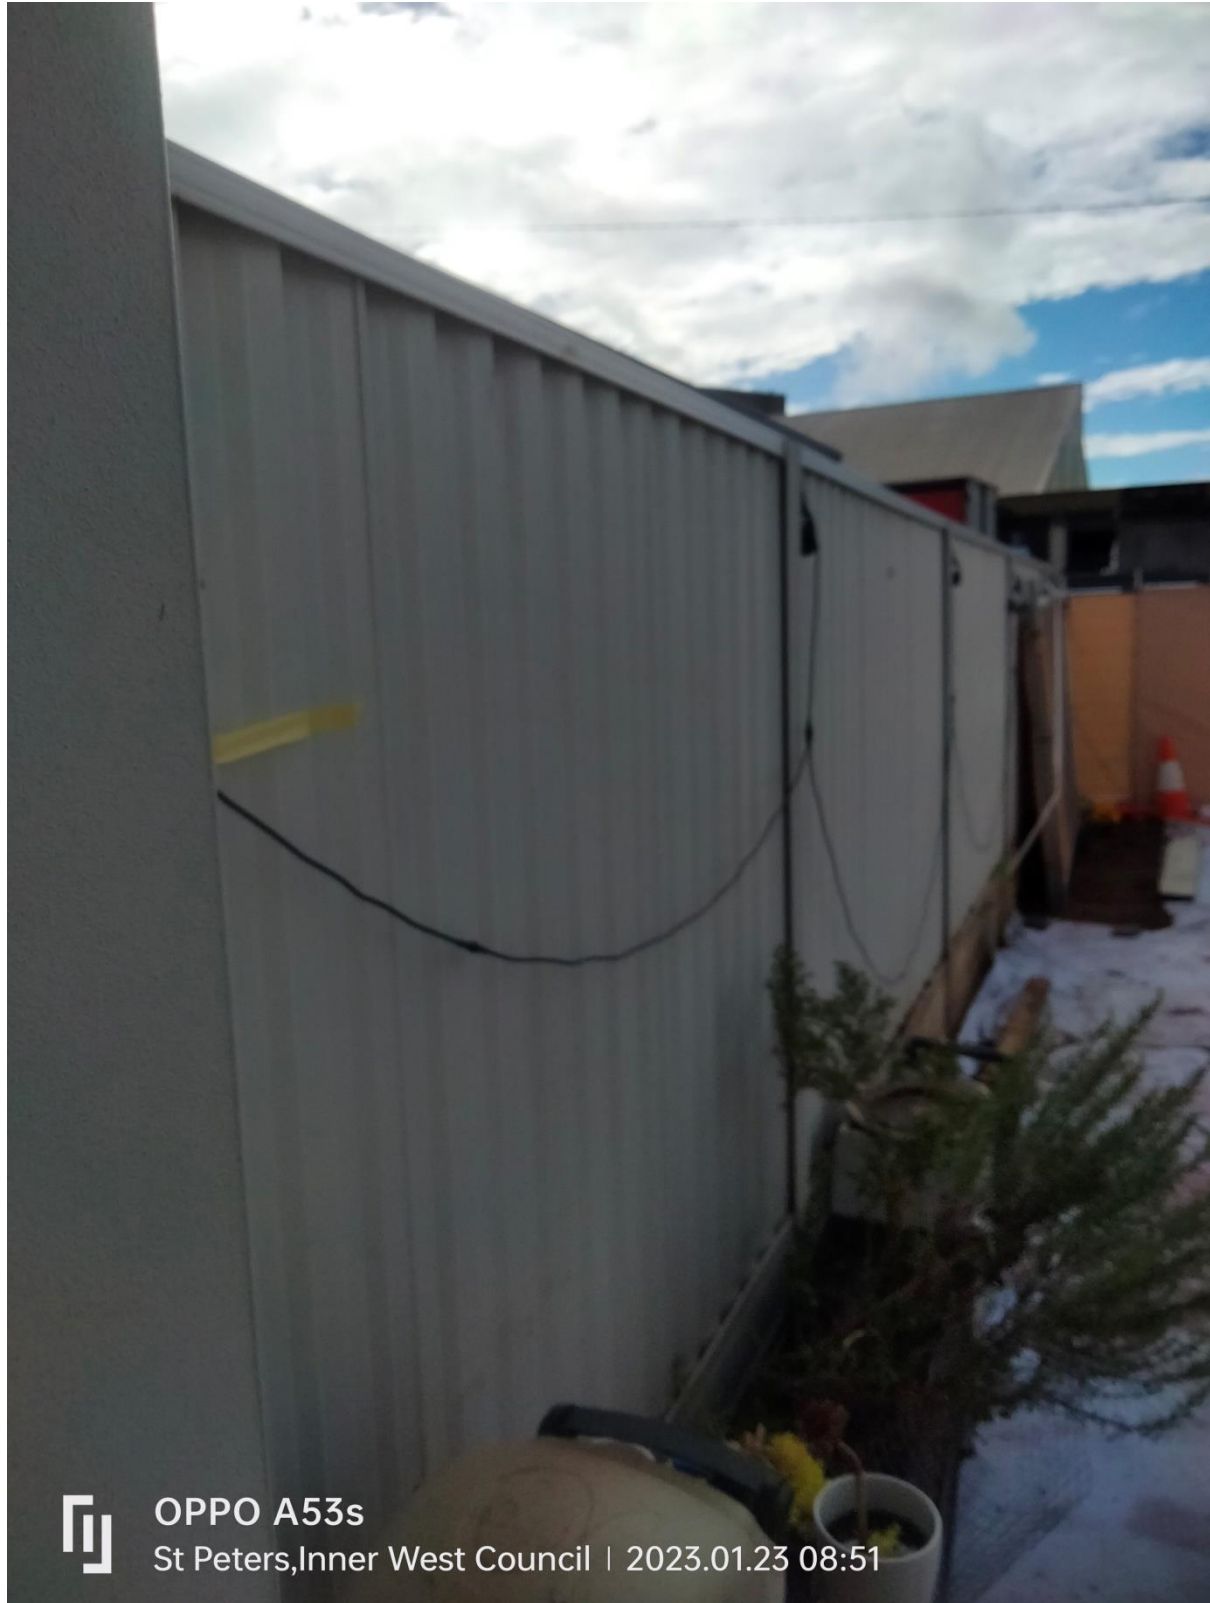
Figure 13 the dividing metal fence between 118 and 116 rear view.

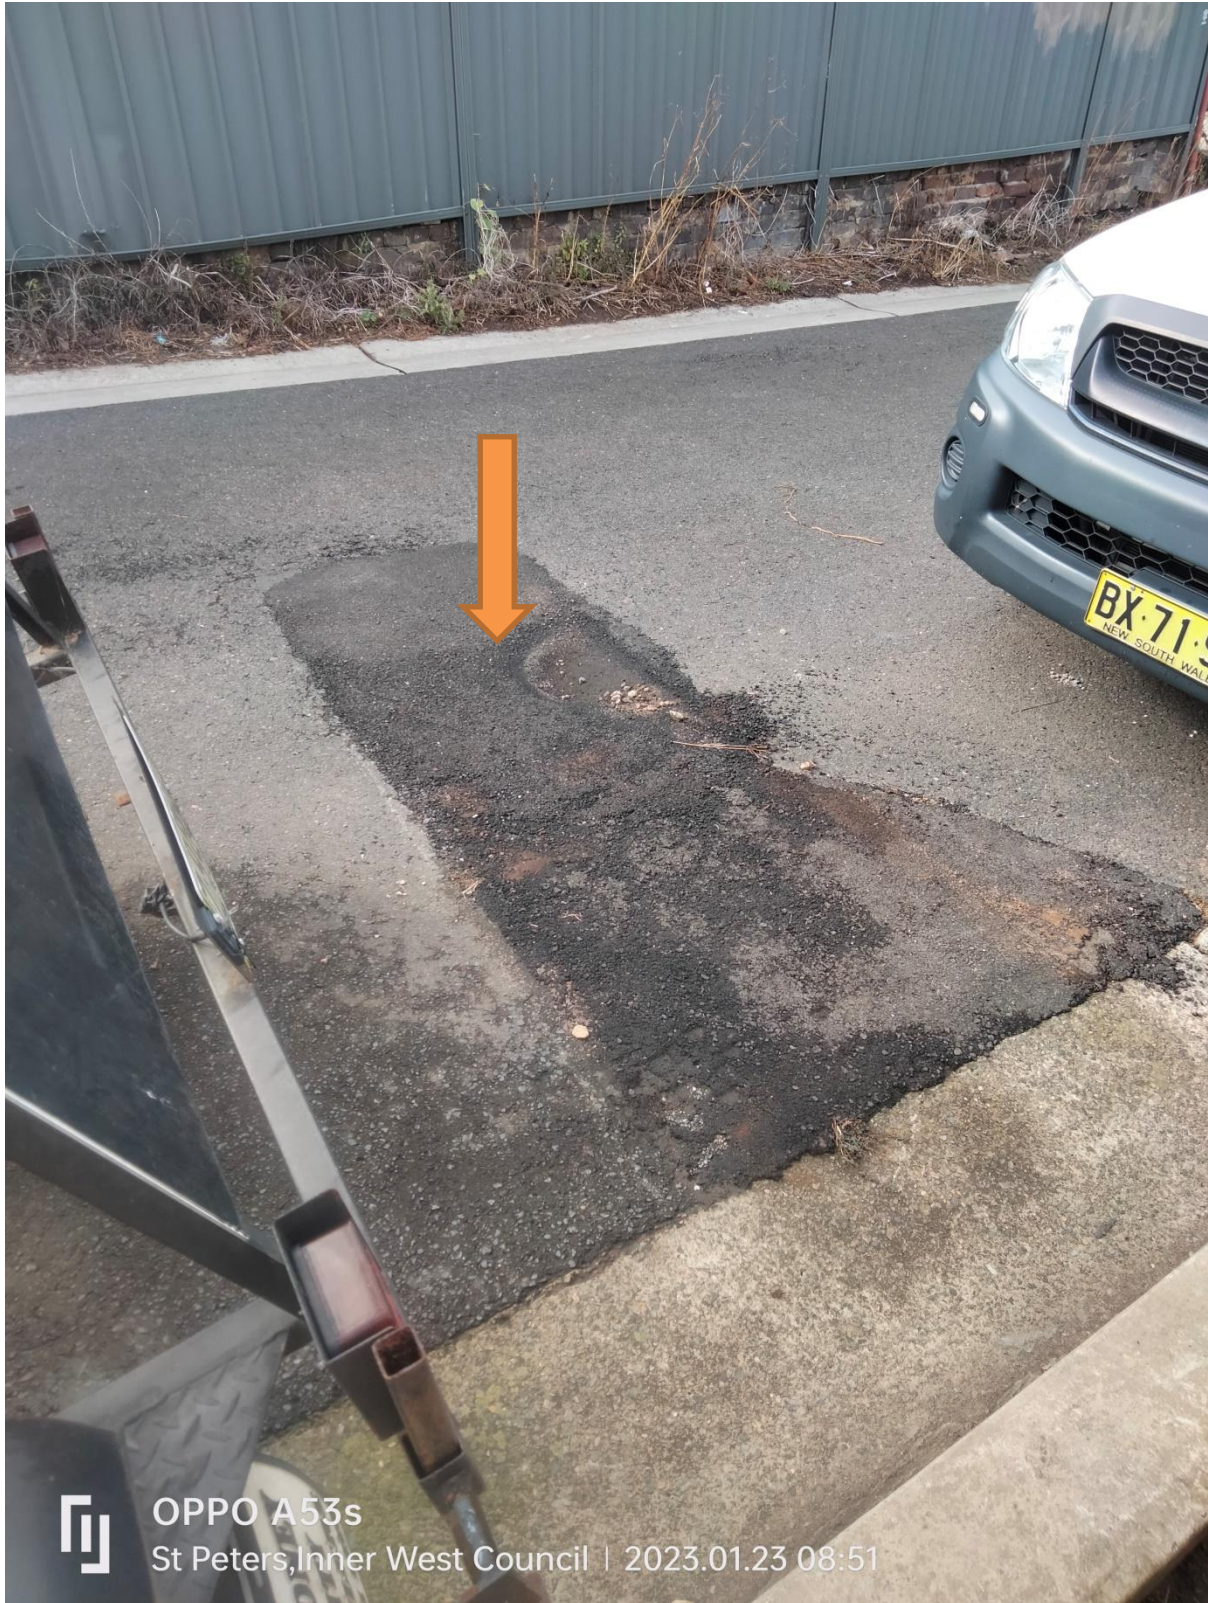
Figure 14 the rear road had filled in location with existing damage to the road behind number 118 where the garage is to be demolished and built.

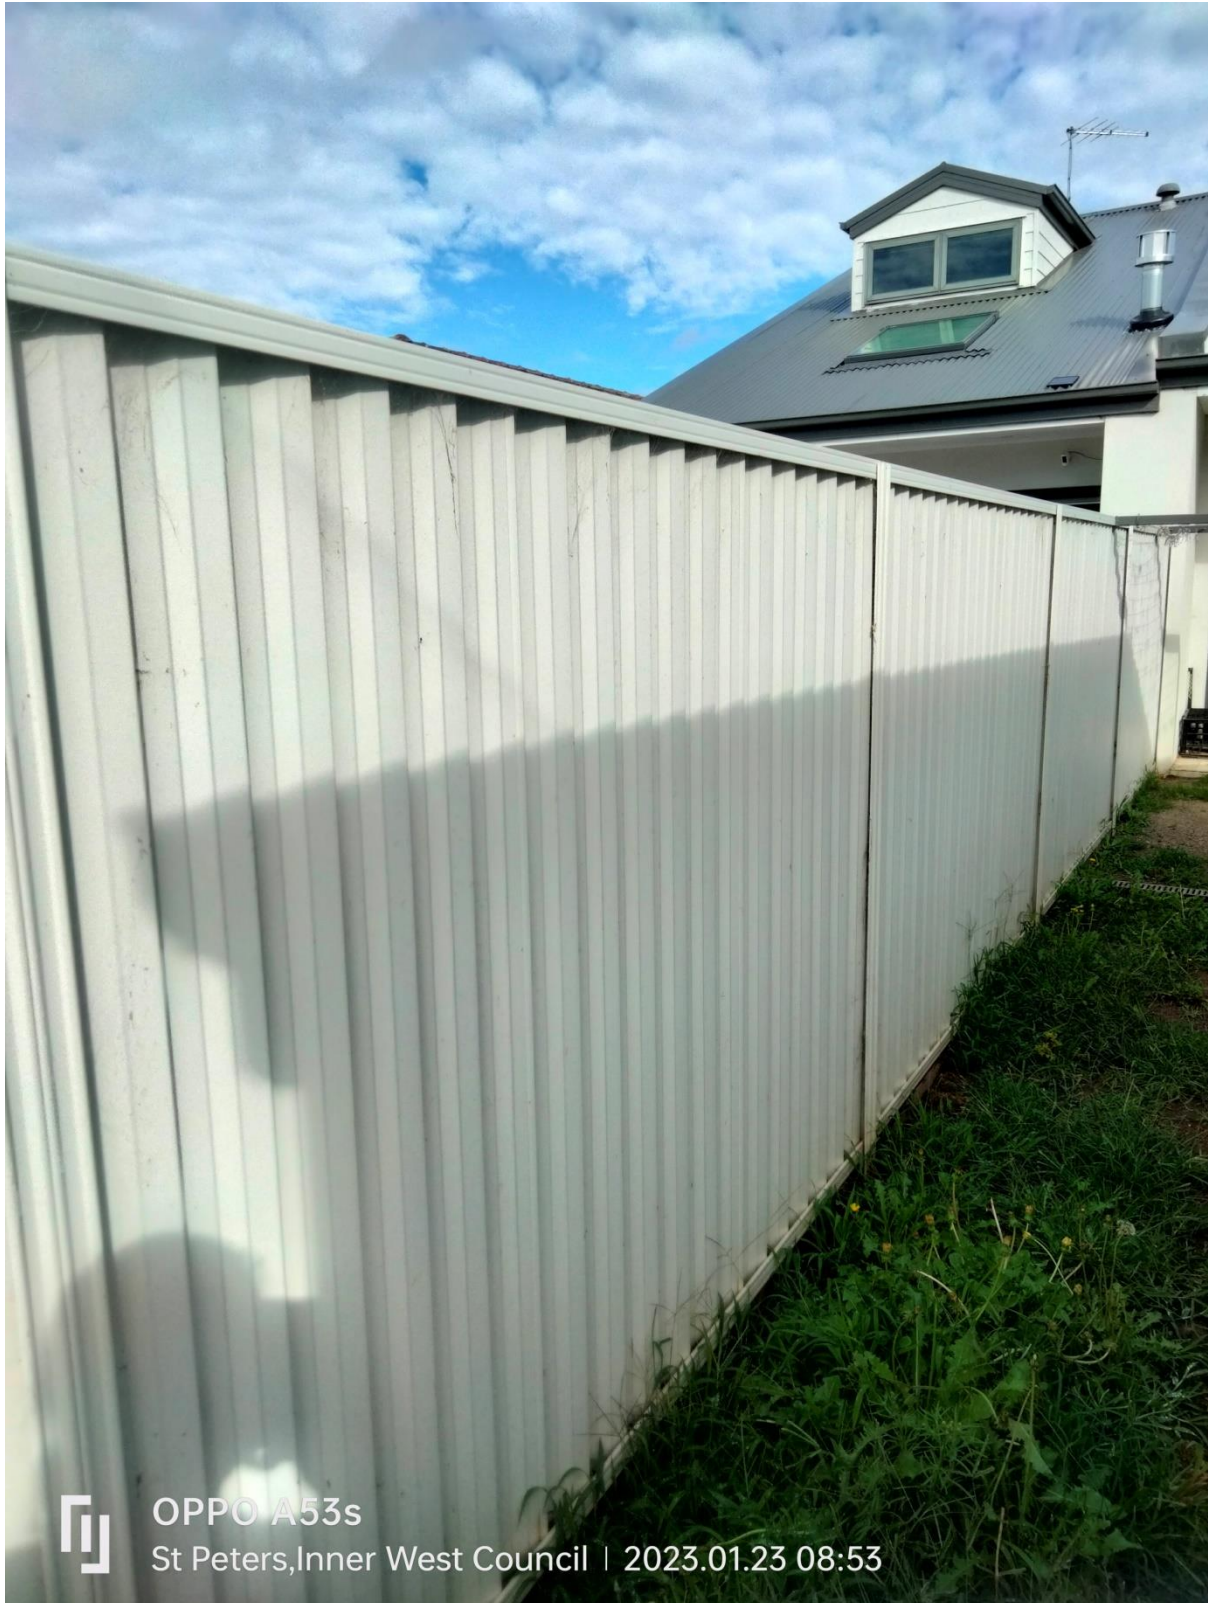
Figure 15 rear dividing fence picture taken between number 116 and 118 rear.

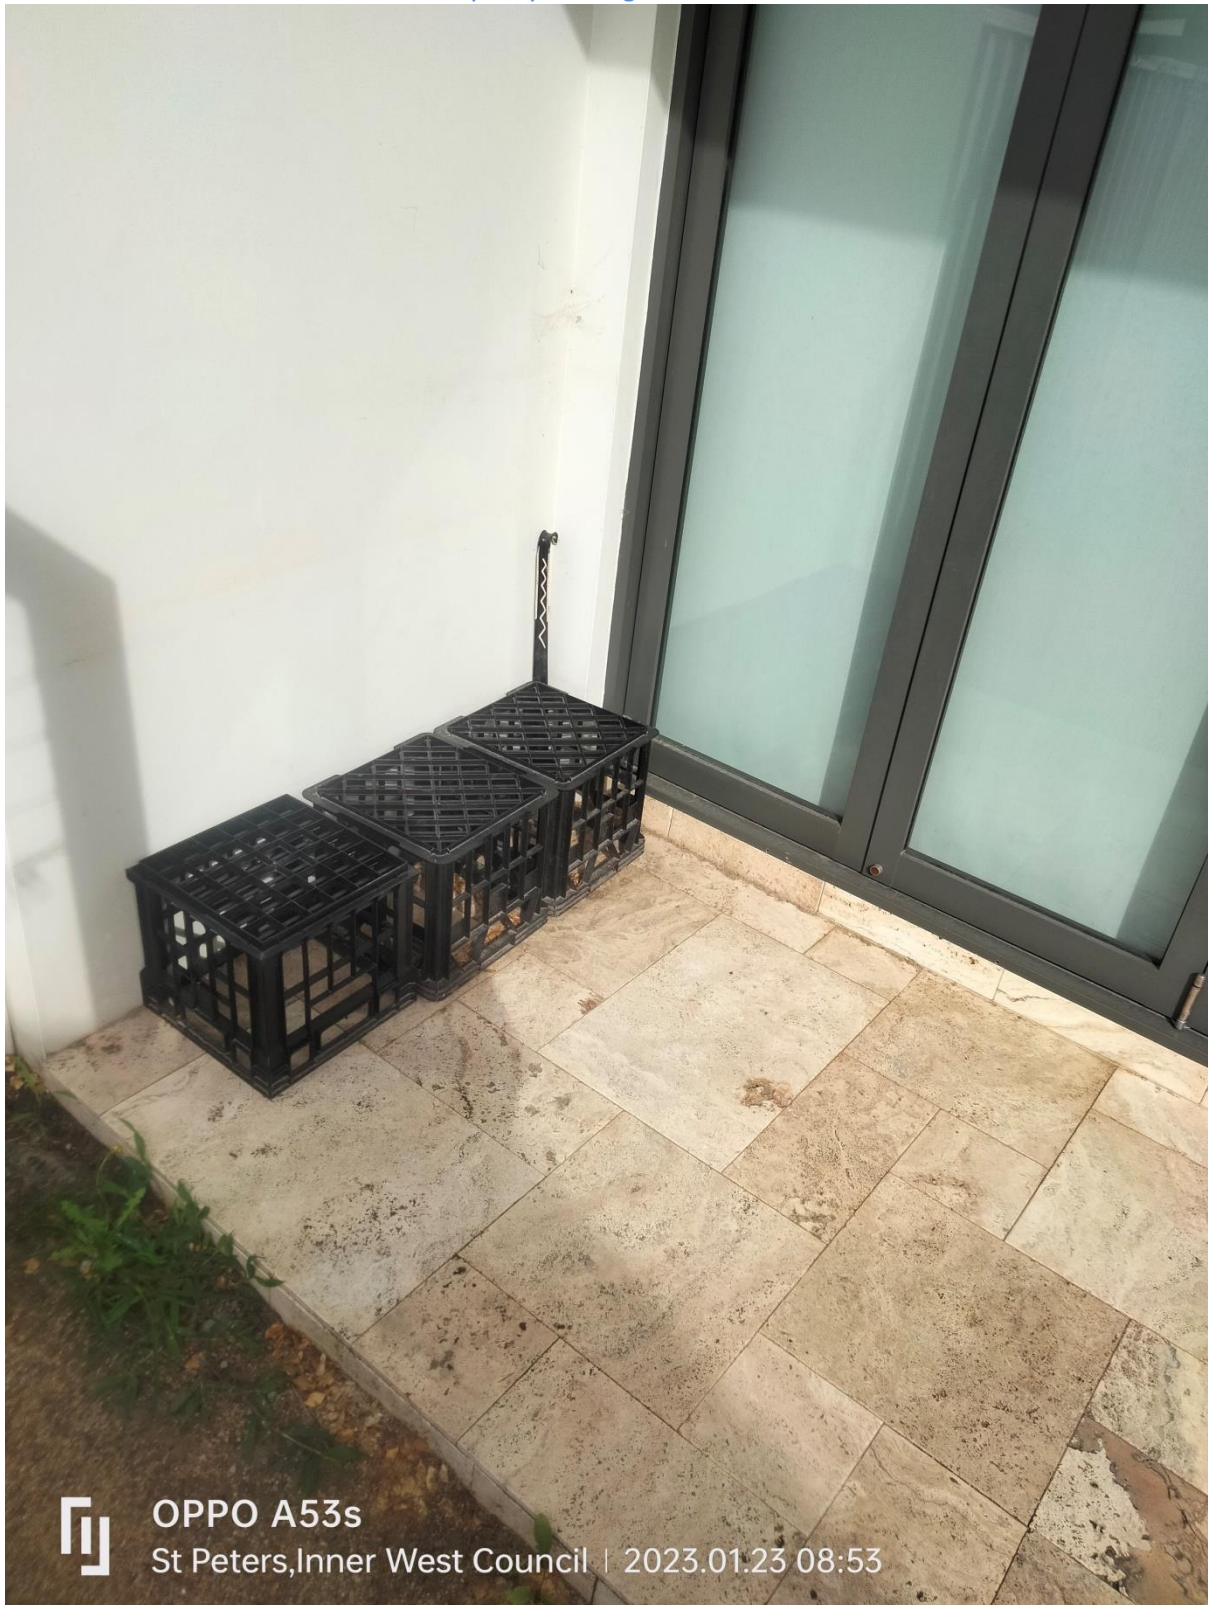
Figure 16 rear of number 116.

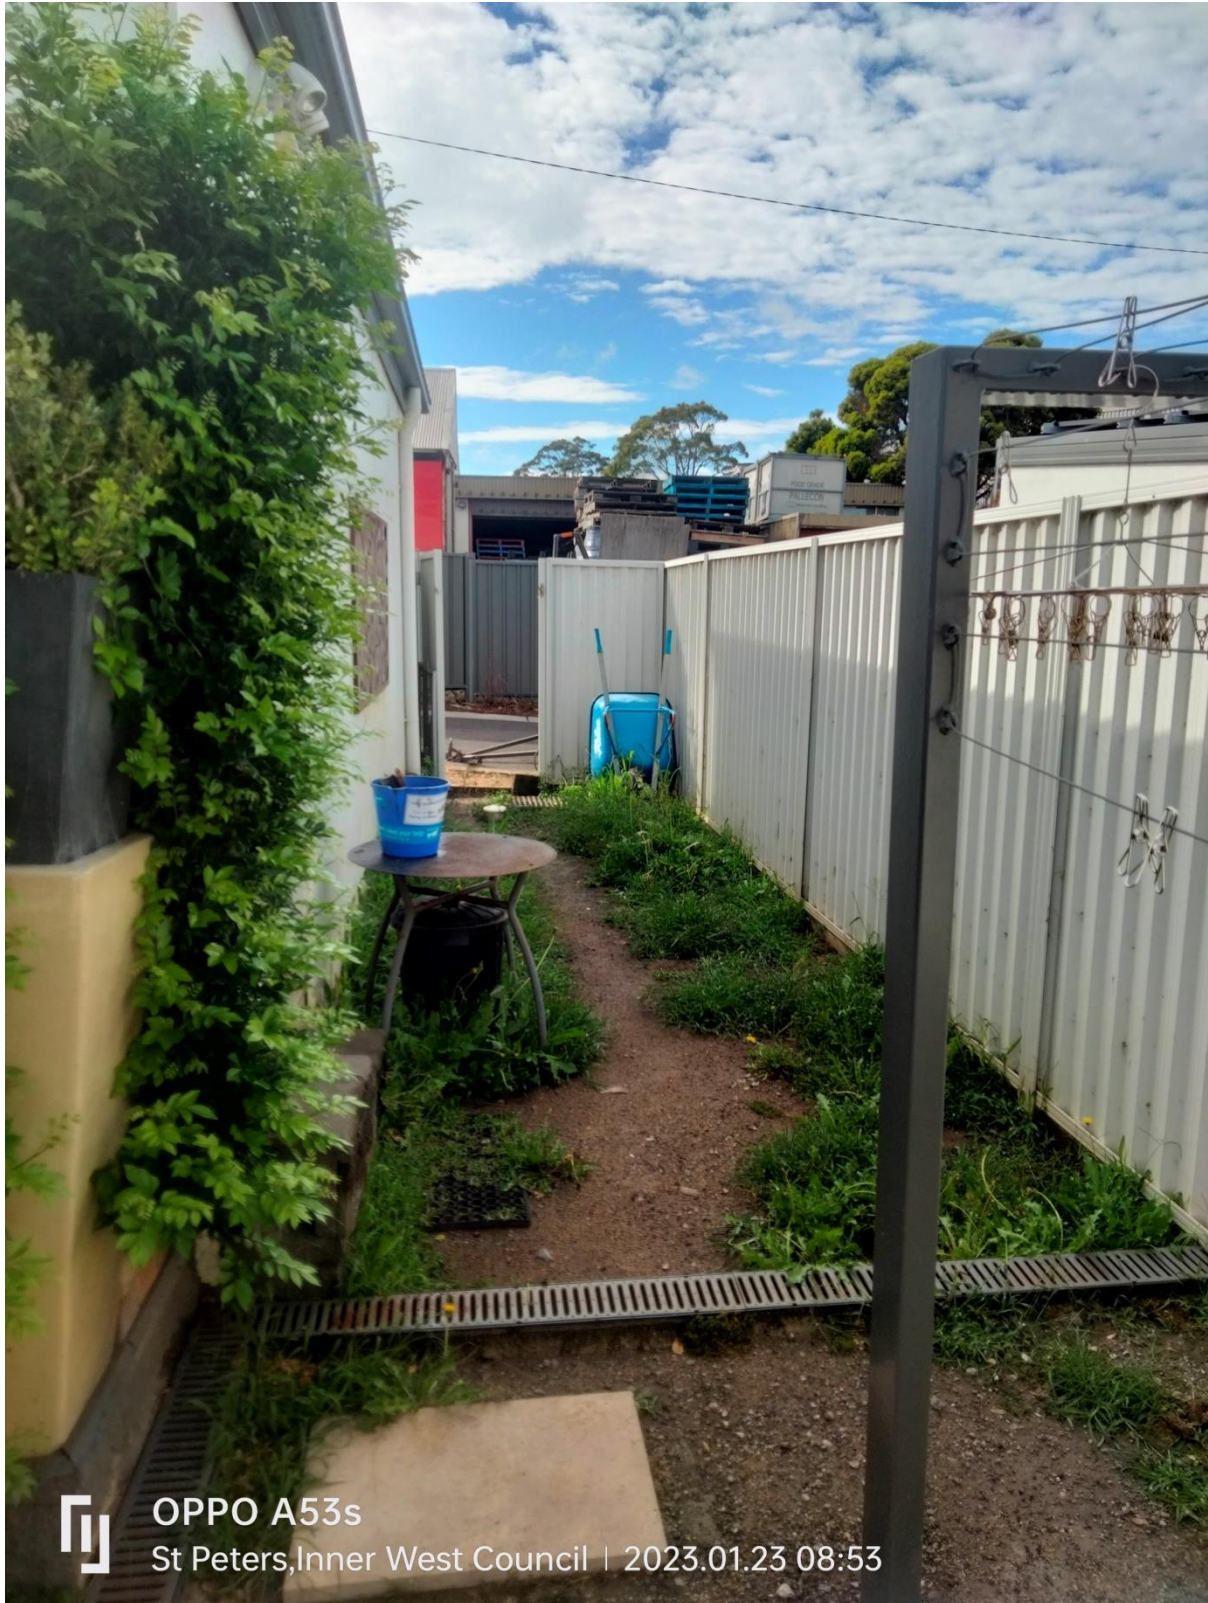
Figure 17 rear view taken from 116 dividing fence with number 118.

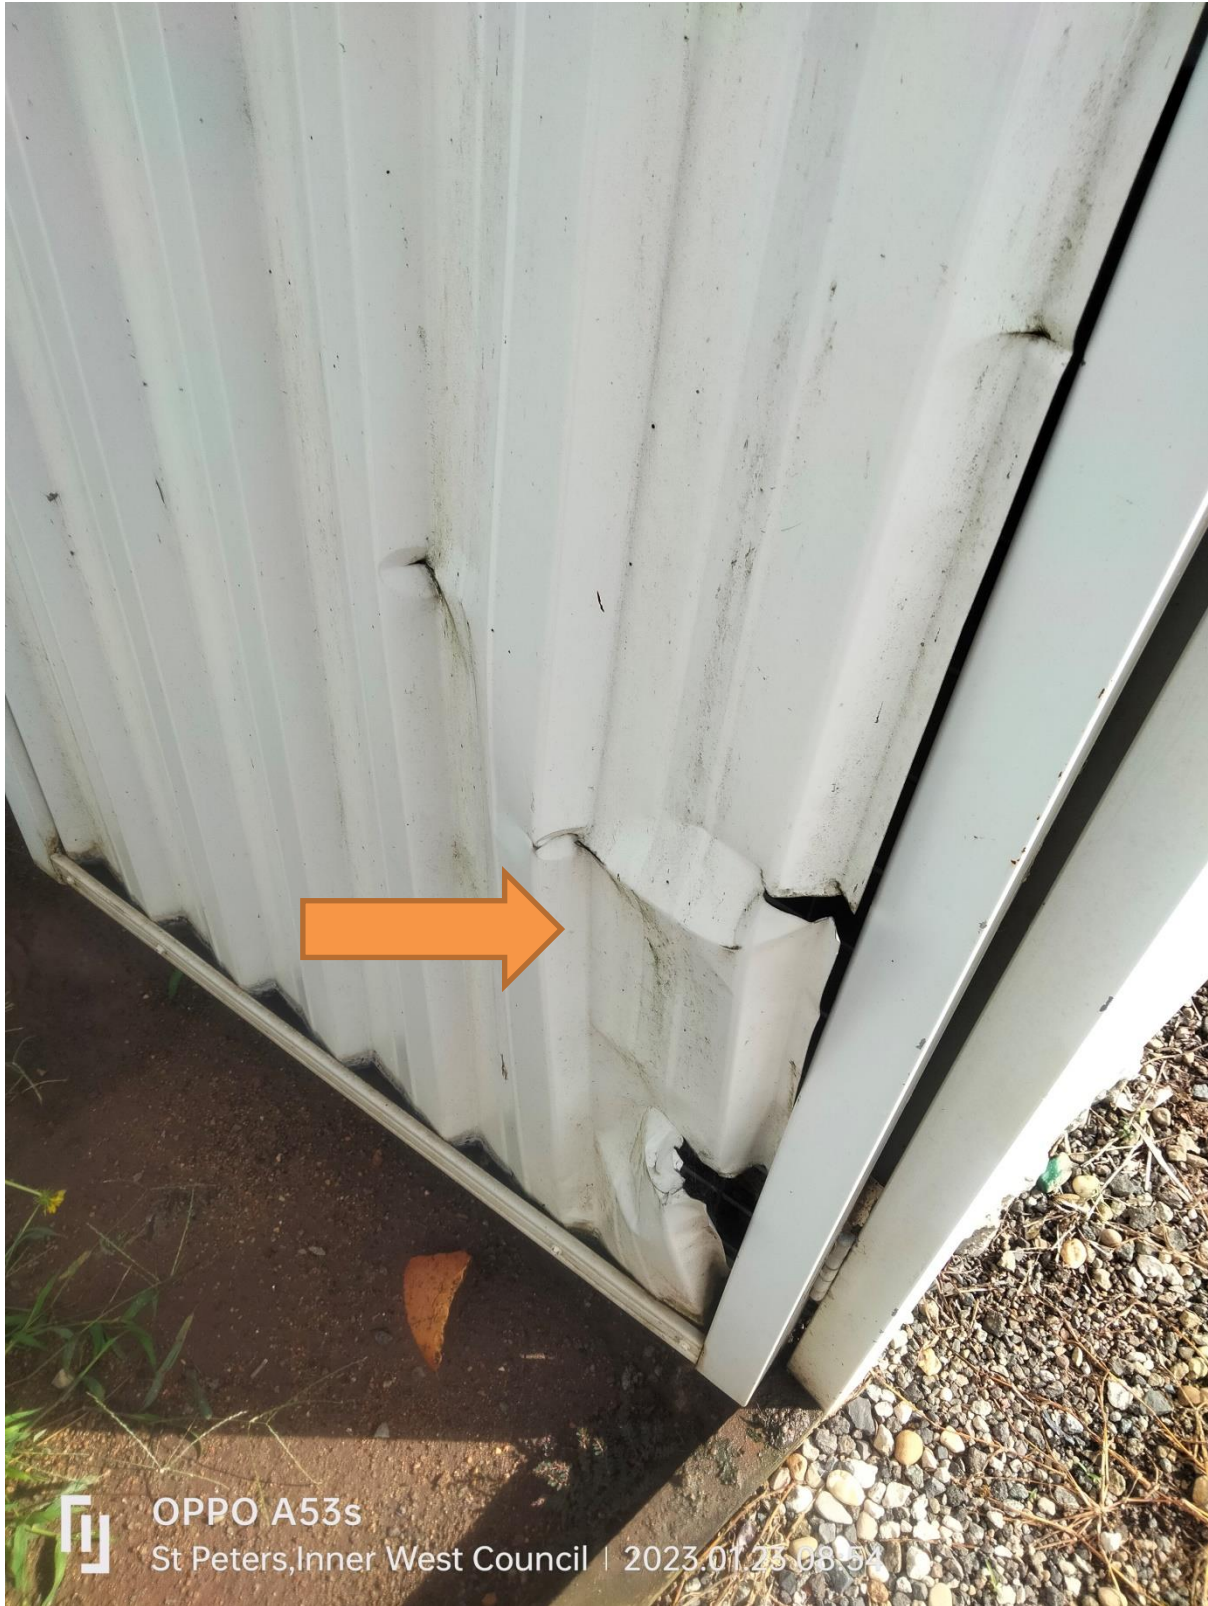
Figure 18 rear metal gate of 116 has metal gate damage observed.
