## Handover Inspection Building Inspection Report To AS4349.0-2007 Inspection of Buildings General Requirements

Property Address: 1 Smith St Bondi

Name: John Sample report

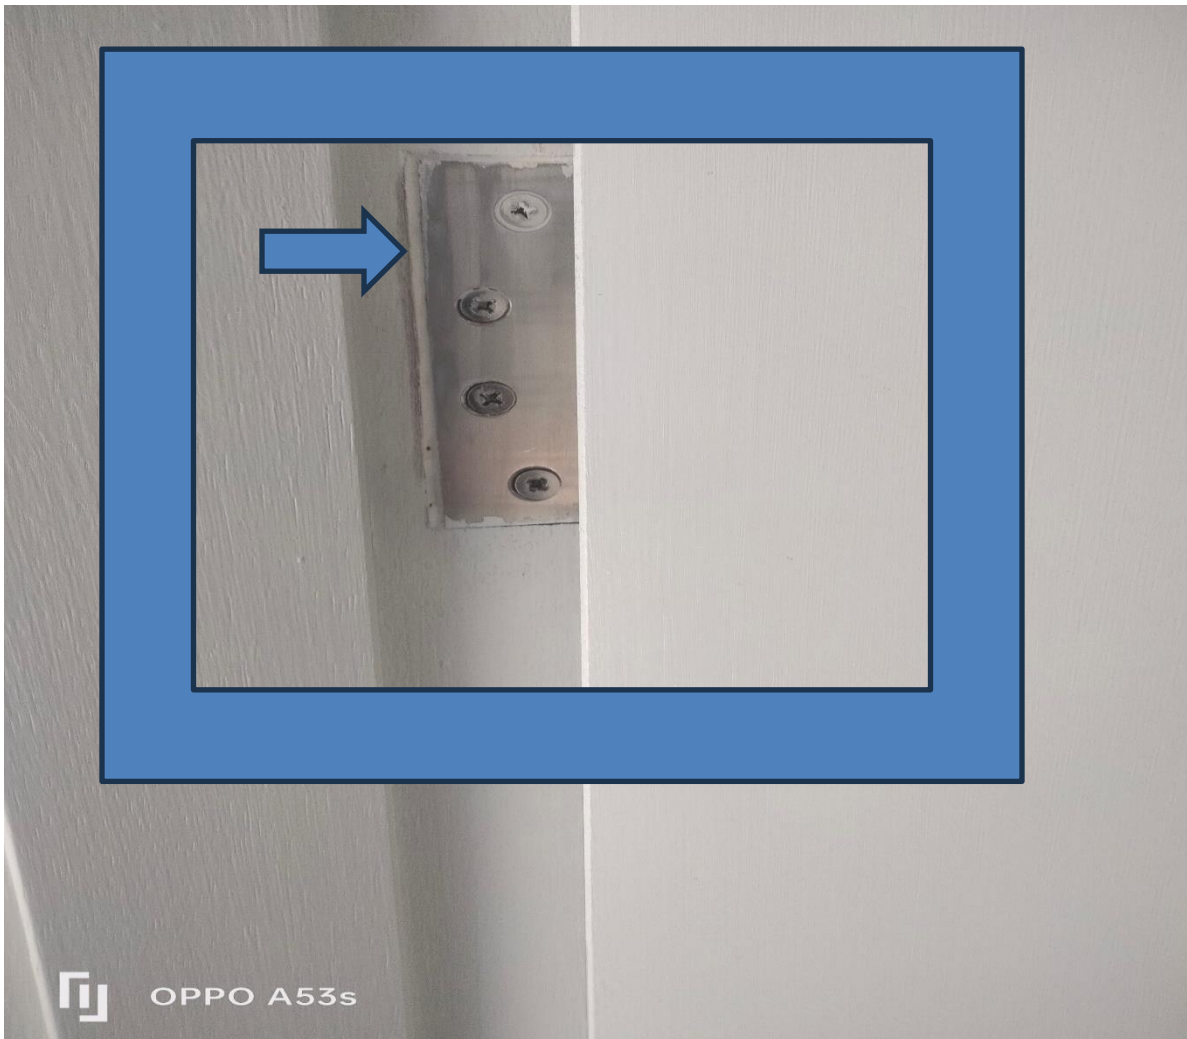
Figure 1 ground floor doors were observed with missing screws to the hinges incomplete work.

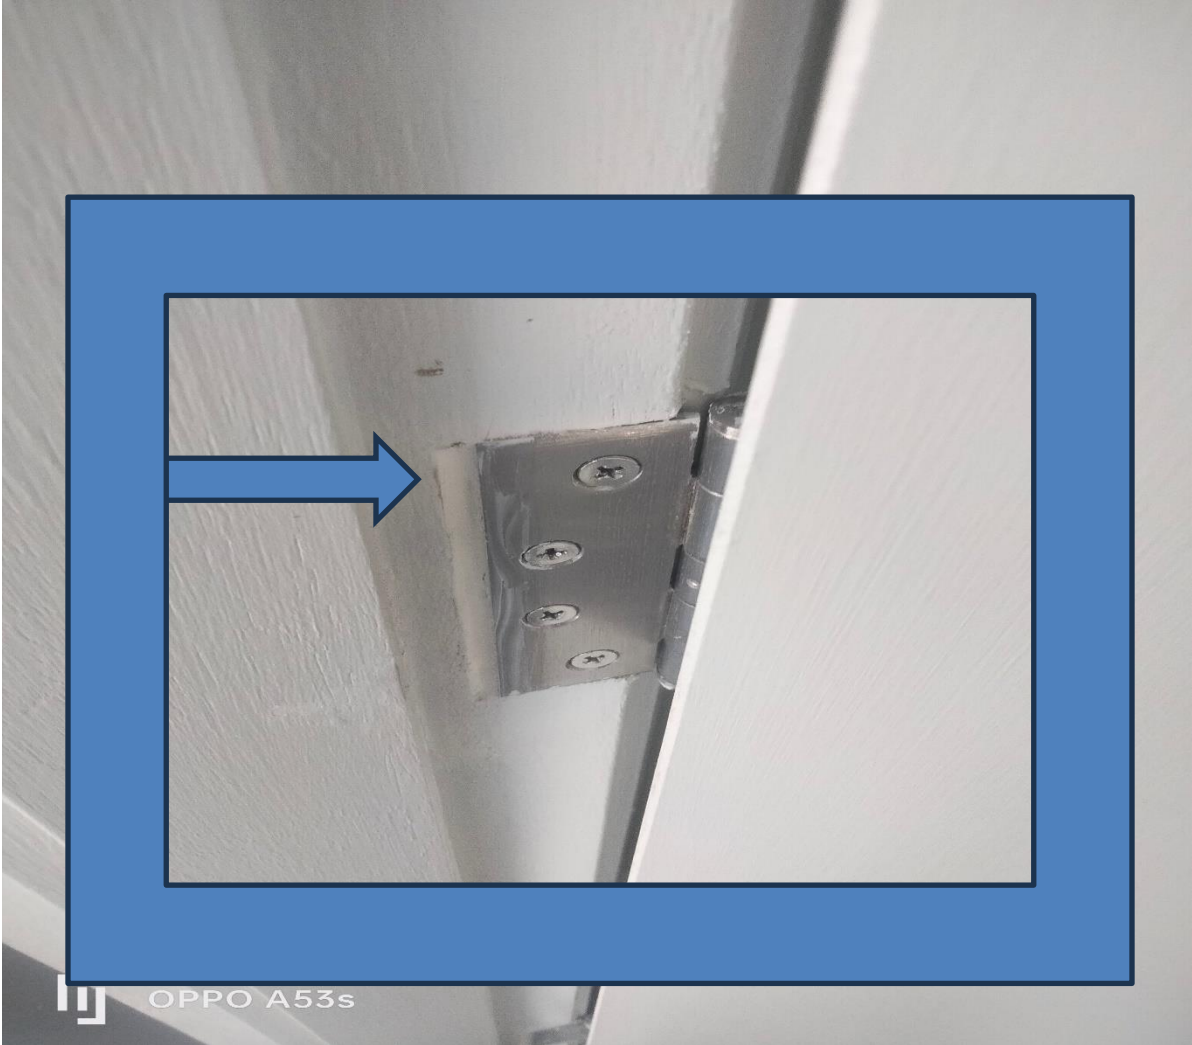
Figure 2 door hinge carpentry has been cut poorly by the contractor.

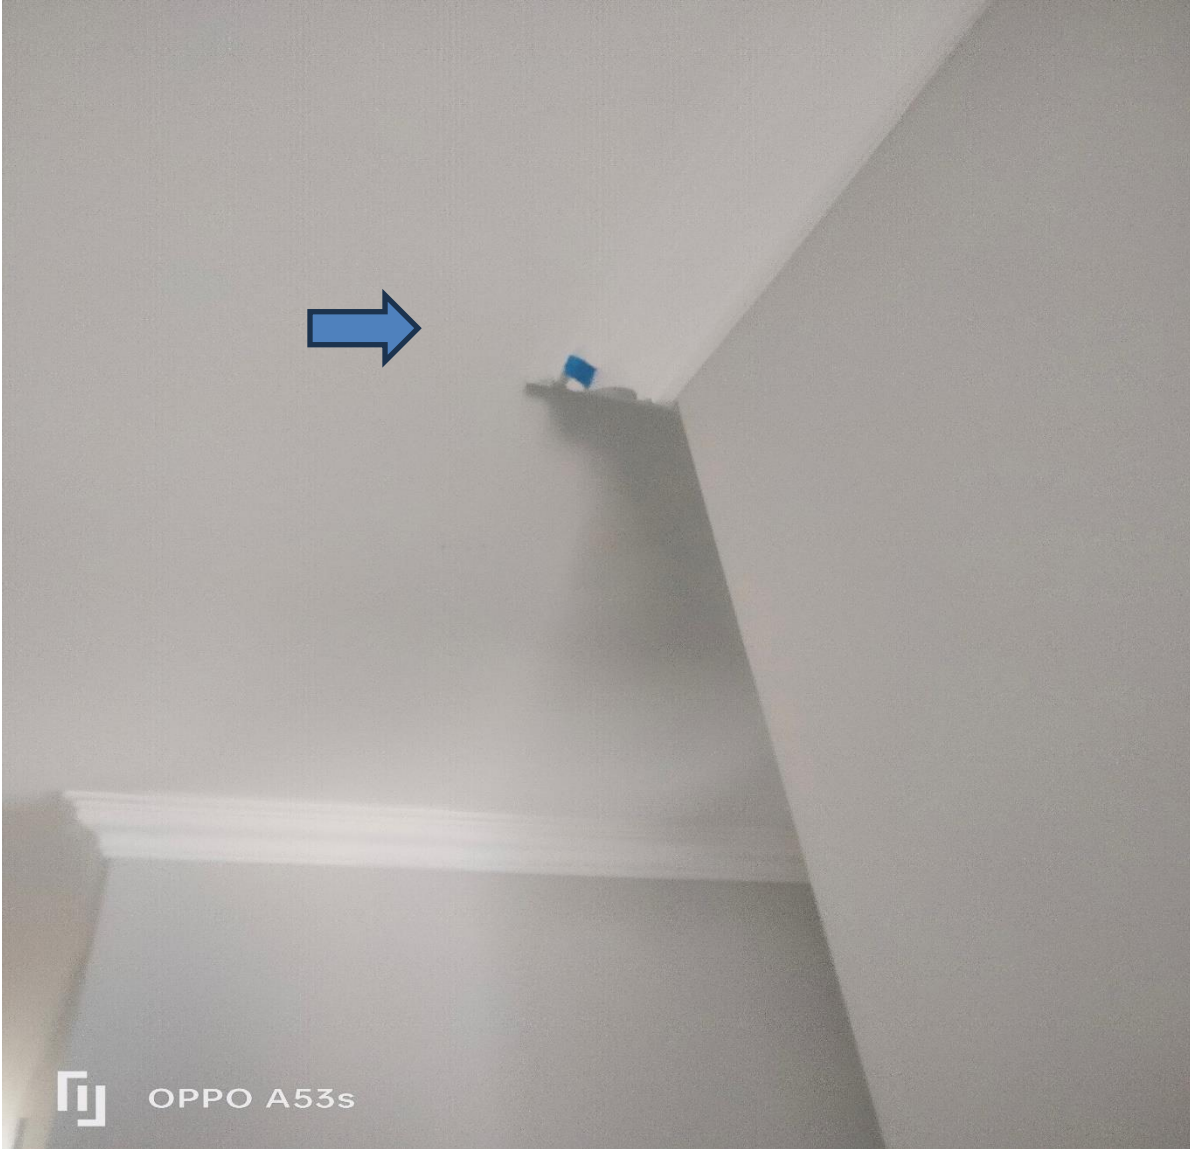
Figure 3 the interior walls and ceilings were observed as requiring final paint multiple locations. Incomplete work.

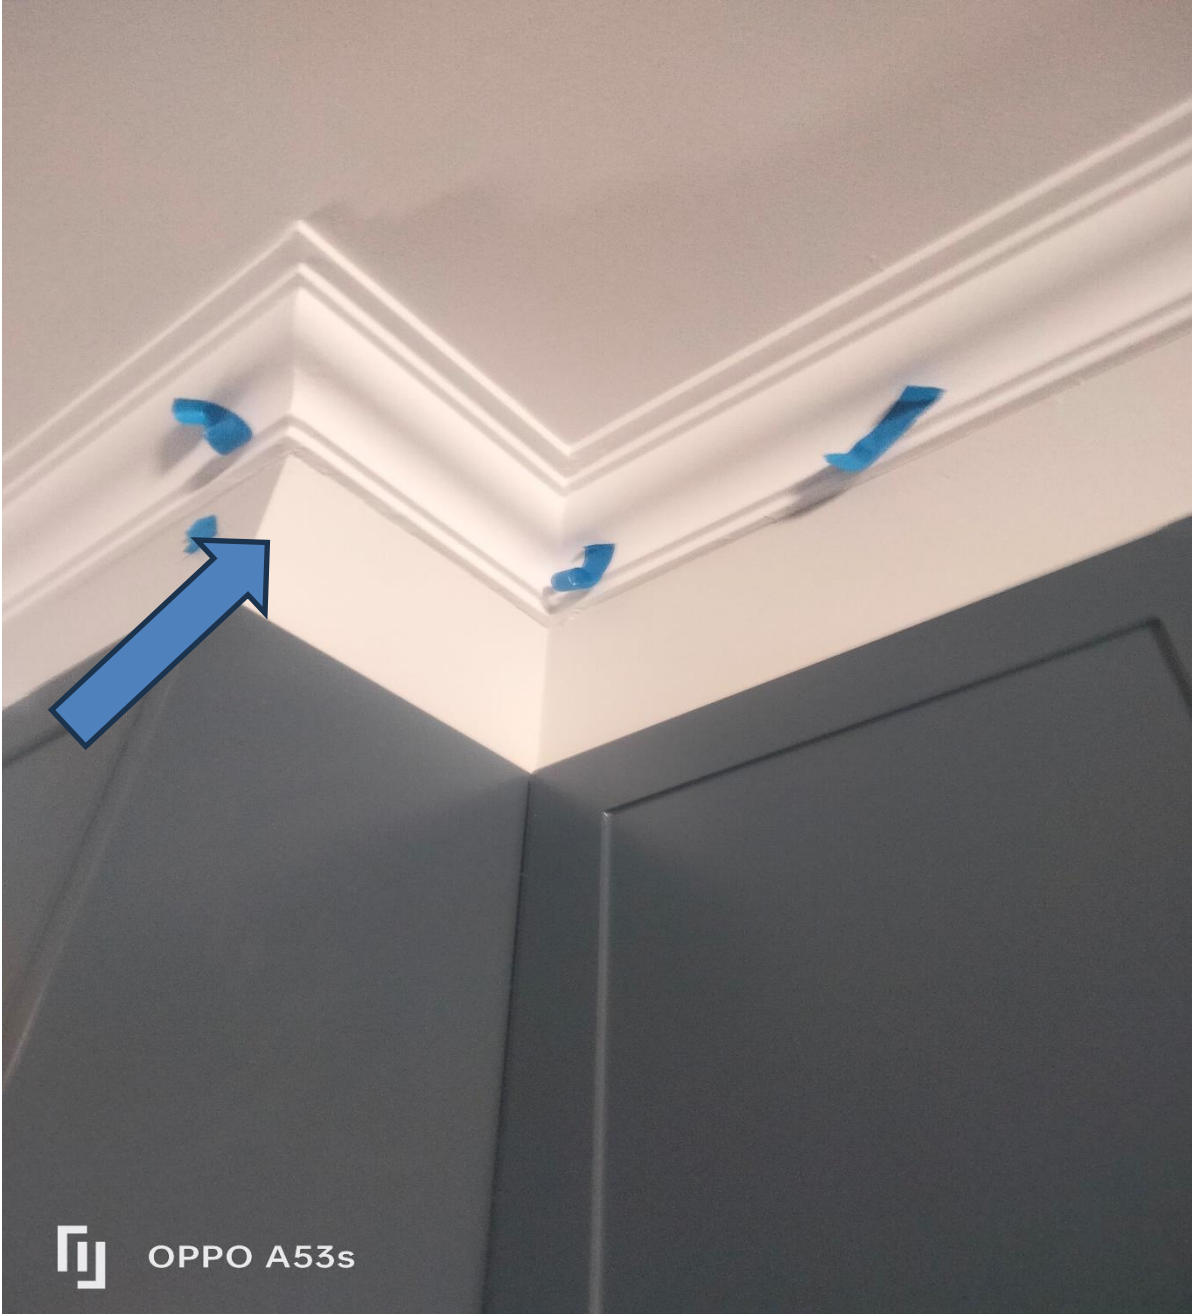
Figure 5 incomplete painting observed throughout the house clearly visible from 1.5 meters away. Incomplete work.

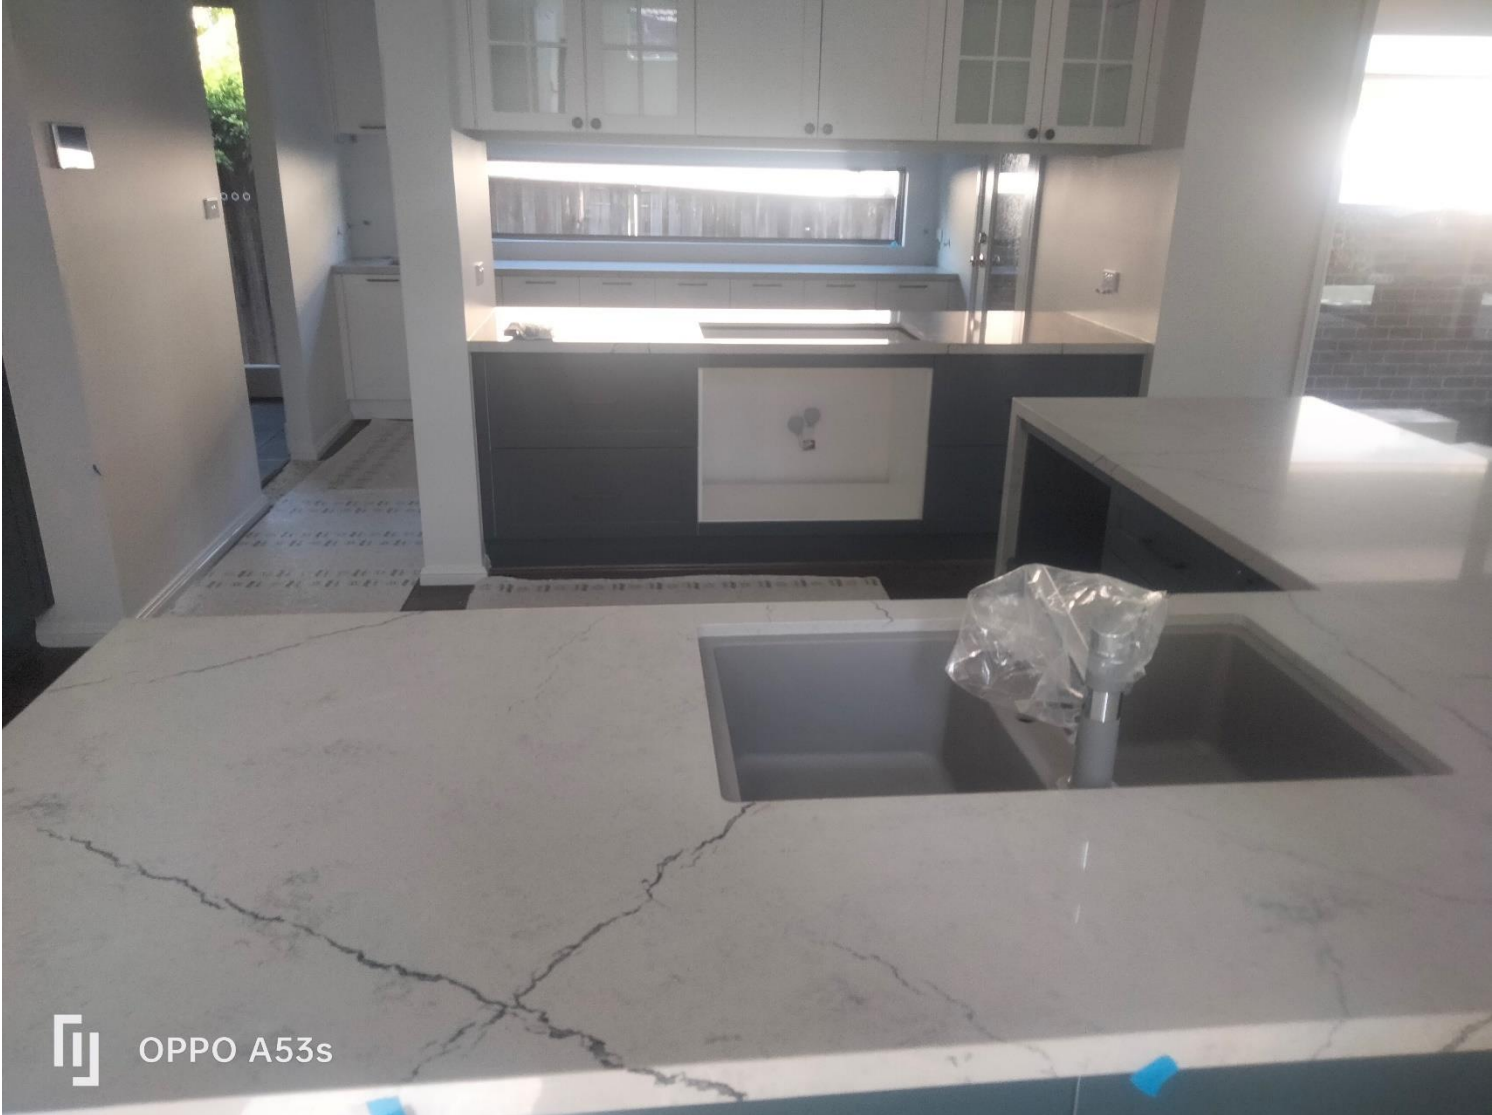
Figure 6 the kitchen benchtop was observed as having blue tape indicating incomplete locations.

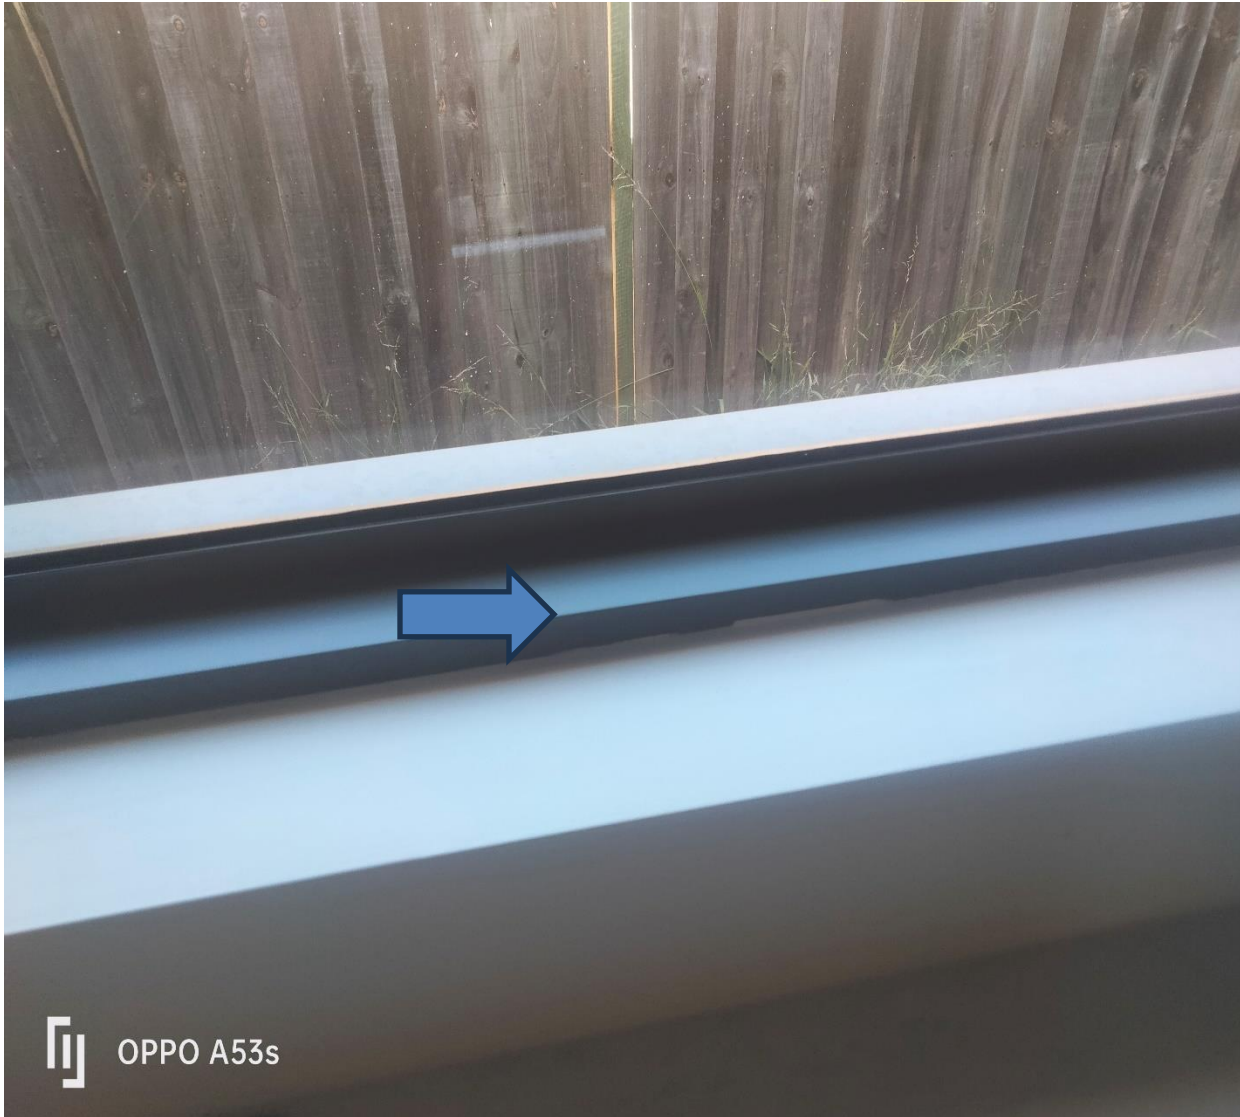
Figure 7 kitchen window was observed as having over painting and this requires completion to an acceptable standard, this is incomplete work. All windows should be inspected by the builder and corrected where applicable.

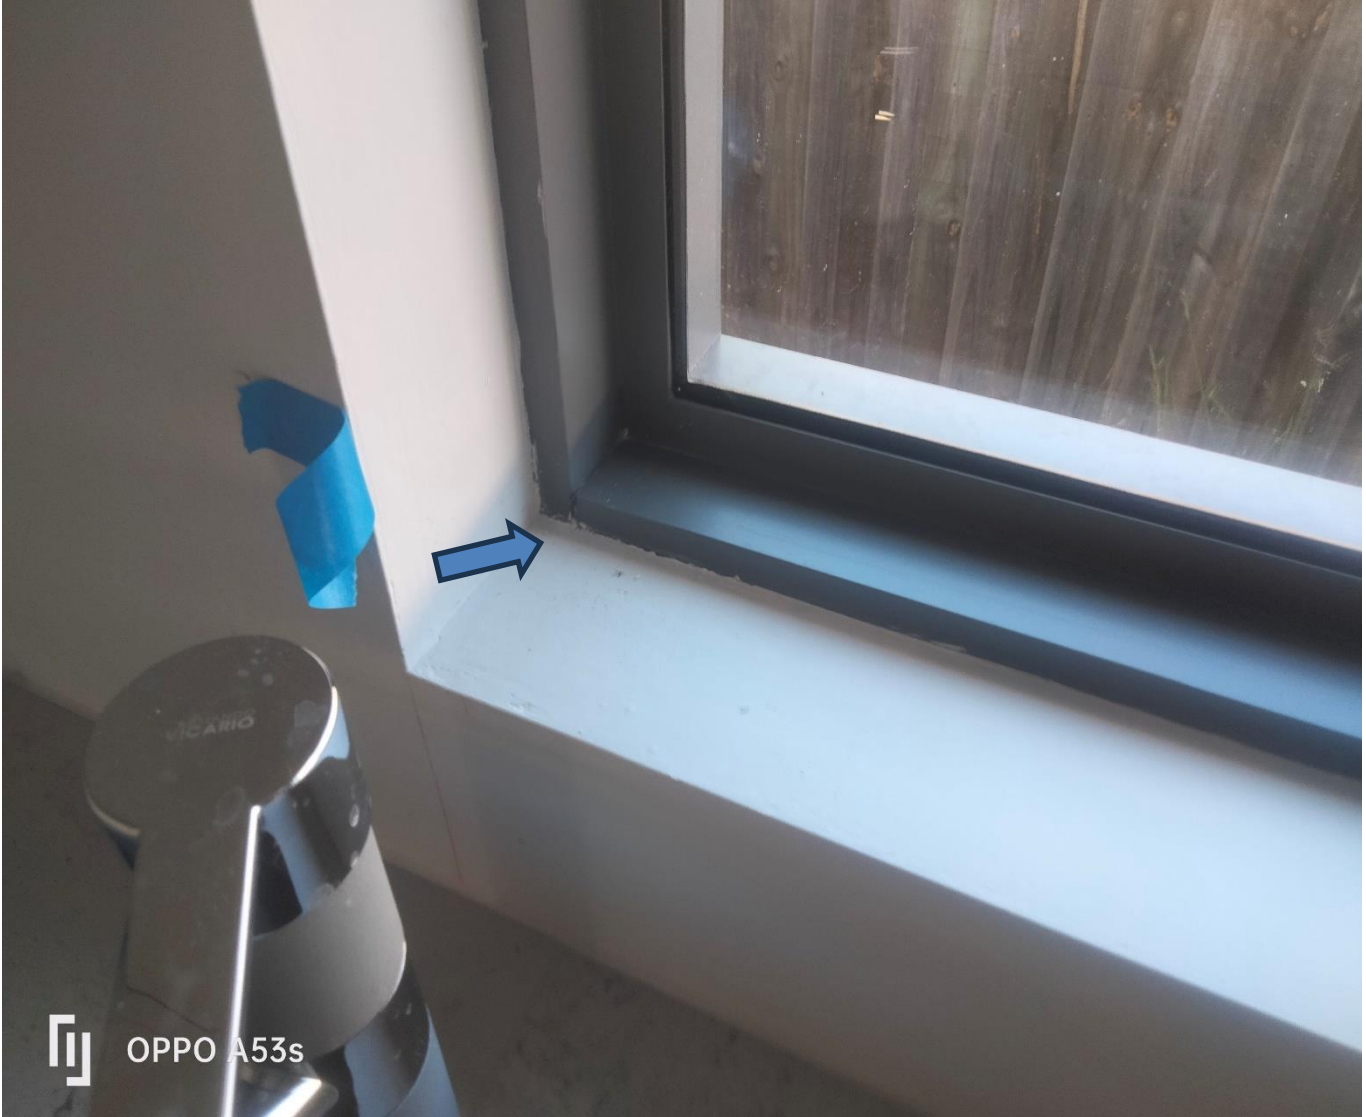
Figure 8 poor kitchen painting to metal frame windows.

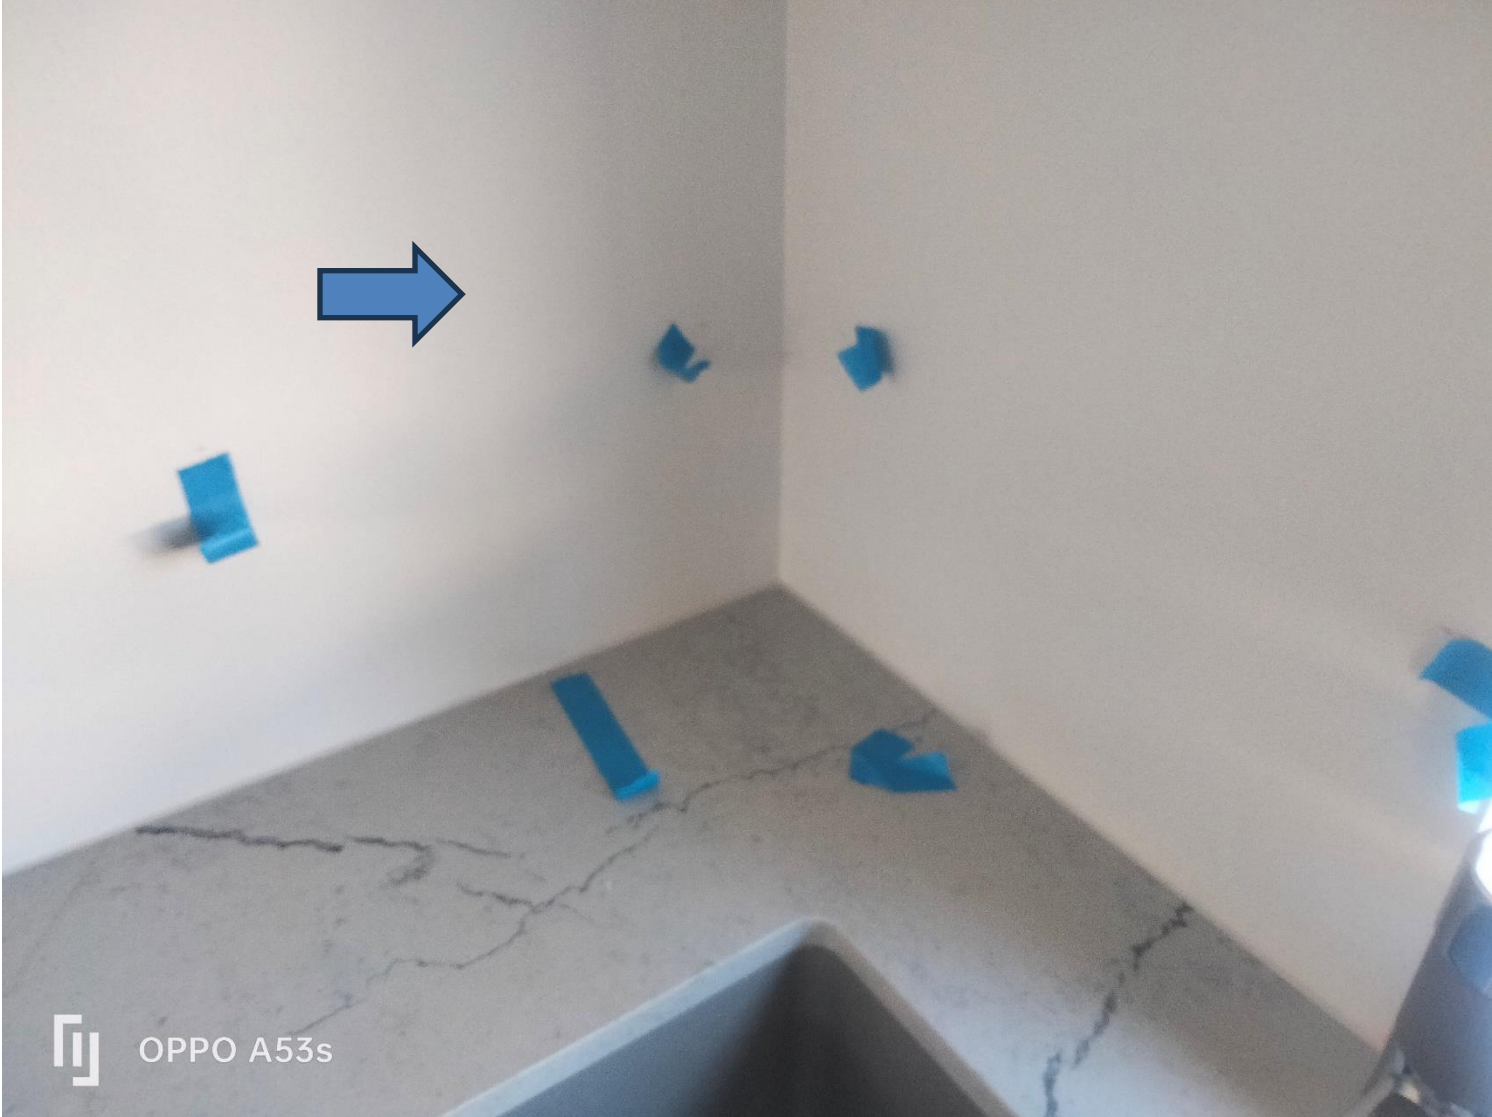
Figure 9 kitchen location wall also had painting incomplete noted. This is incomplete work.

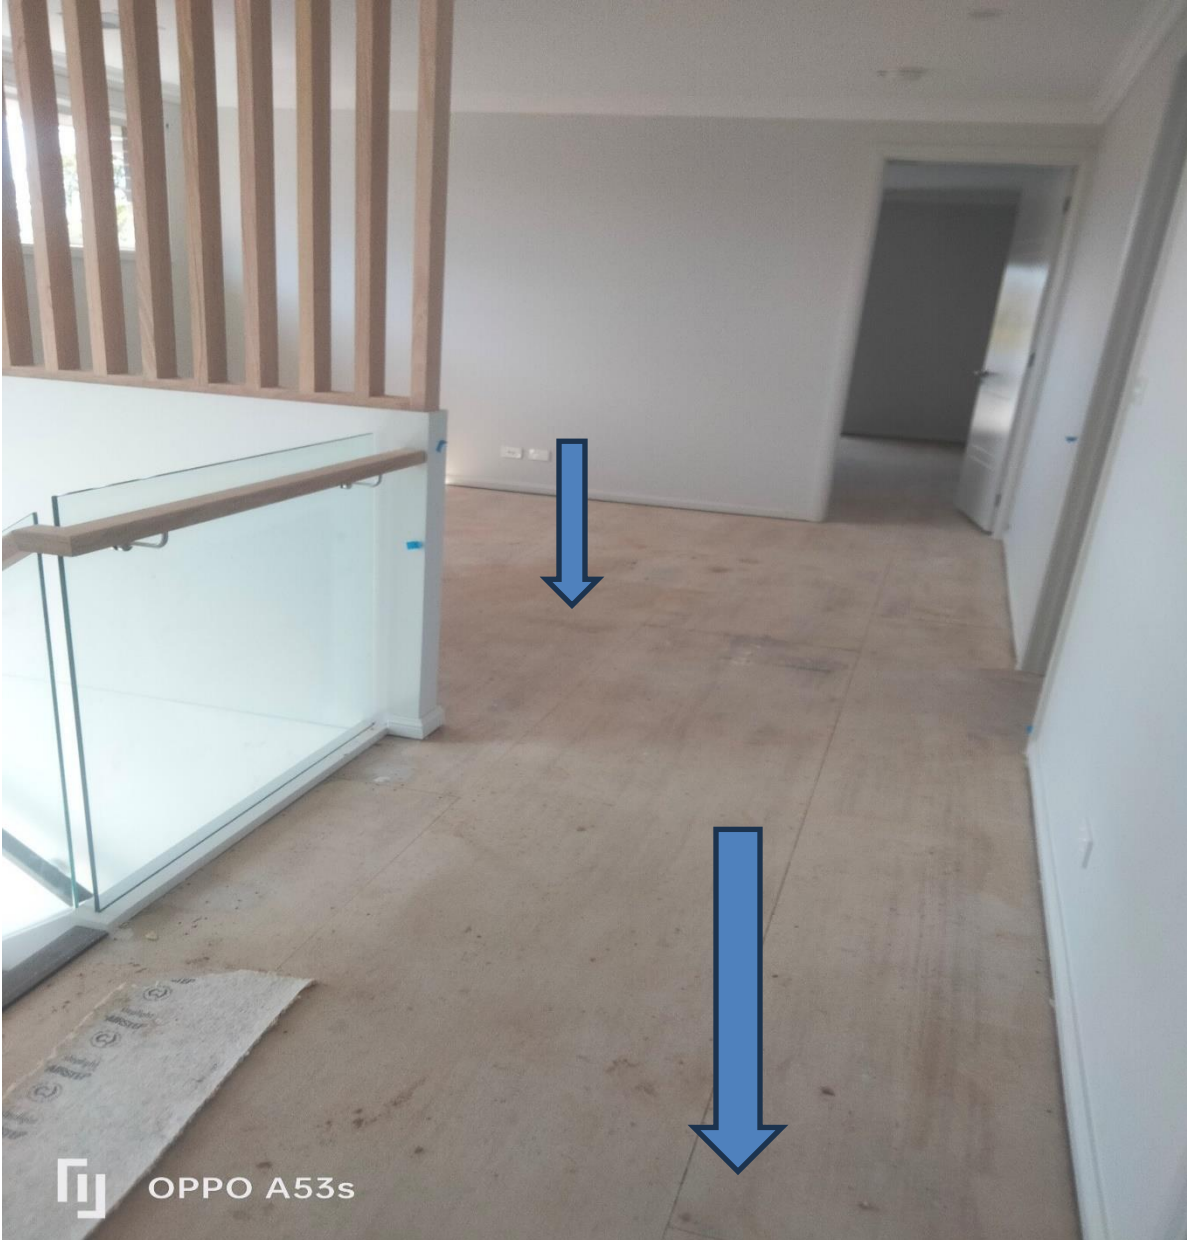
Figure 13 the first floor was observed as squeaking, this is not compliant with the NSW Fair trading tolerance Guide 2017.

Defect.

Floors that consistently squeak by a person walking normally in a trafficable area within the first 24 months from handover are defective.

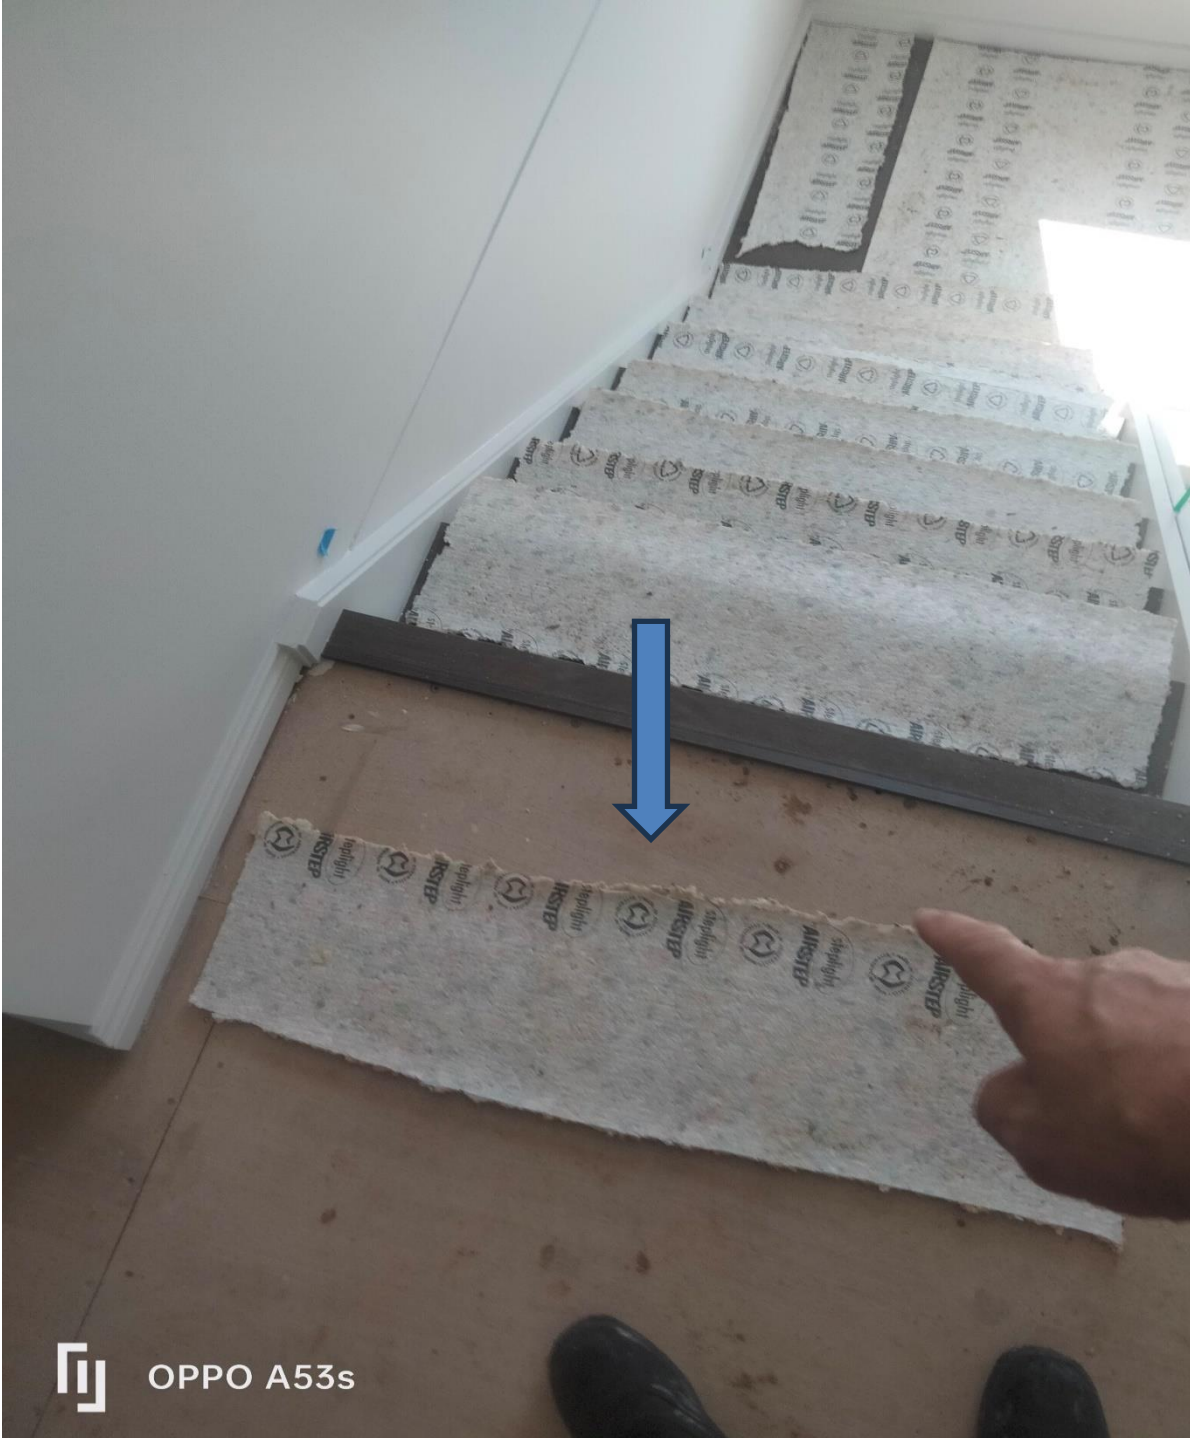
Figure 14 squeaking observed at the top of the landing, builder to investigate and rectify.

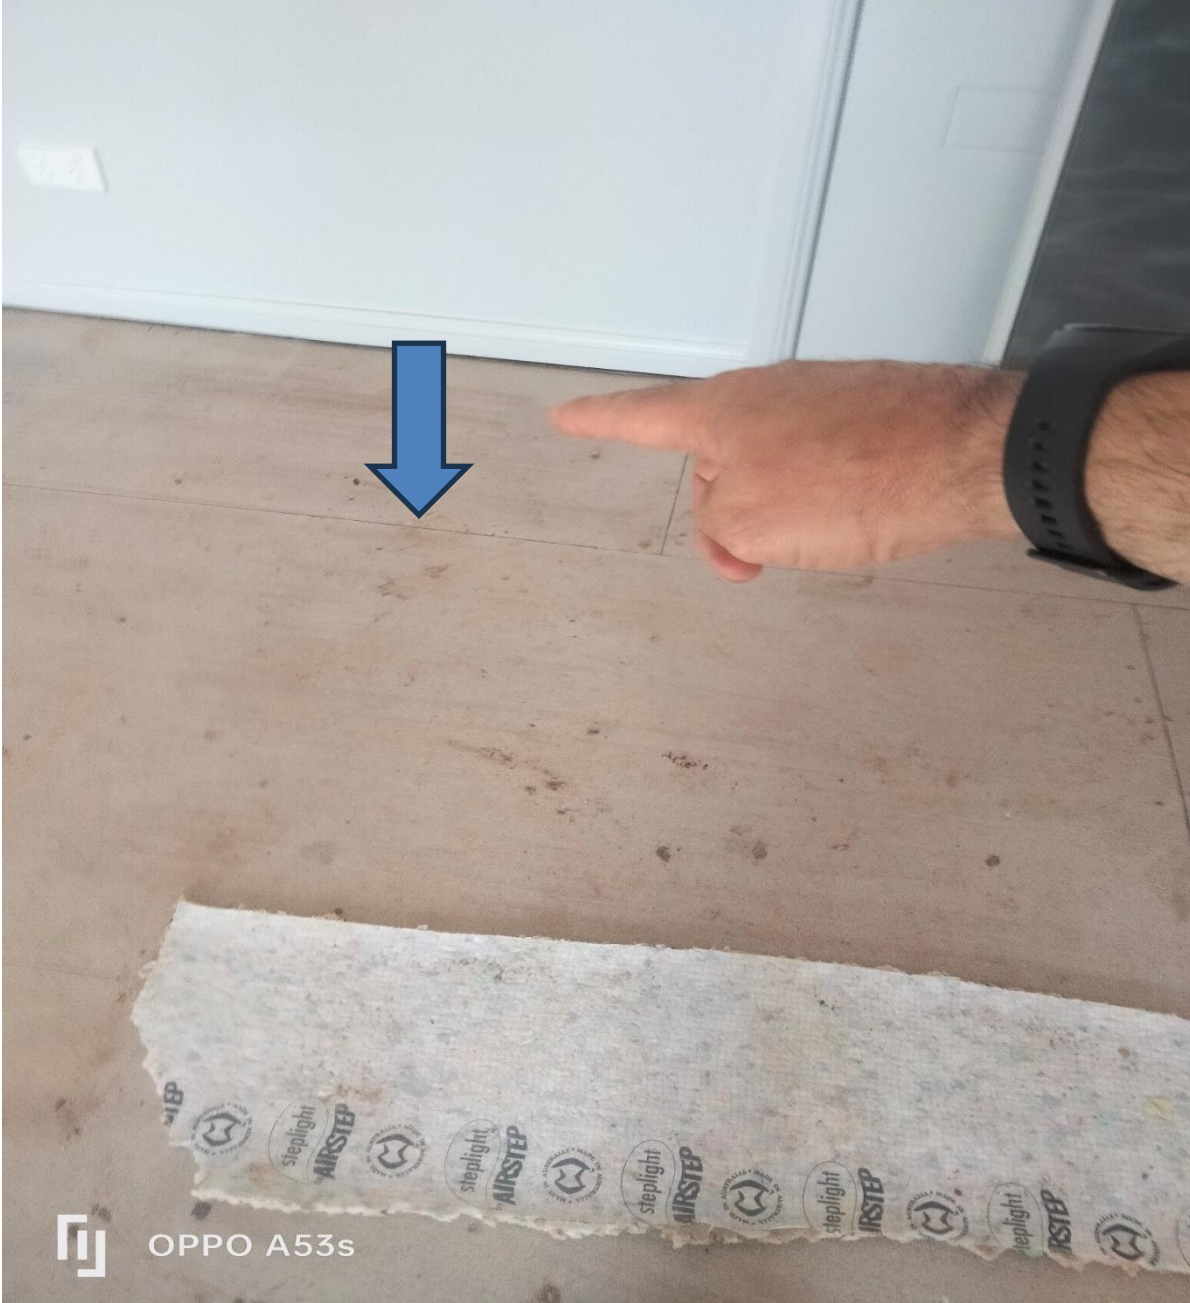
Figure 15 location top of stair landing squeak observed to the floor.

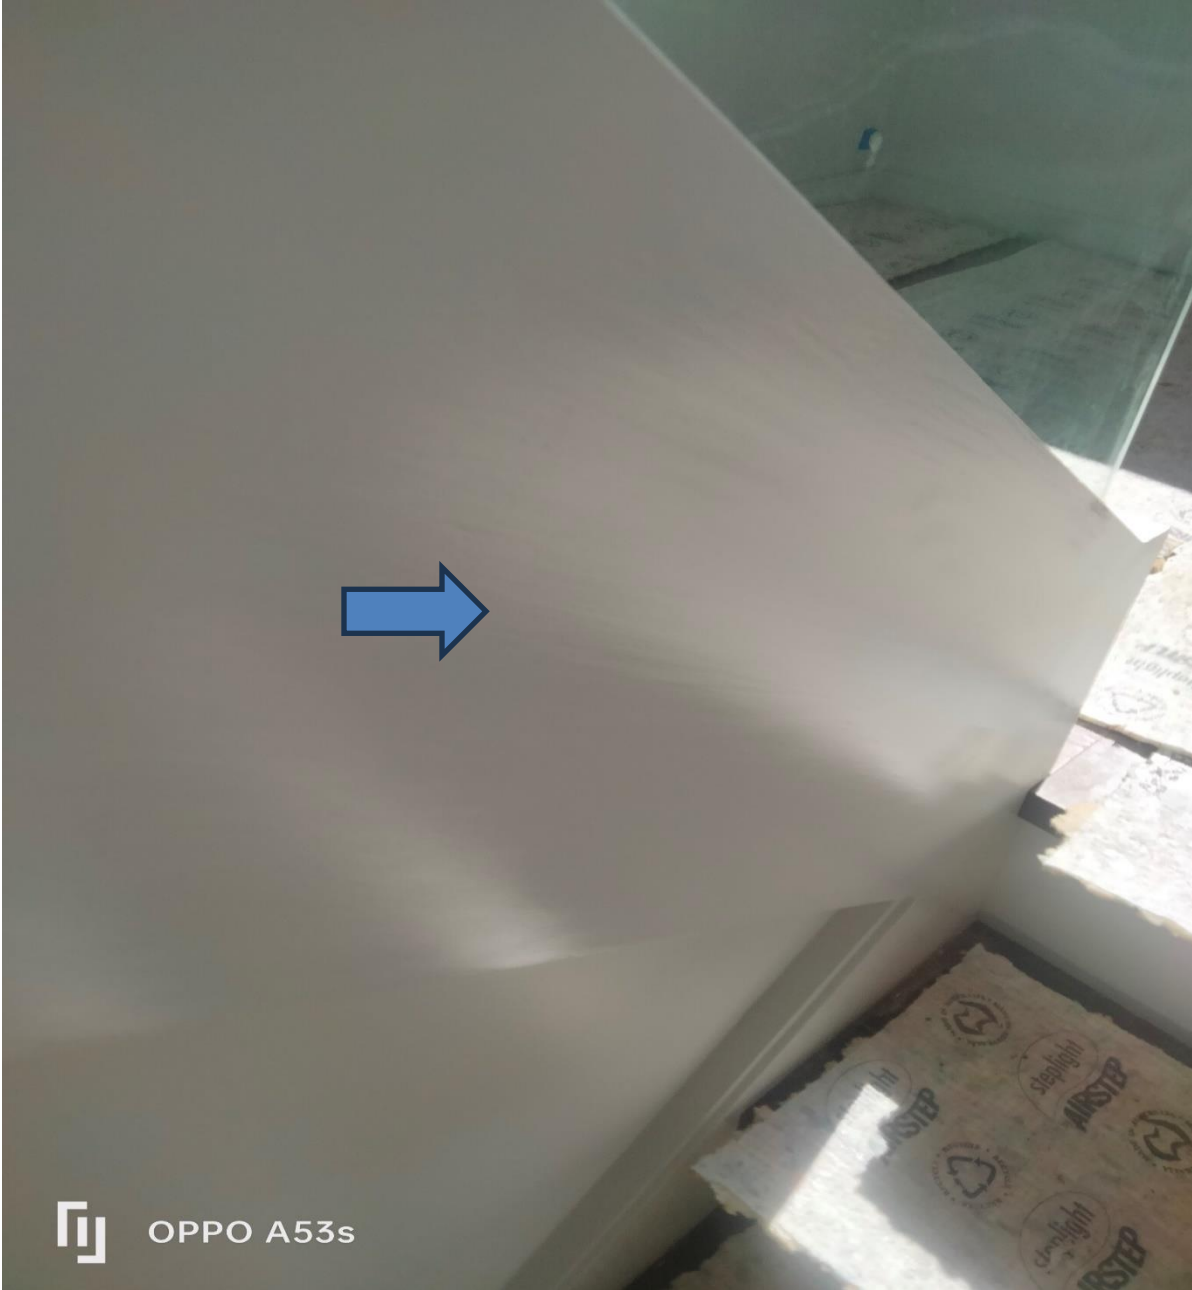
Figure 16 the timber stringer was observed in natural light requiring final coats. Incomplete painting.

Poor painting requires completion.

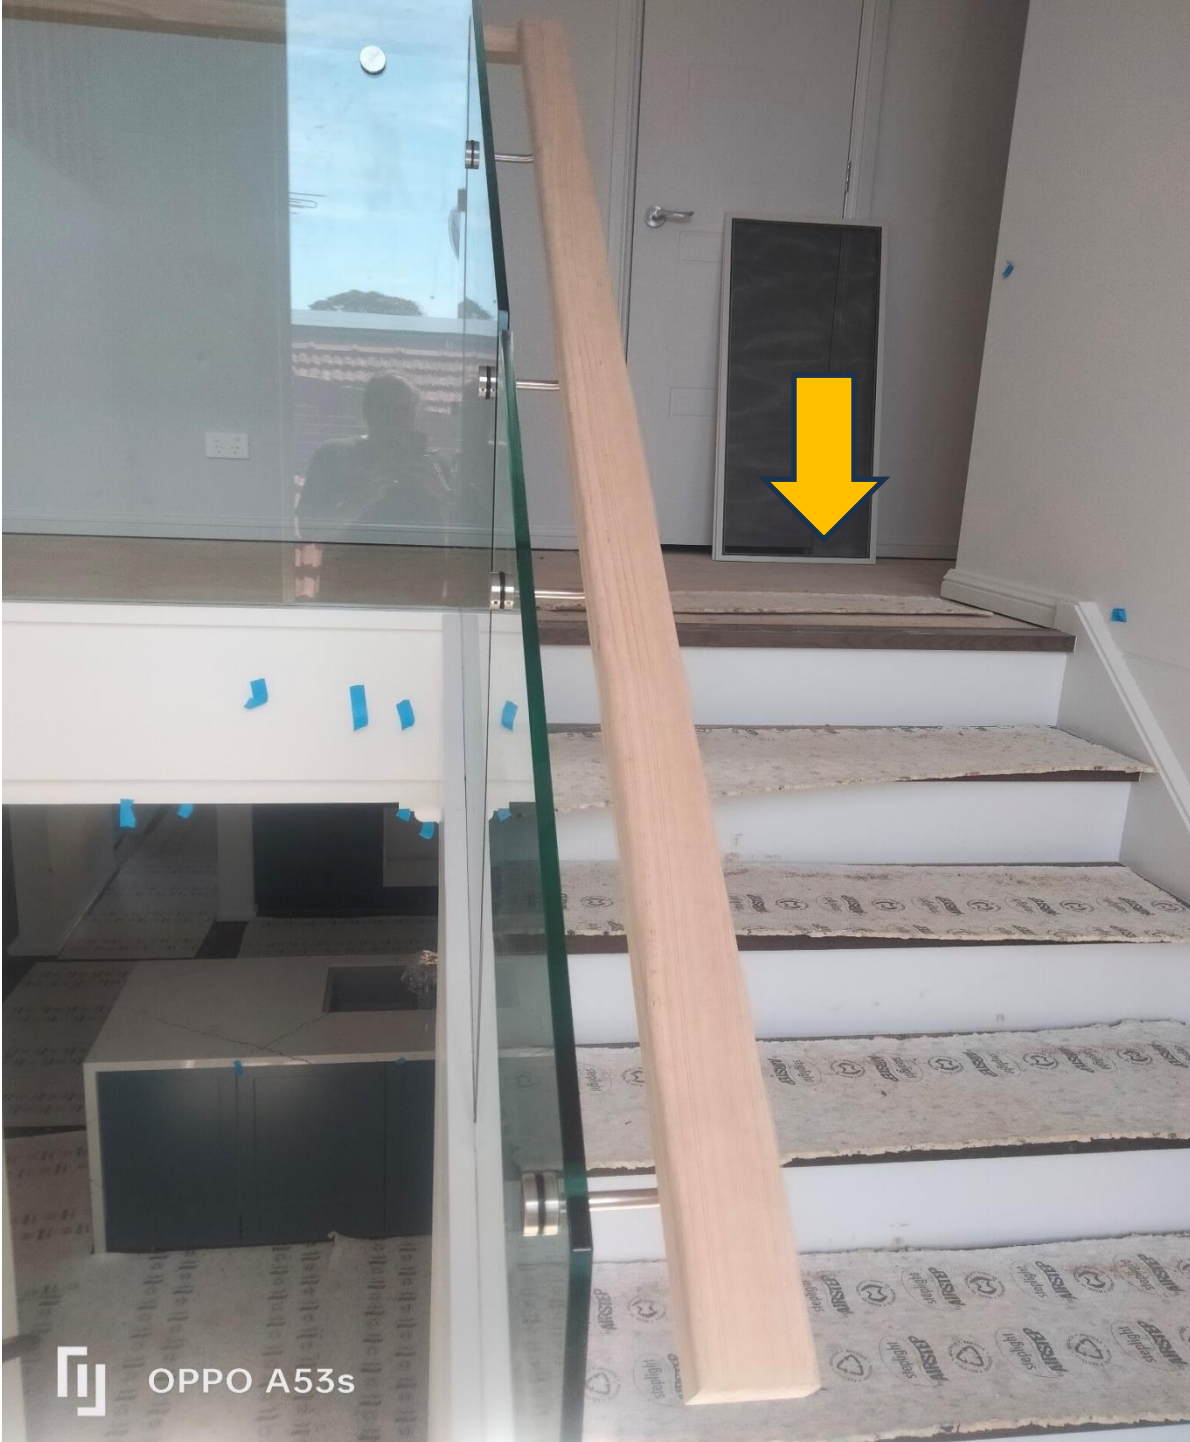
Figure 17 the top of the stairs was noted as squeaking. This is a defect.

Additional floor squeaks observed first floor.

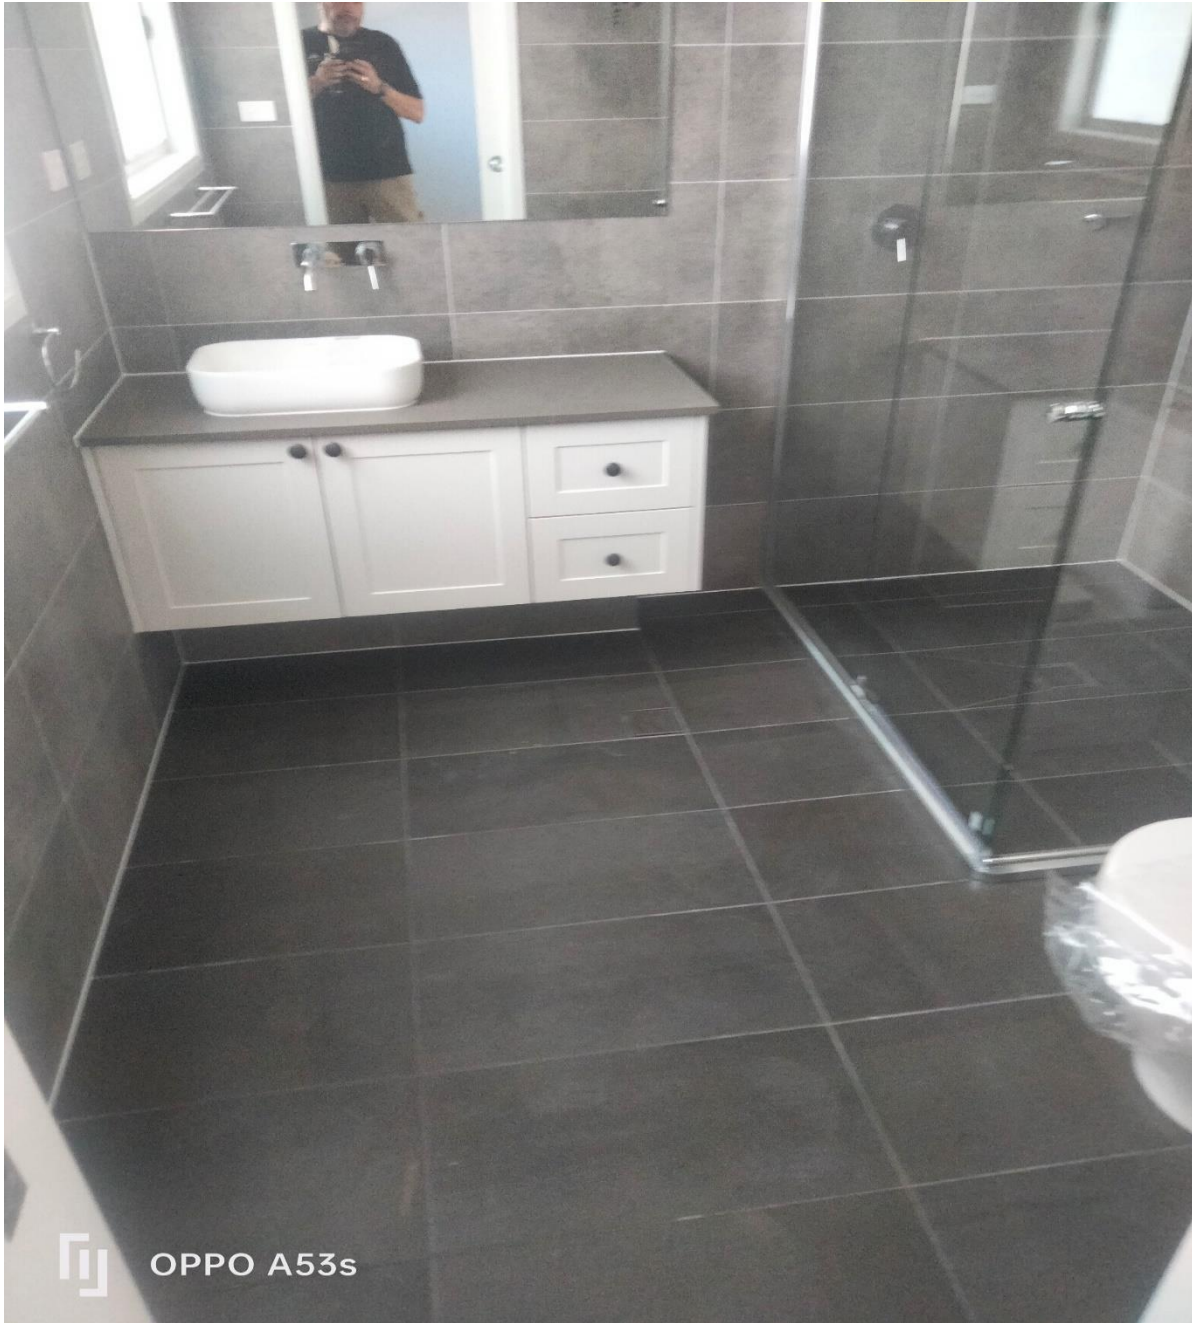
Figure 19 bathrooms were inspected and revealed incomplete works throughout including missing kitchen components.

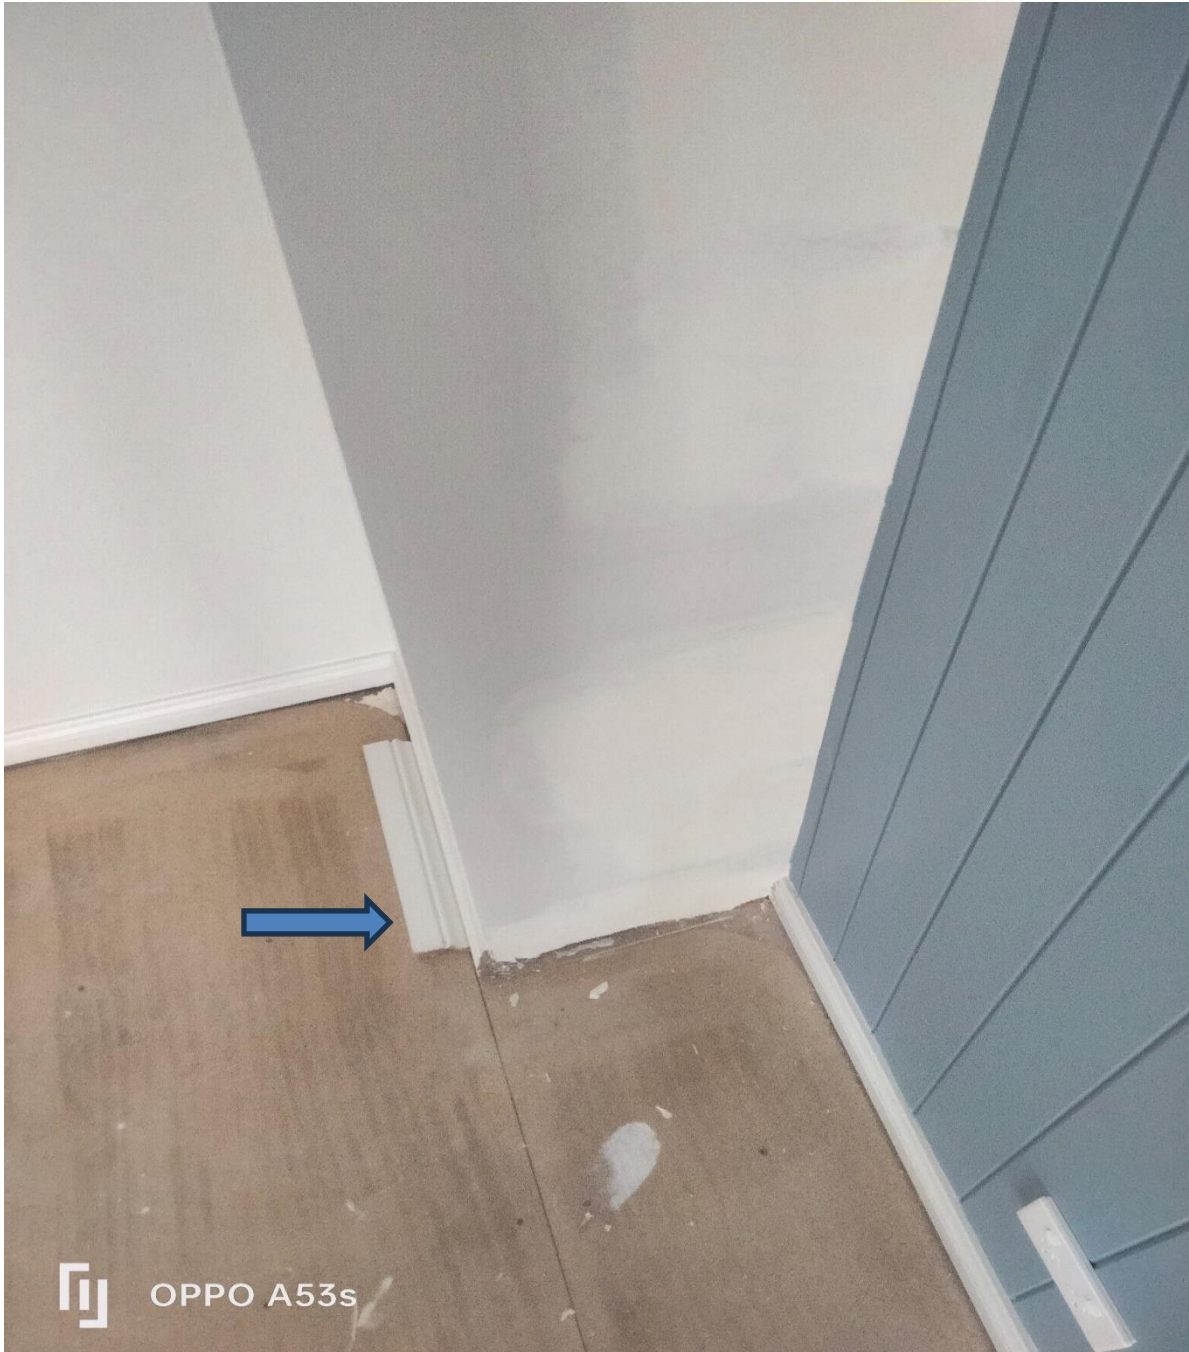
Figure 20 front main bedroom location skirtings were observed as incomplete.

Holes were observed in the overlay flooring builder to fill with silicone.
