## Handover Inspection Building Inspection Report To AS4349.0-2007 Inspection of Buildings General Requirements

Property Address: 1 Smith St Bondi

Name: John Sample report

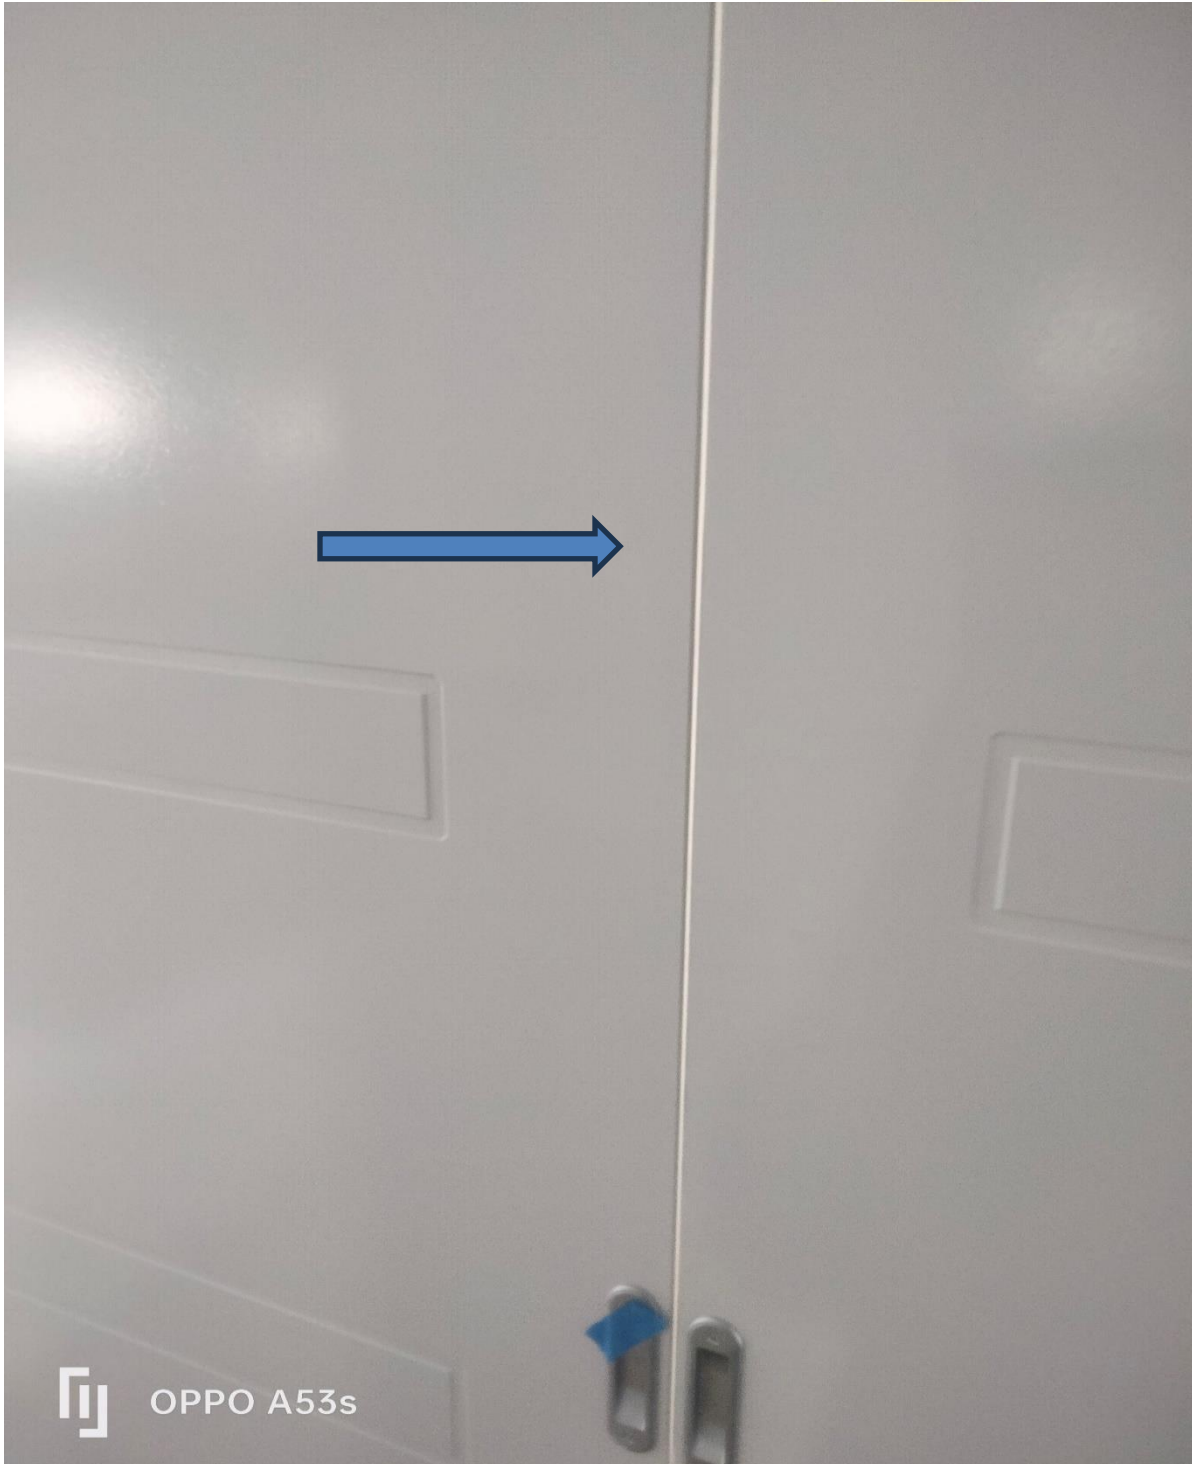
Figure 21 Ground floor sliding doors to the cinema room do not line up. This is a defect.

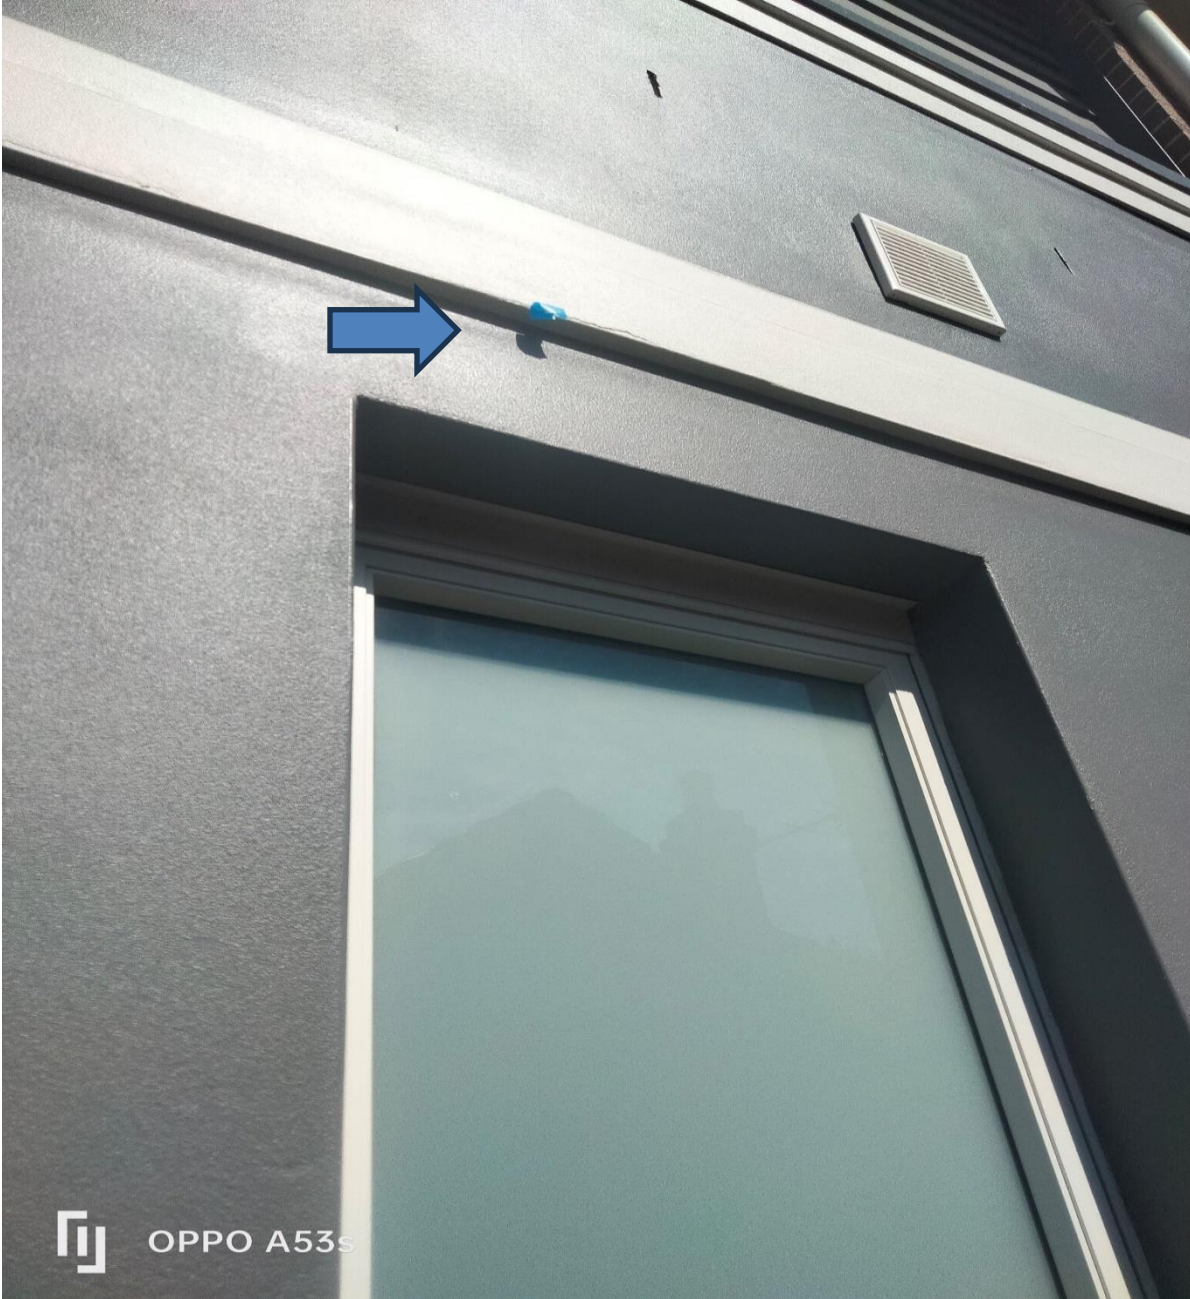
Figure 22 external render front right-hand side facing was observed as damaged requiring completion.

Visible from the natural viewing point. Incomplete work.

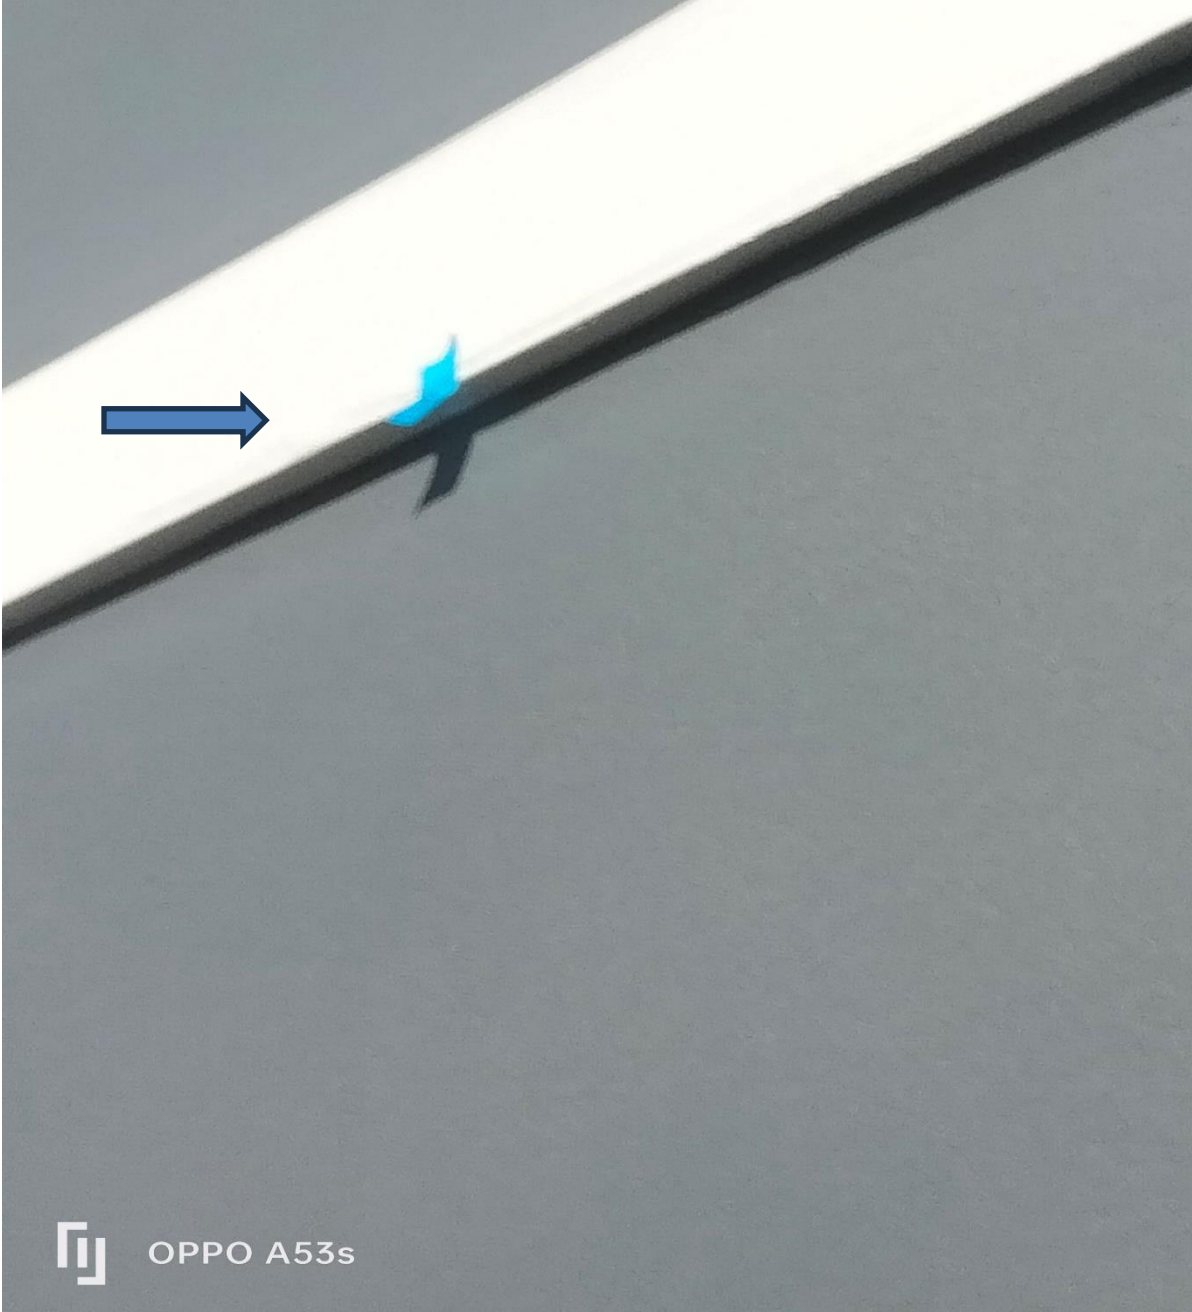
Figure 23 cracked mortar front right hand side facing.

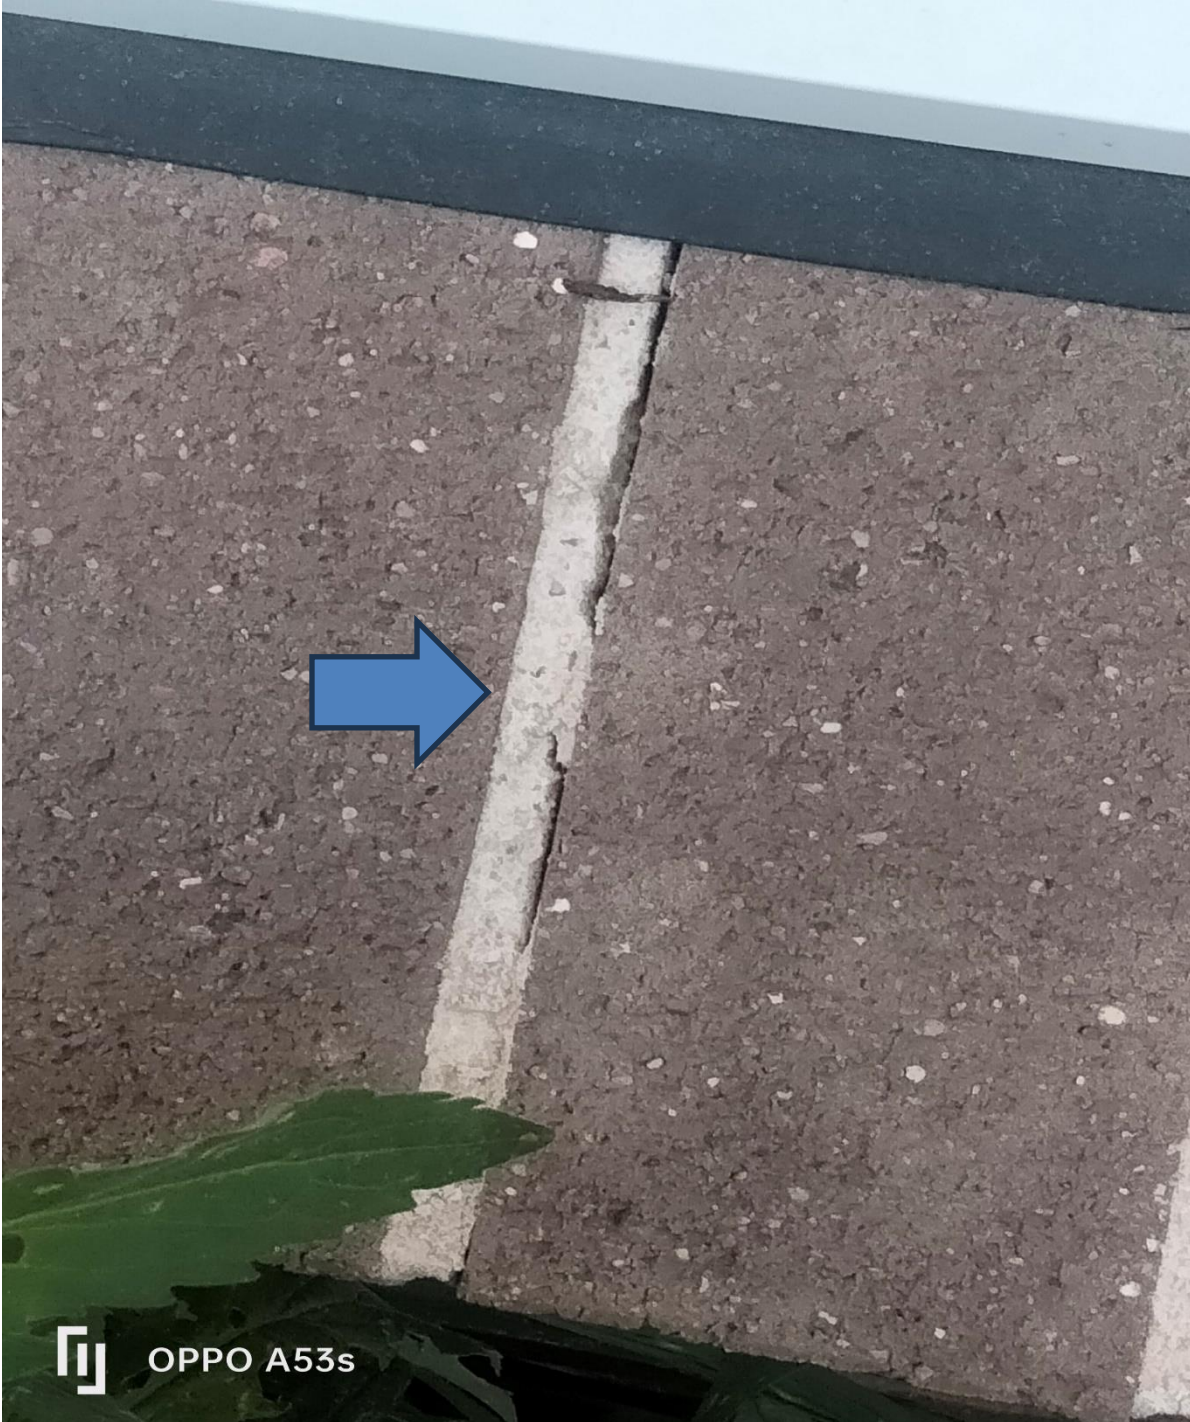
Figure 24 exterior brick work was observed as not compliant to windowsills and the exterior brick work not in accordance with NSW Fair trading tolerance Guide 2017.

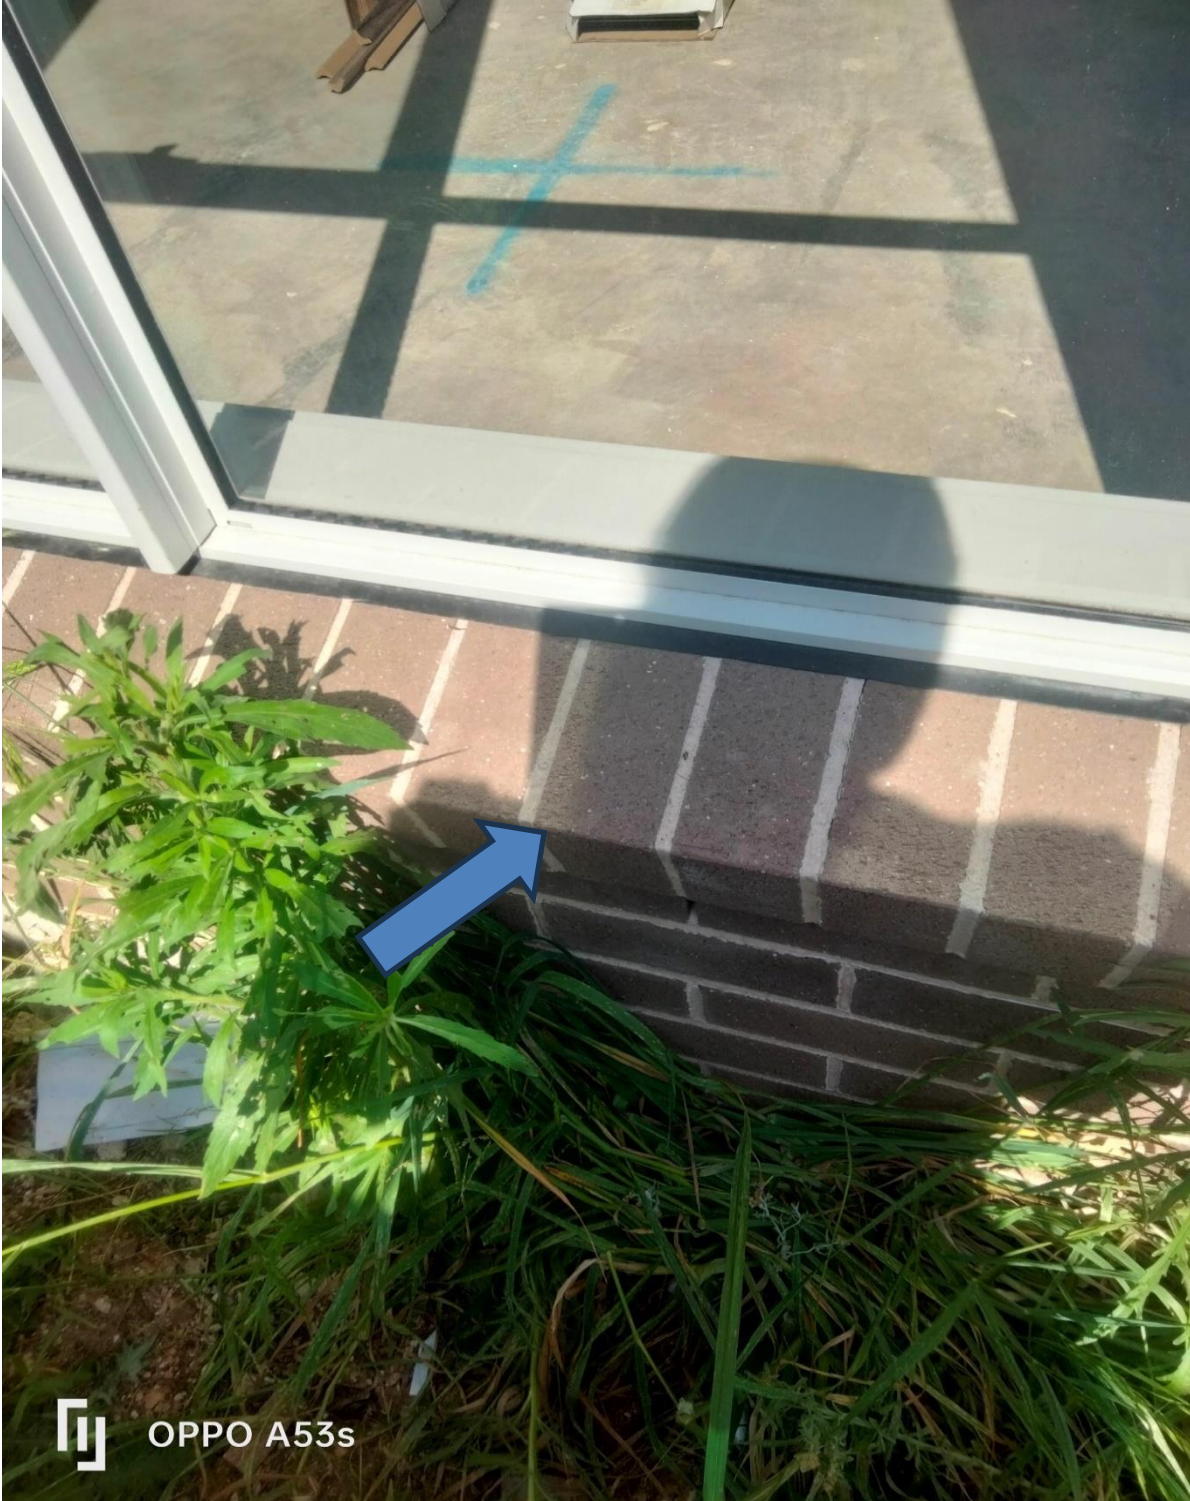
Figure 25mortar requires completion.

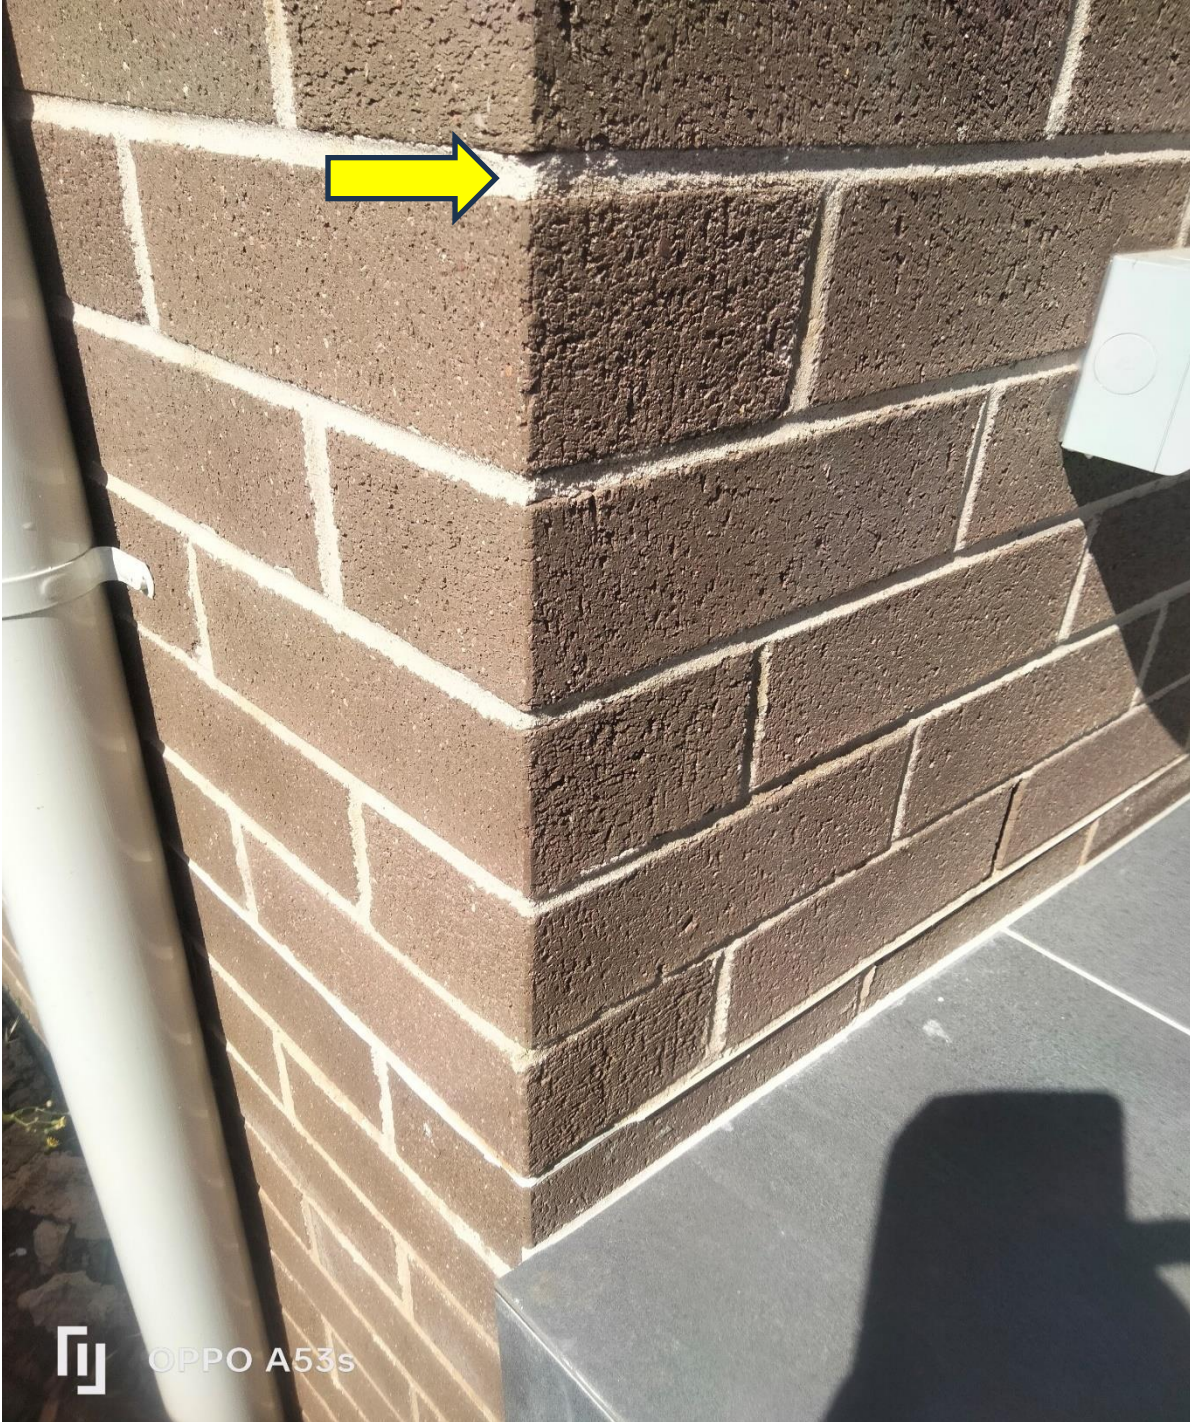
Figure 26 rear alfresco brick piers were observed as incomplete. This is non-compliant work.

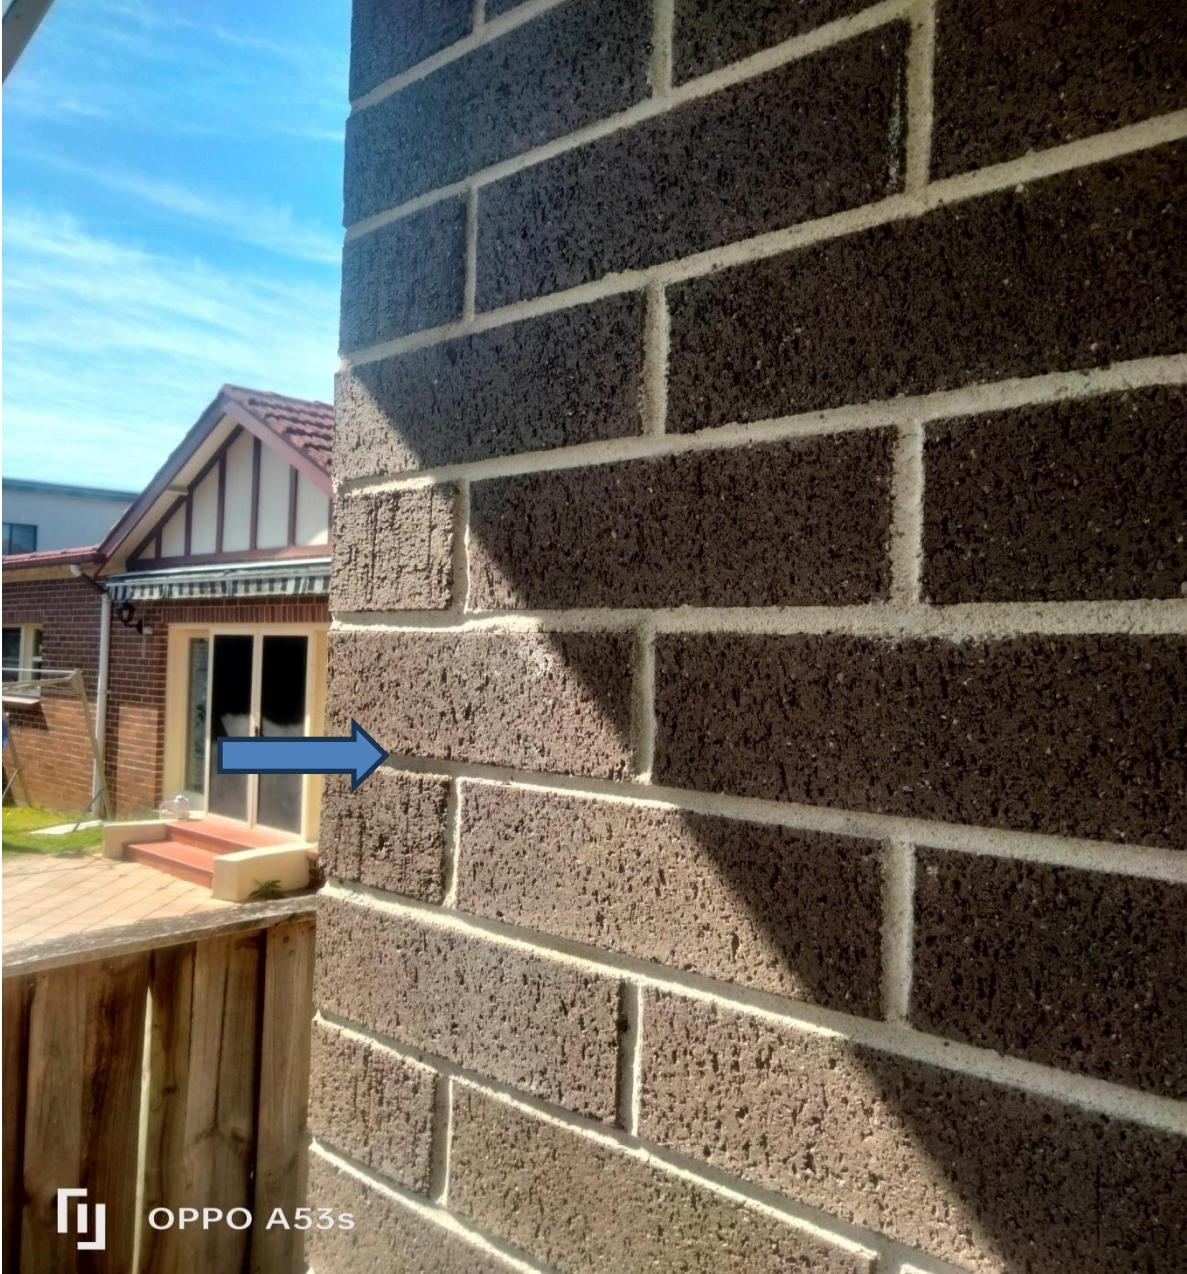
Figure 27 The rear exterior alfresco brick work was observed as requiring cleaning.

Voids and holes in mortar in masonry walls, with the exception of weepholes and vents, are defective if they are visible from normal viewing position, which is 1.5 metres.

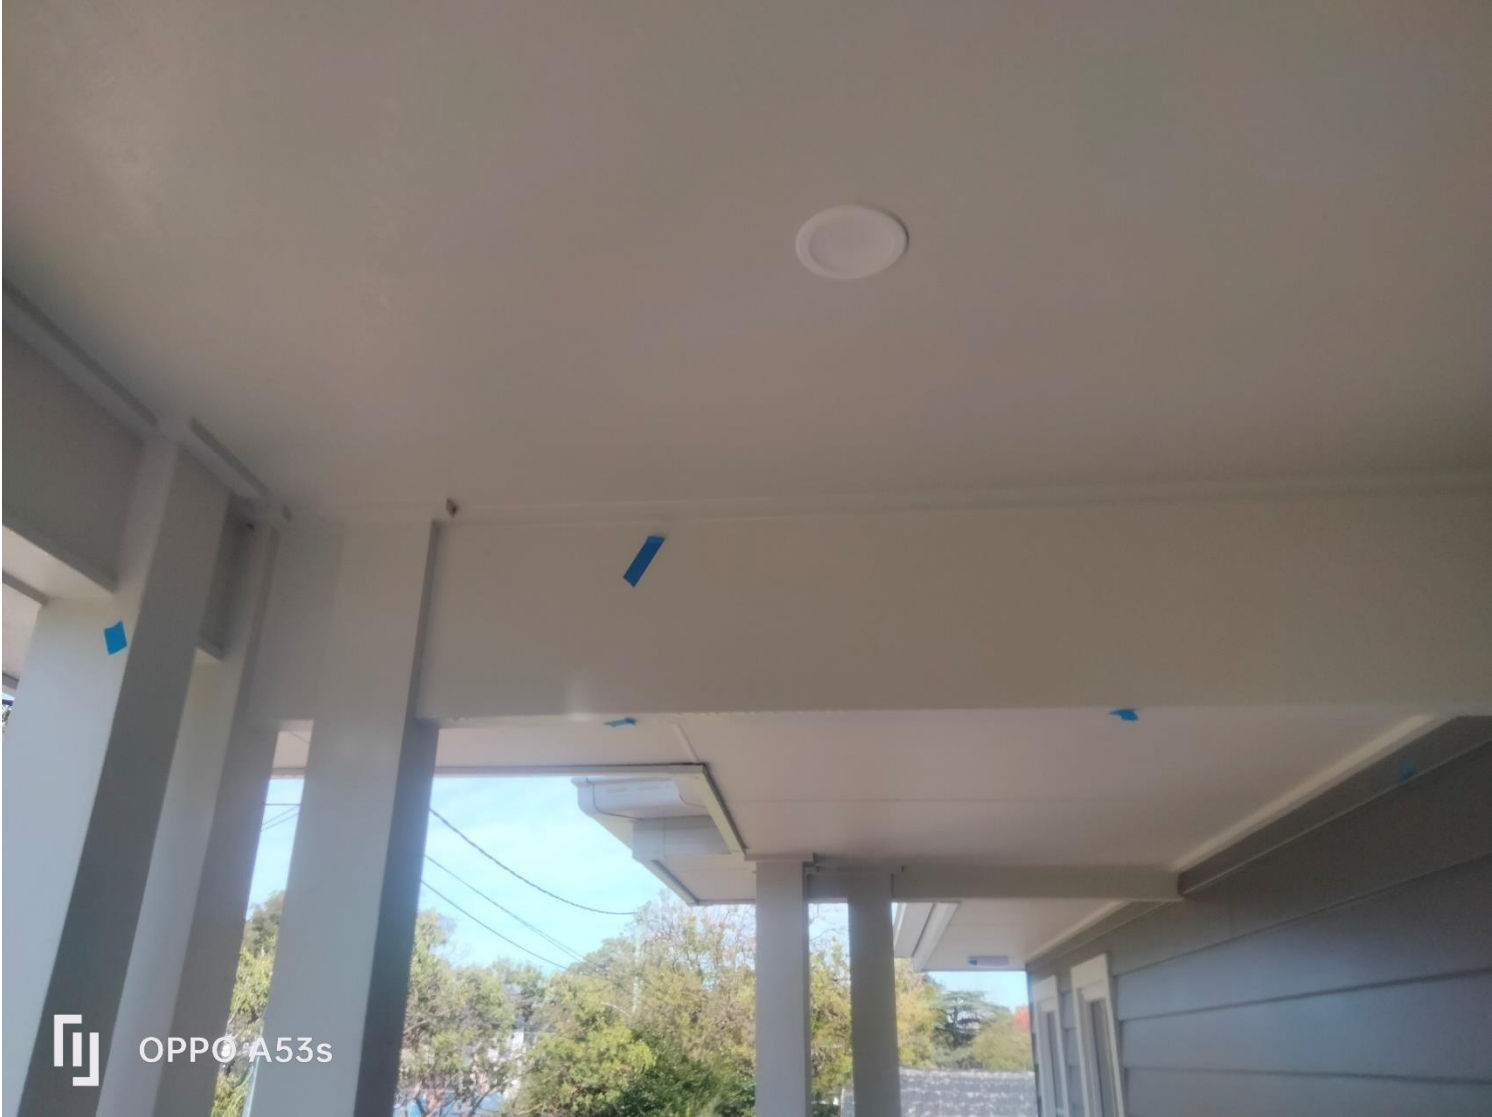
Figure 28 the ceiling to the alfresco ceiling was observed as not completed with regards to the painting, blue tape was observed indicating incomplete works.

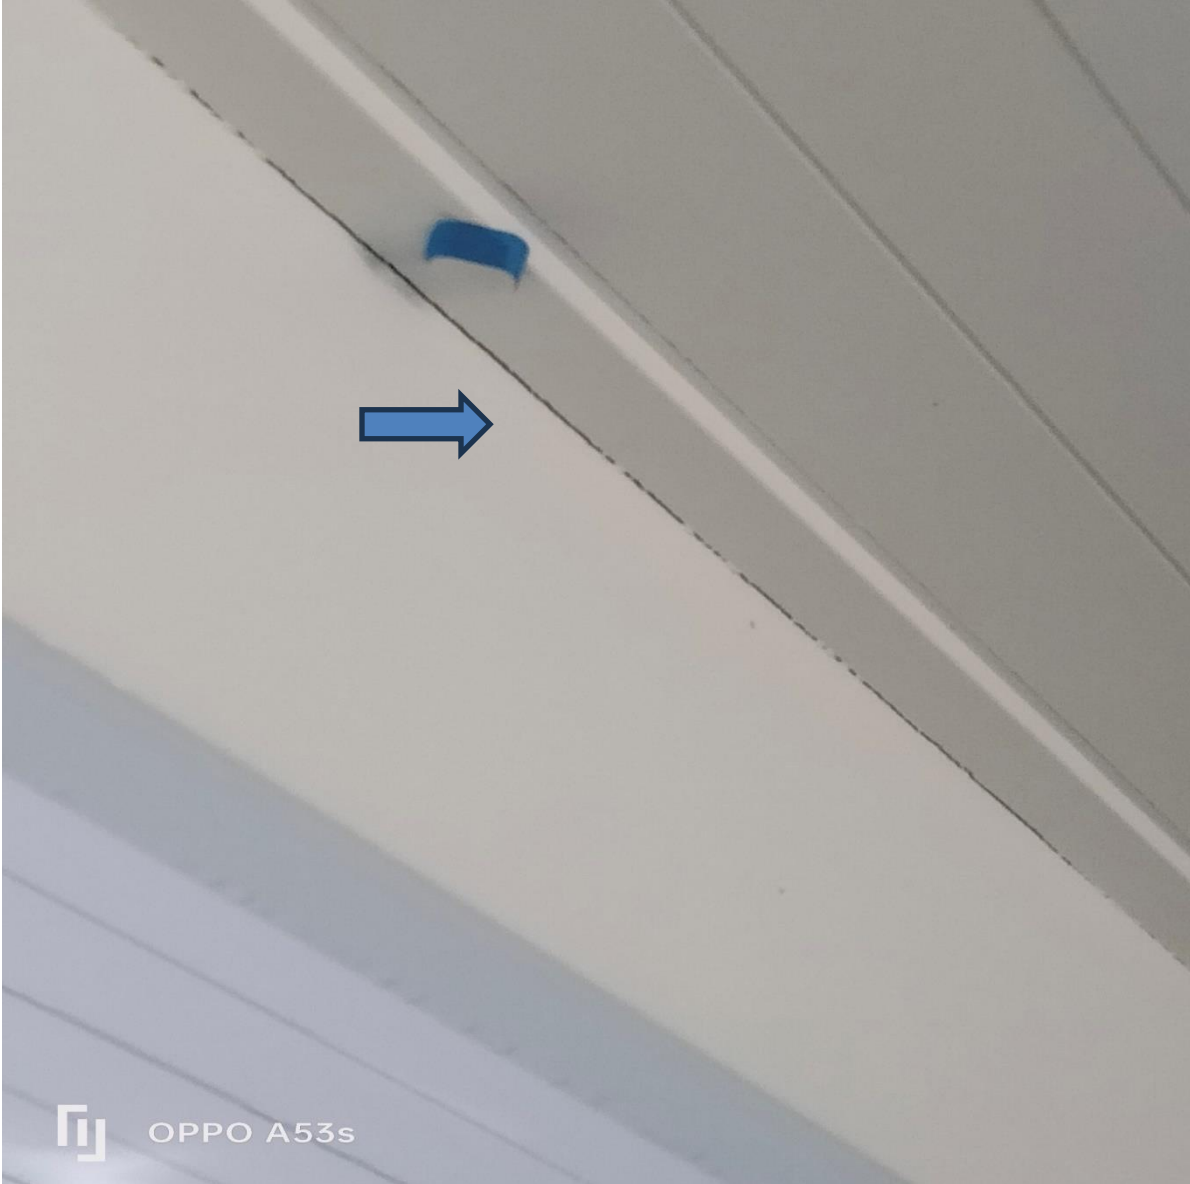
Figure 29 gap filler was observed as missing to the midpoint ceiling, incomplete work.

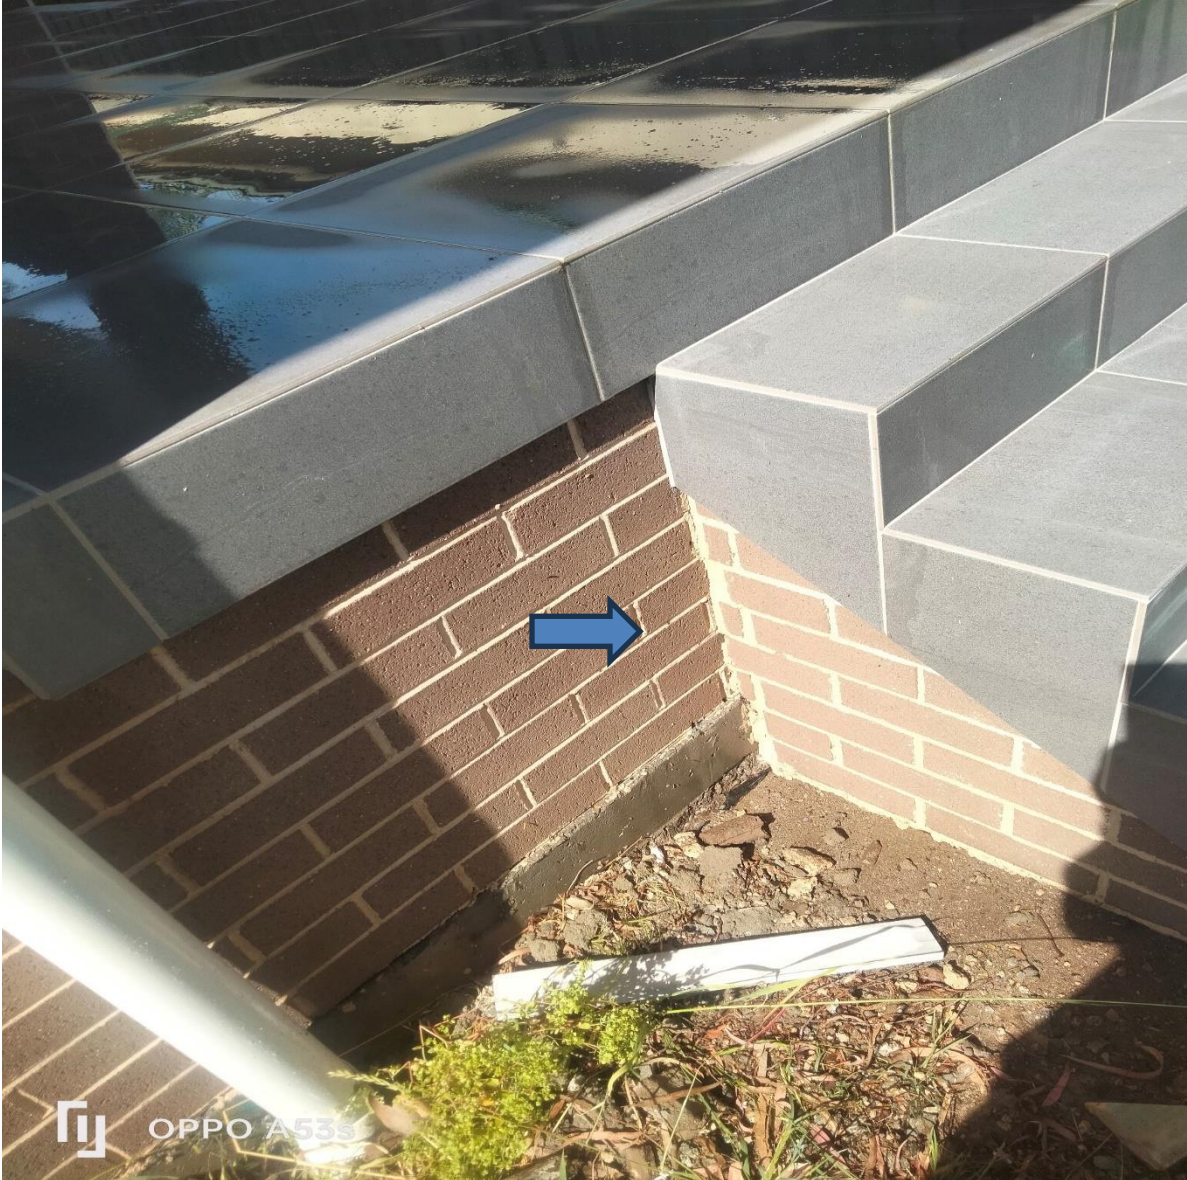
Figure 30 rear step location brick work was observed as requiring completion to the brick mortar, brick mortar was observed as incomplete.

Voids and holes in mortar in masonry walls, with the exception of weepholes and vents, are defective if they are visible from normal viewing position, which is 1.5 metres.

Builder to complete this work.

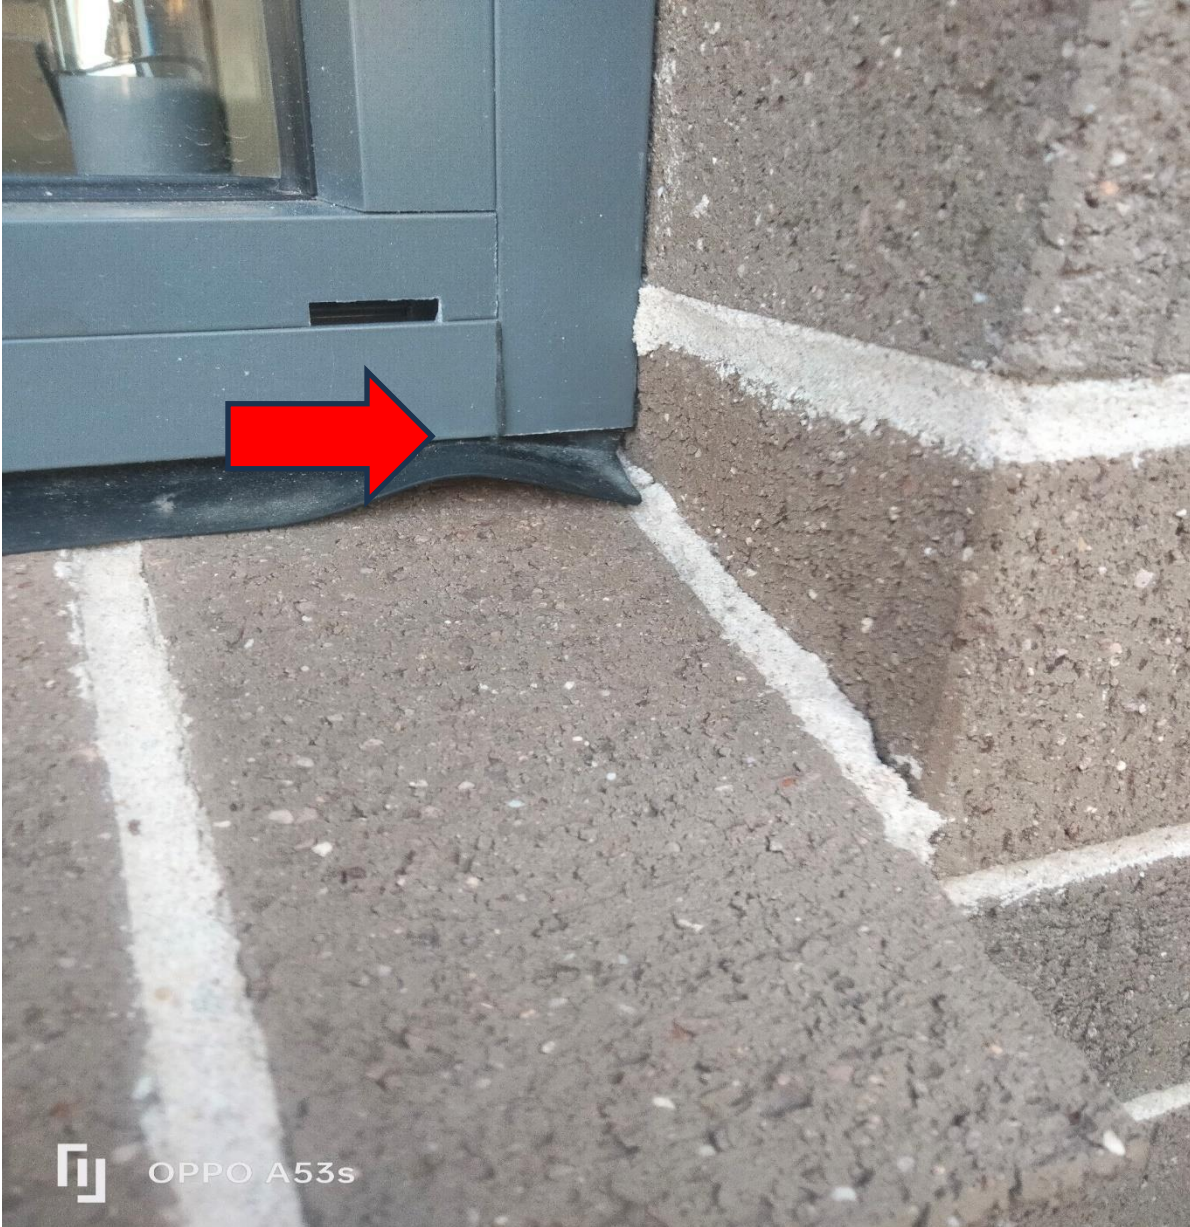
Figure 31 the window rubber seal is not installed correctly and may allow water to enter the building/.non-compliant work.

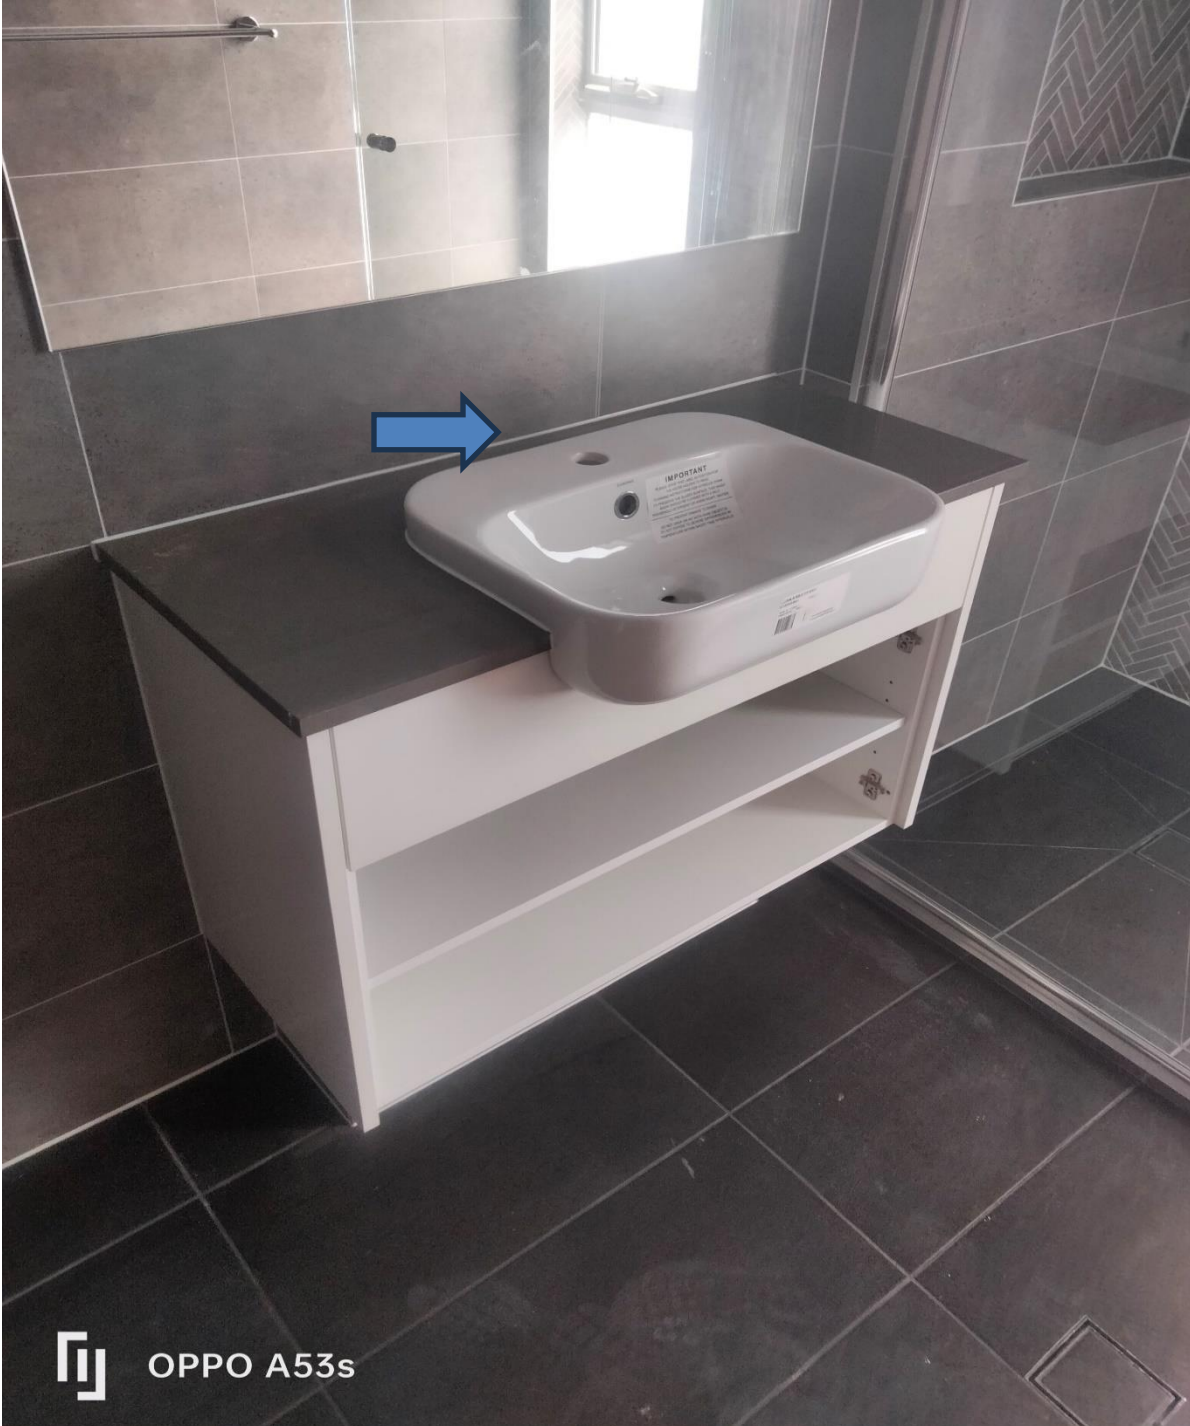
Figure 33 bathroom components were observed as missing.

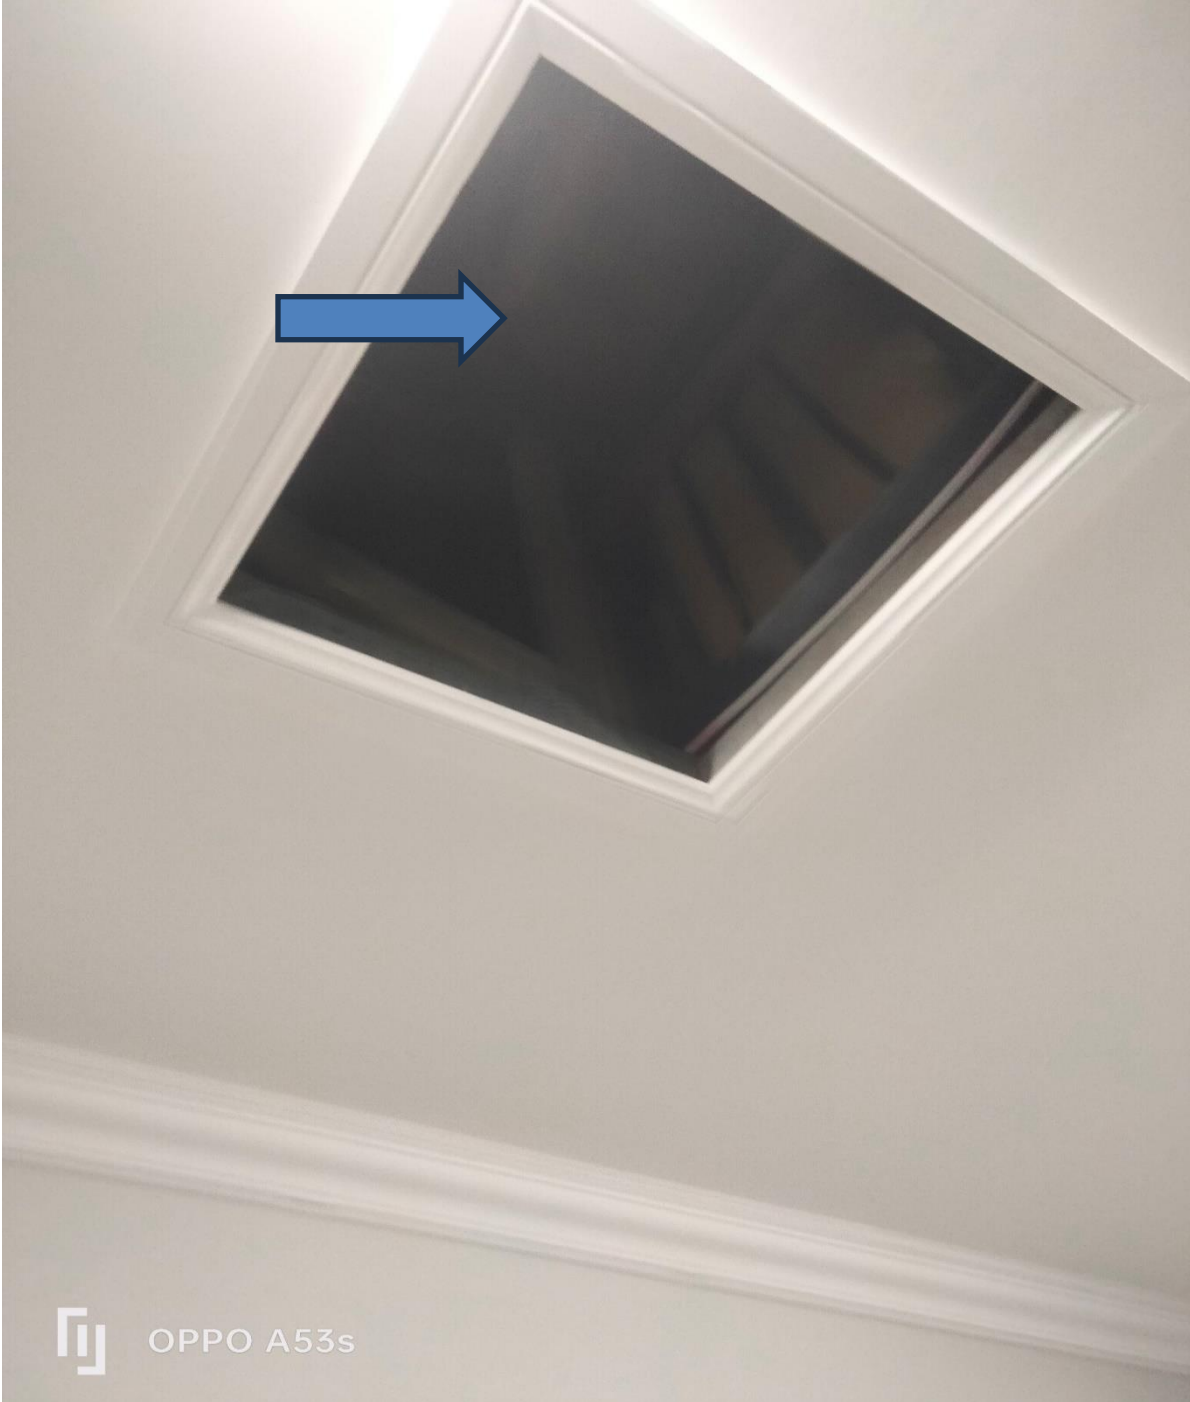
Figure 34 the manhole was observed as missing to the garage.
