## Handover Inspection Building Inspection Report To AS4349.0-2007 Inspection of Buildings General Requirements

Property Address: 1 Smith St Bondi

Name: John Sample report

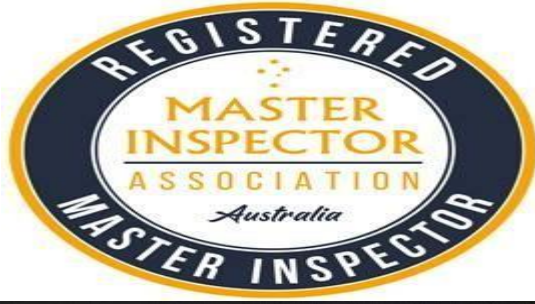
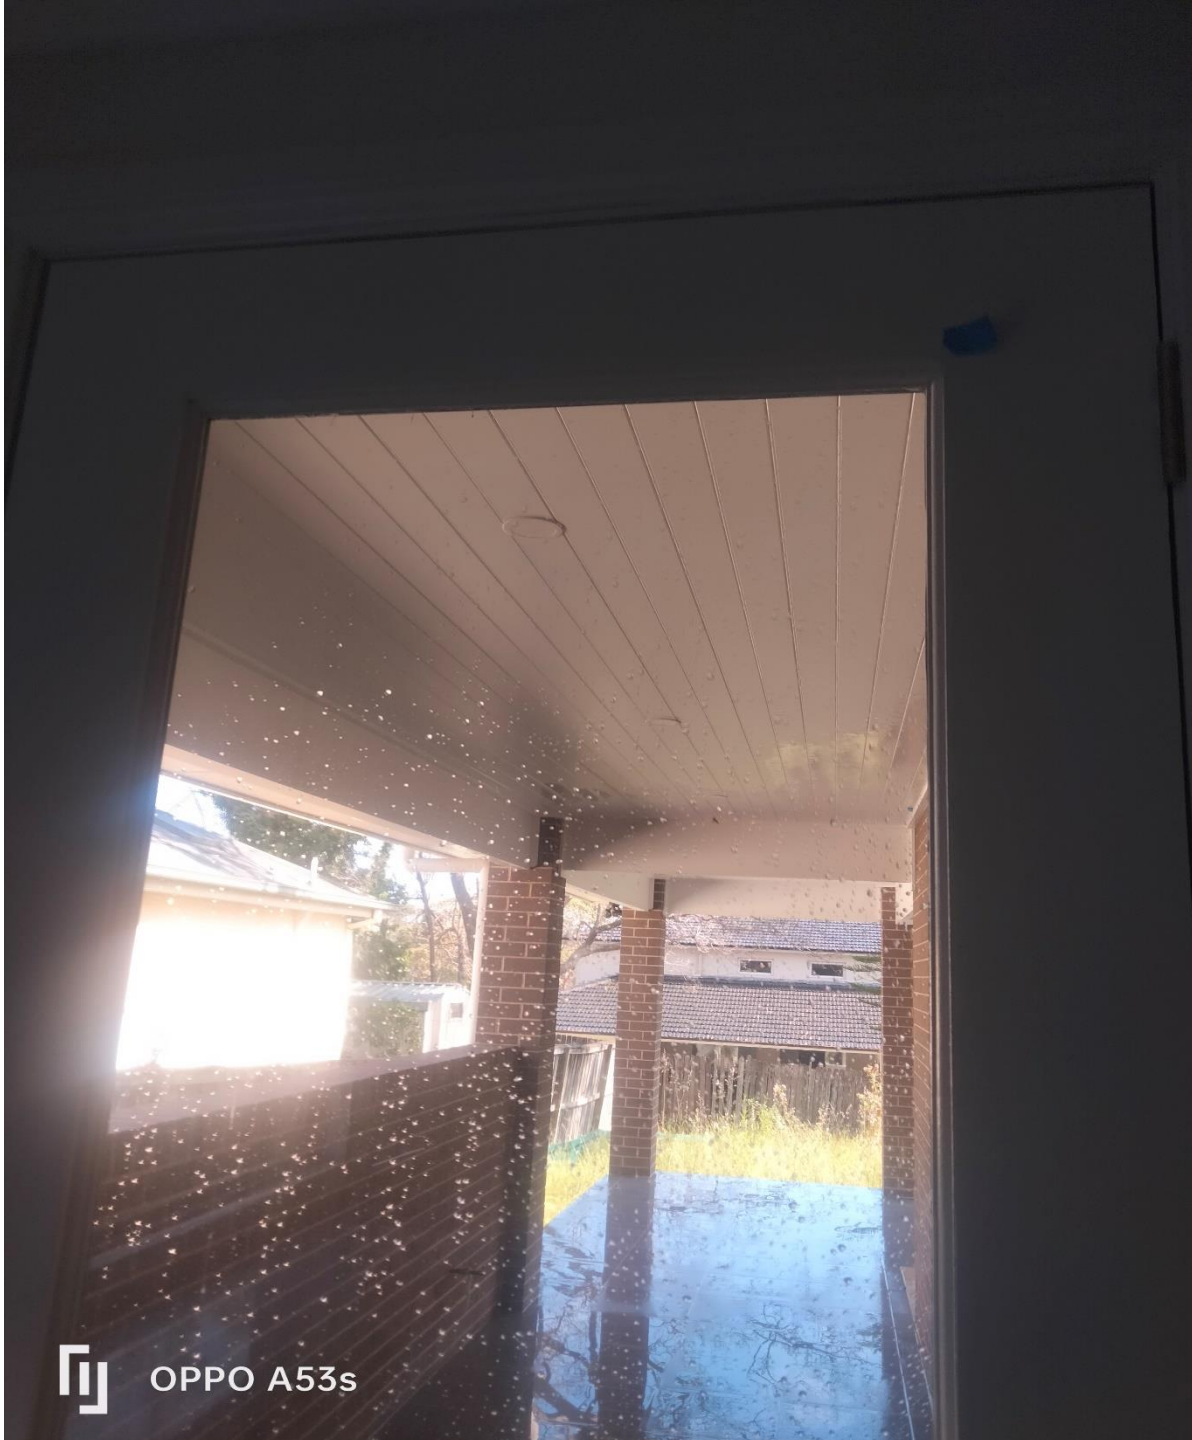
Figure 10 the exterior was high pressure water cleaned on the day of the inspection restricting access to the exterior.

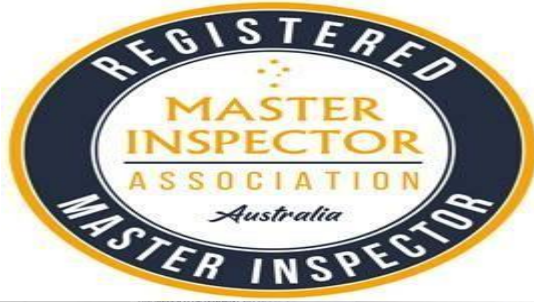
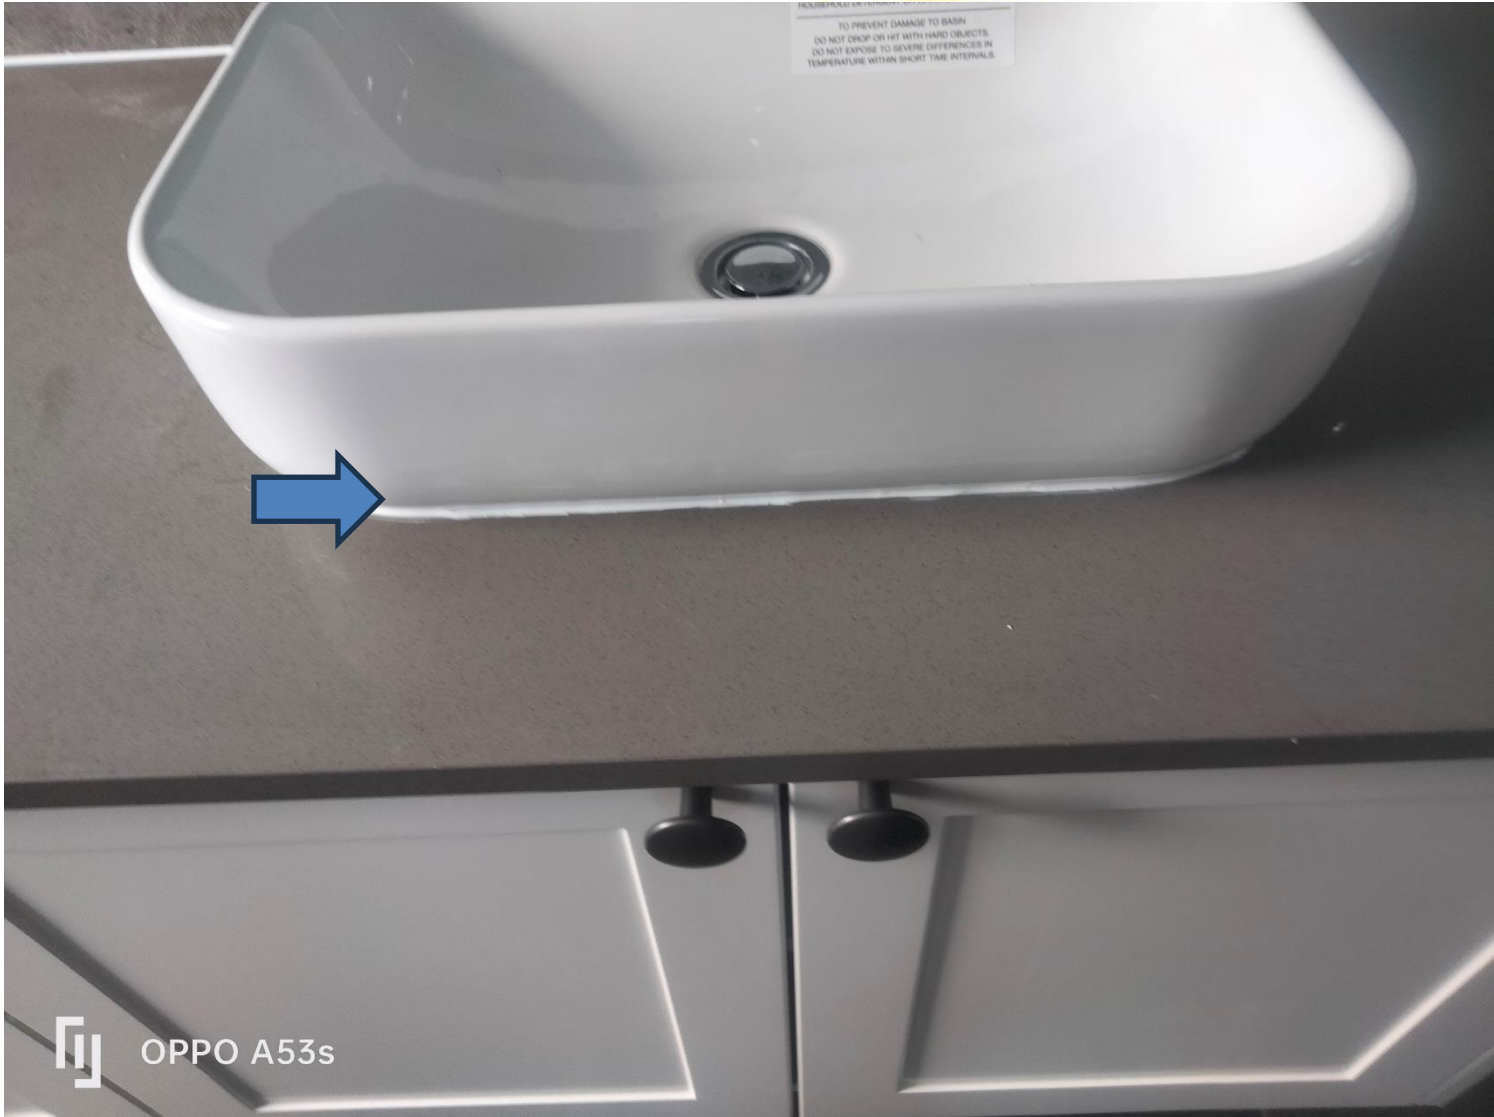
Figure 12 Rear ensuite vanity left hand side facing from the back has poor silicon application requiring completion.

Defect
